California 5 District: Delivery Operations

AUDIT REPORT

Report Number 24-027-R24 | March 22, 2024

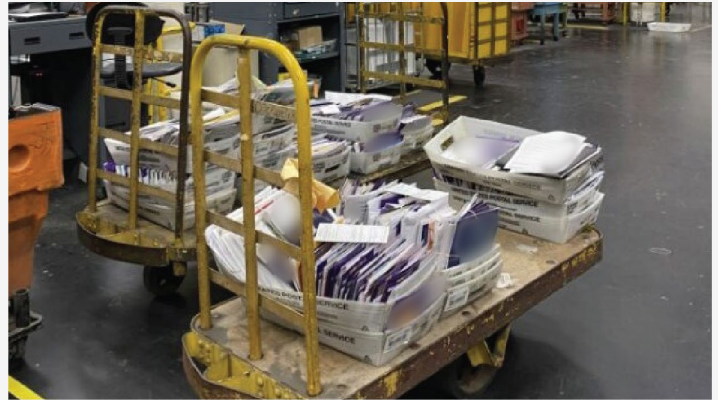
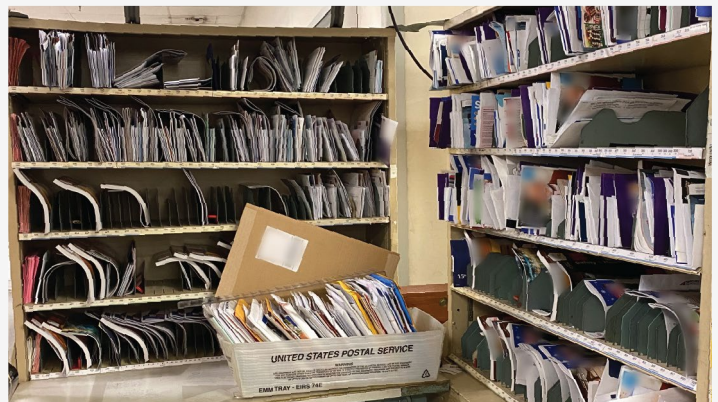
Figure 3. Examples of Delayed Mail at the Delivery Units

On the morning of November 14, 2023, we identified about 67,418 pieces¹² of delayed mail at the Dockweiler Station, Downtown Long Beach Station, and Inglewood Carrier Annex. The delayed mail included 427 Business Reply Mail (BRM)¹³ pieces at the Dockweiler Station and 225 BRM pieces at the Downtown Long Beach Station that had not been processed and given to carriers to deliver. Management at the Downtown Long Beach Station did not accurately report this mail as undelivered; and the Dockweiler Station and Inglewood Carrier Annex did not report any of this mail in the Delivery Condition Visualization (DCV)¹⁴ system. See Table 4 for the number of pieces for each mail type and Figure 3 for examples of delayed mail found at the units.

We recommend the **District Manager, California 5 District**, provide sufficient management oversight of staff at the Dockweiler and Downtown Long Beach Stations and the Inglewood Carrier Annex to deliver all committed mail daily.

We recommend the **District Manager, California 5 District**, verify that management at the Dockweiler and Downtown Long Beach Stations and the Inglewood Carrier Annex conduct mail sweeps and enter all delayed mail into the Delivery Condition Visualization system accurately.

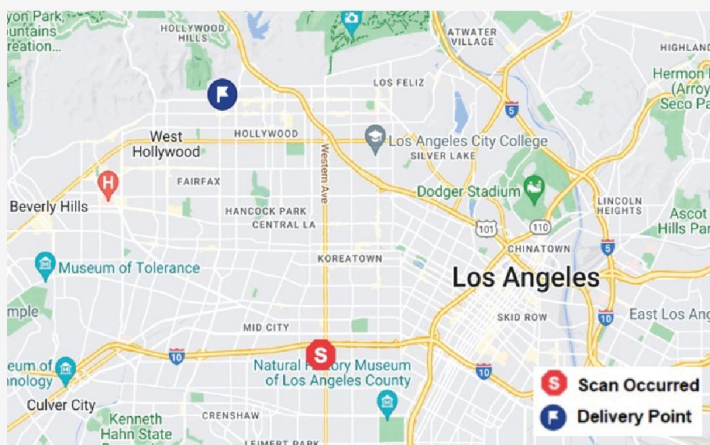
Figure 4. Scan Away From the Delivery Point

For example, the map below (see Figure 4) shows an instance where a carrier scanned a package as delivered 2.2 miles away from the delivery point.

We recommend the **District Manager, California 5 District**, verify unit management review package scanning performance data daily and enforce compliance at the Dockweiler and Downtown Long Beach Stations and Inglewood Carrier Annex.

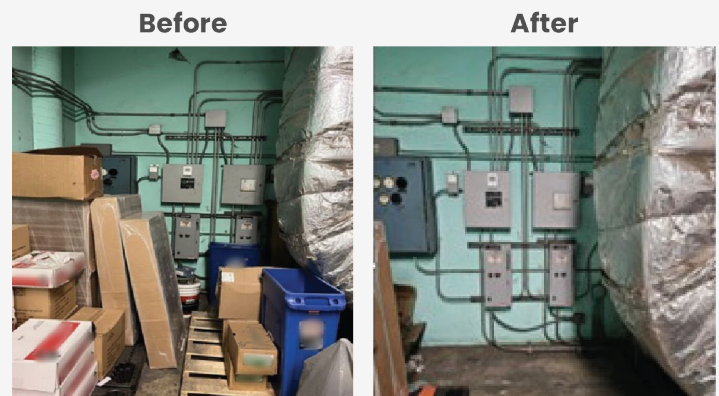
Figure 5. Blocked Electrical Panels at the Dockweiler Station

- At the Dockweiler Station, we found one of 10 fire extinguishers missing a monthly inspection and three blocked by mail transport equipment. In the workroom were exposed and low hanging wires, an unsecured ladder, improperly stored container of flammable liquid, and blocked electrical panels (see Figure 5). In addition, we identified a damaged sidewalk in the customer parking

During our audit, district management provided documentation showing that they have addressed all property condition issues identified at the three delivery units. Therefore, we will not be making any recommendations for this finding. See the figures below as examples of issues abated at the three units.

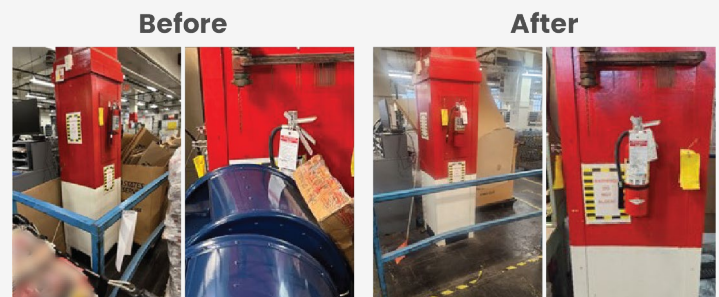
Figure 6. Two blocked Fire Extinguishers at Downtown Long Beach Station

- At the Downtown Long Beach Station, we found two blocked fire extinguishers (see Figure 6), an uncovered lobby fire alarm, one blocked manual fire alarm, and an automatic handicap-use lobby door that was inoperable.
- At the Inglewood Carrier Annex, we found one blocked fire extinguisher, 17 missing annual inspections, three missing monthly inspections, and a faded location sign. Also, there was a broken dock camera, several missing “This is Not an Exit” signs, a hanging electrical cord (see Figure 7), improperly stored cleaning solutions, a broken dock lift, and a large hole in the ground adjacent to a dock area foot path.
