Office of Inspector General | United States Postal Service

Audit Report

Efficiency and Safety of Lift Gates

Report Number 20-203-R20 | September 16, 2020

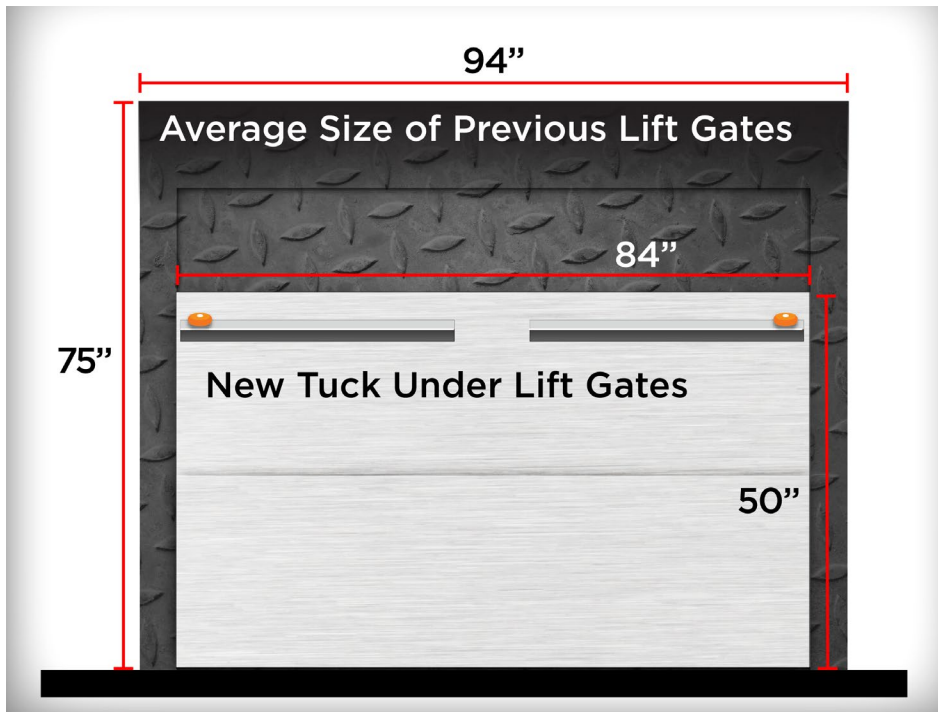
Figure 1. Comparison of Previous Lift Gates to the New Tuck Under Lift Gate in Portland, OR

For example, we did receive specifications for three older rail lift gates from management at the Portland VMF. The lift gates on average, measured 94 inches wide by 75 inches long. The new tuck under lift gates are 10 inches narrower and 25 inches shorter compared to the previous rail lift gates (see Figure 1).

We recommend the **Vice President, Logistics**, reevaluate the effectiveness of the new tuck under lift gates and the process of loading/unloading mail transport equipment to determine if changes are needed to increase efficiency.

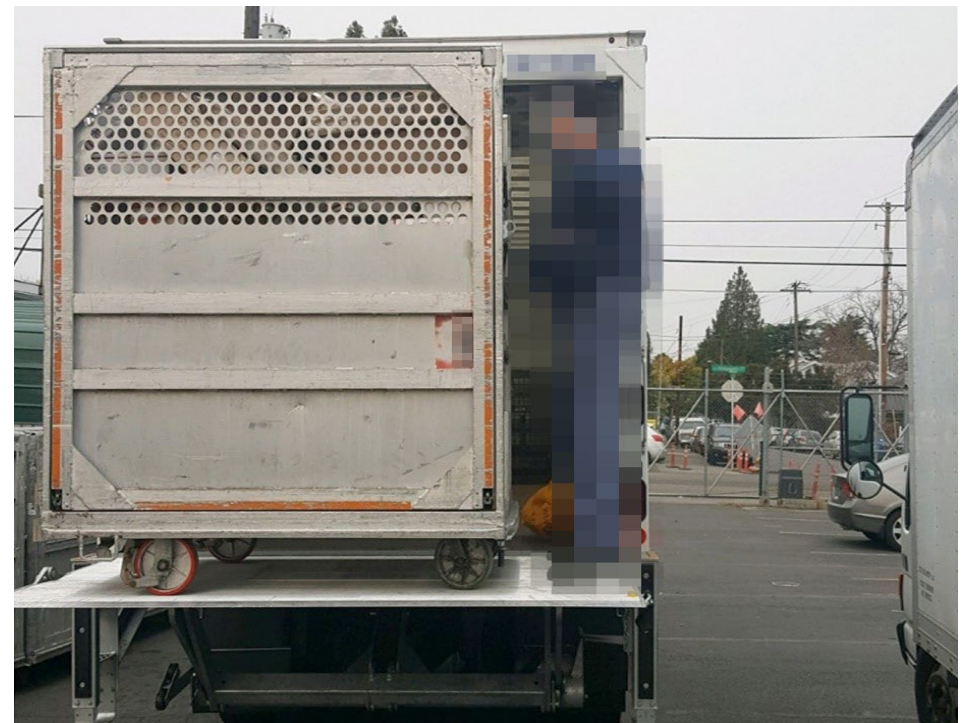
Figure 2. OTR Container on the New Tuck Under Lift Gate

Additionally, to compensate for the smaller size, PVS drivers must place MTE, such as over the road (OTR)² containers and pallet jacks, sideways on the tuck under lift gates (see Figure 2). PVS drivers also have to pull MTE off the tuck under lift gate; however, Postal Service policy states that MTE should be pushed, rather than pulled.³

Source: Picture from Postal Service presentation on the new tuck under lift gates on April 19, 2019. Also, the safety stoppers are not up.

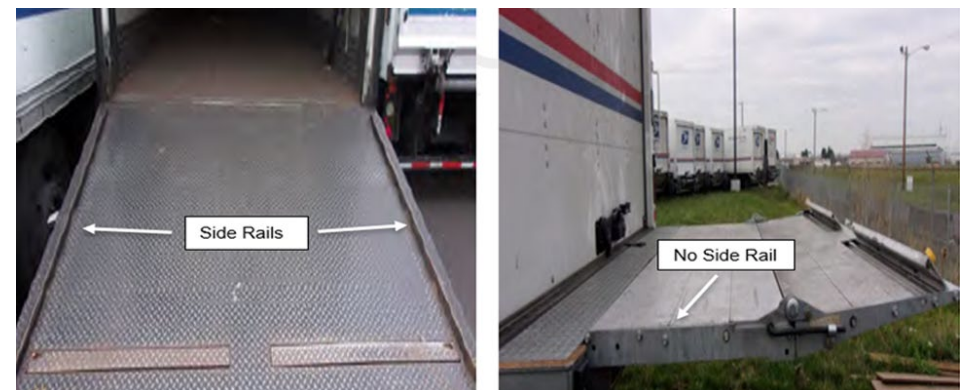
Figure 4. Side Rails on Lift Gates

- Short and narrow on 11-ton cargo vans.
- Steep incline when it is in the down position and when it is being raised.
- No side rails to prevent MTE from rolling off (see Figure 4).

Source: Pictures from Postal Service personnel in Portland, OR, on October 13, 2019. Picture on the left is an older, customized rail lift gate with side rails. Picture on the right is the new tuck under lift gate with no side rails.

OSHA requested that the Postal Service investigate the complaint and provide the results of the investigation and the corrective action taken. To resolve the issue, Postal Service's Arizona District Safety office created an On-the-Job Safety Review/Analysis (JSA)⁹ to address the safety concerns. The JSA was sent to transportation management at the Phoenix P&DC to share with the PVS drivers.

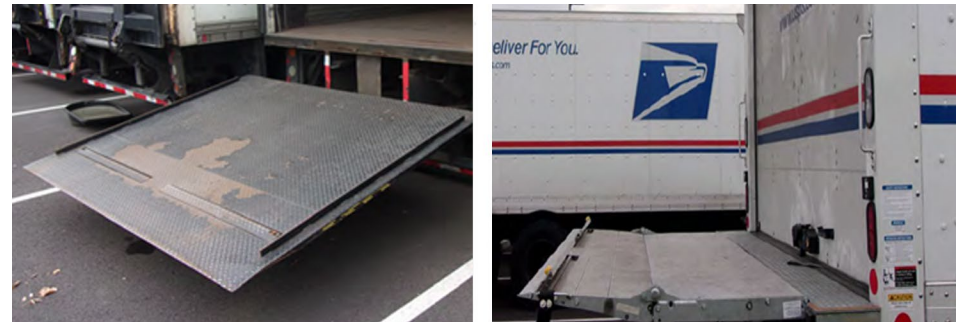
Figure 6. Comparison of Size of Prior Lift and New Tuck Under Lift Gate

- No safety rails to prevent MTE from rolling off.
- Unsafe to operate on uneven surfaces.¹⁷
- MTE must be loaded sideways due to the smaller size.
- Too narrow (see Figure 6).
- No tilt function.

Source: Pictures from Postal Service personnel in Portland on October 13, 2019. Picture on the left is the old rail lift gate and the picture on the right is the new tuck under lift gate.

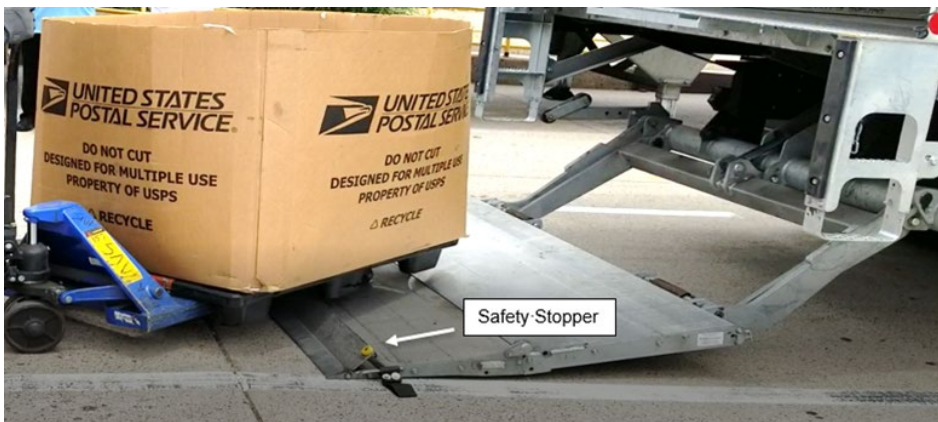
Figure 9. Pallet Jack With MTE Getting Stuck

- Not sufficient room for a PVS driver to stand alongside MTE.
- Some MTE has to be pulled, not pushed, when loading/unloading.
- Issues with the safety stoppers keeping MTE from falling off (see Figure 9).
- Durability due to the lift gates bending and tilting.

Source: Picture from Phoenix P&DC personnel recording a PVS driver loading MTE with a pallet jack and getting stuck on the safety stopper. Fleet Management personnel stated the safety stoppers should be down when loading MTE.

We recommend the **Vice President, Employee Resource Management**, perform a safety assessment to evaluate the new lift gates and in coordination with the **Vice President, Logistics**, develop a national training program and create a standard operating procedure on the operation and safety of the new lift gates to determine if modifications are needed.
