Office of Inspector General | United States Postal Service

Audit Report

Property Condition Reviews – Garyville, North Kenner, and Lake Forest Post Offices in Louisiana

Report Number 21-093-R21 | April 14, 2021

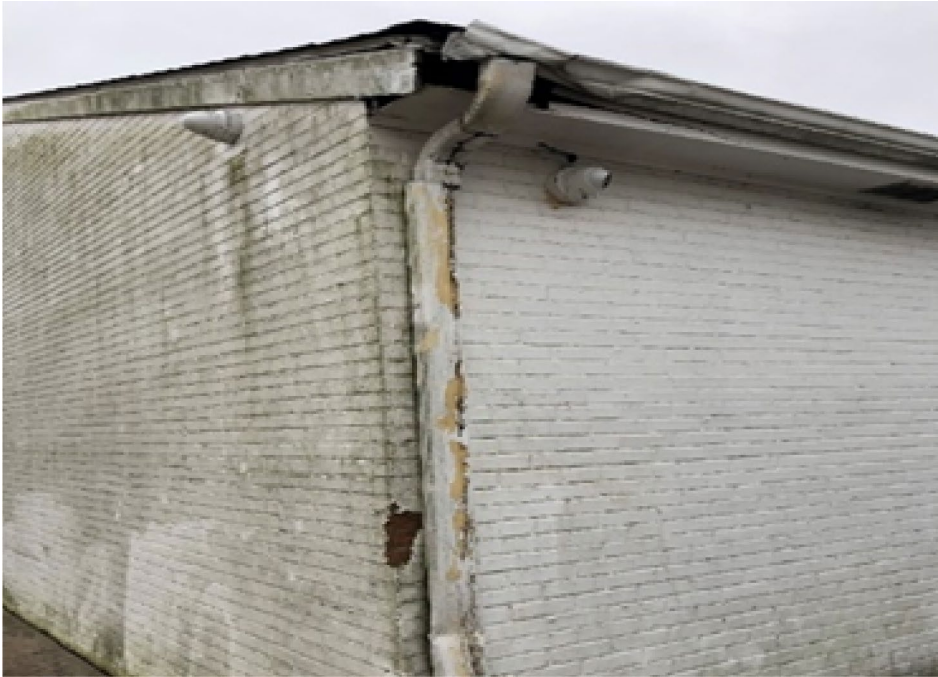
At the Garyville Post Office, we identified rotted wood and damaged gutters (see [Figure 1](#)), a missing drain spout (see [Figure 2](#)), damage to the metal trim above the dock door (see [Figure 3](#)), and the air conditioning (AC) guardrail was leaning and rusted (see [Figure 4](#)).

Figure 1. Rotted Wood and Damaged Gutter

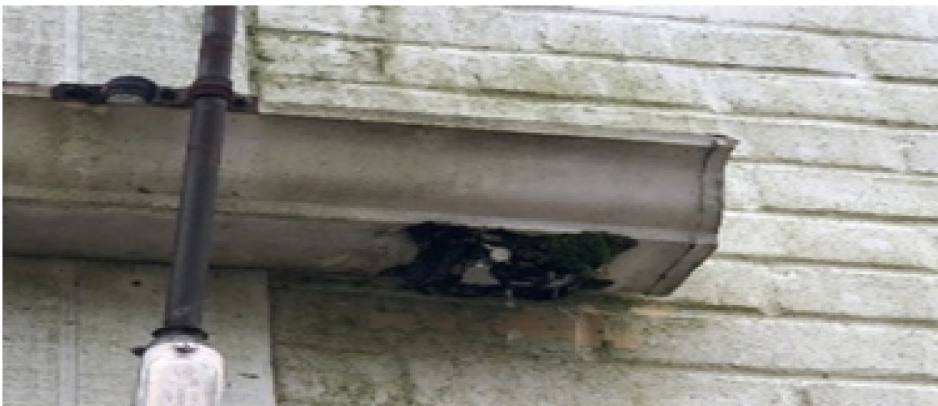
Figure 2. Missing Drain Spout

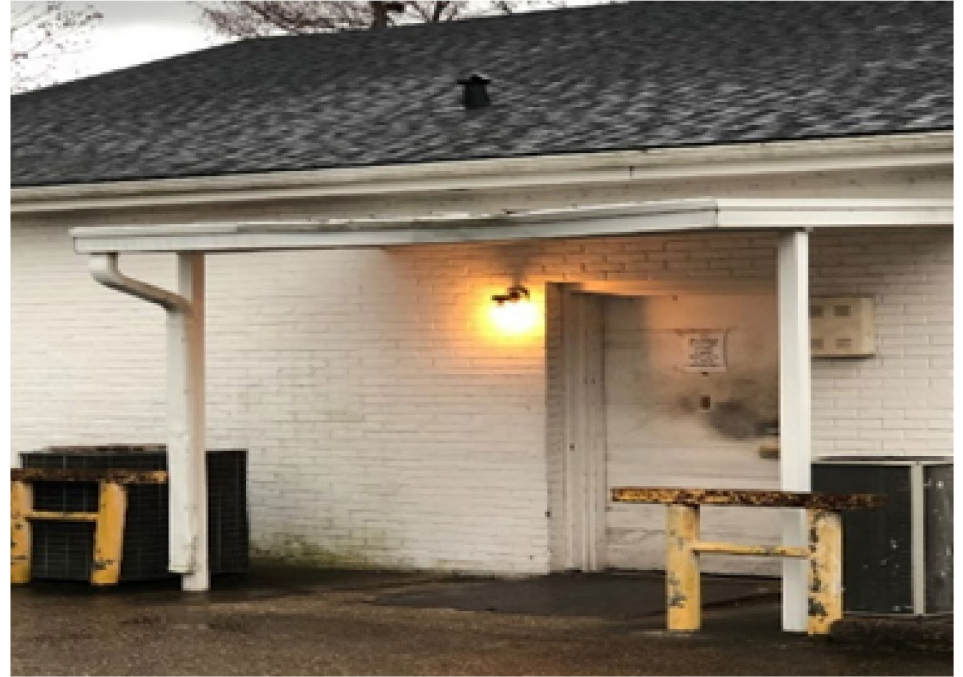
Figure 3. Damaged Trim

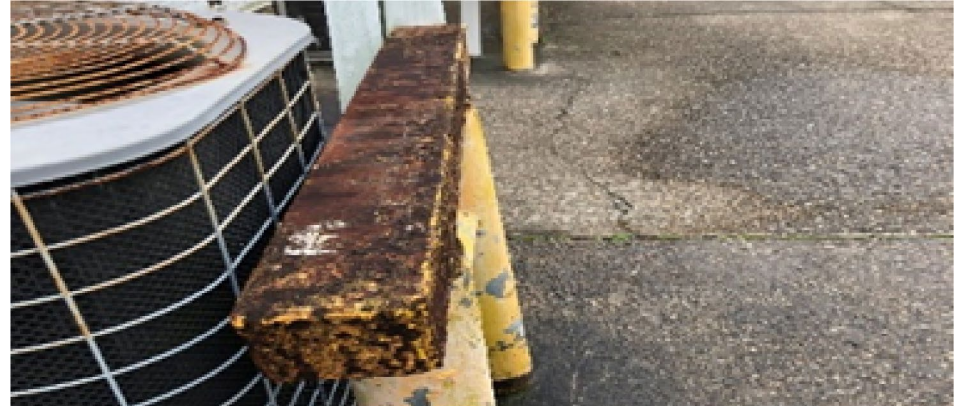
Figure 4. Rusted and Leaning Guard Rail for AC Unit

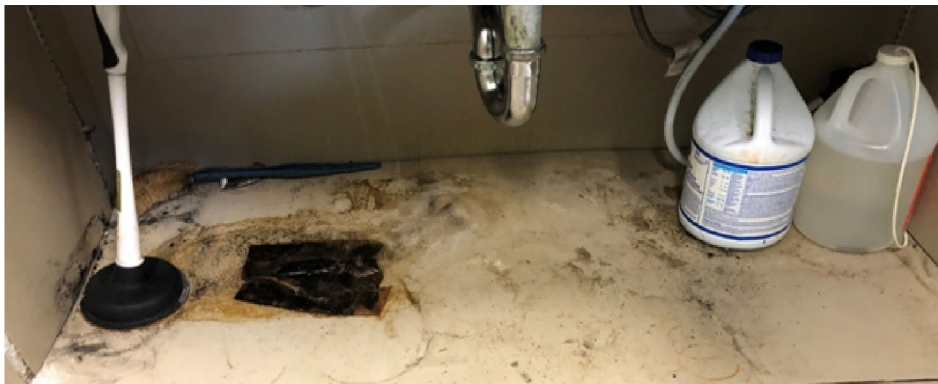
At the North Kenner Post Office, we identified potential mold and water under a sink in the lunchroom (see Figure 5) and a tree encroaching on a gas meter and excess equipment and trash in a fenced area (see Figure 6). We also confirmed that 11 cluster box units (CBU) previously reported in eFMS on September 24, 2020 were still in deplorable conditions (see Figure 7).

Figure 5. Potential Mold and Water Under Lunchroom Sink

We recommend the **Manager, Louisiana District**, test and remediate any potential mold at the North Kenner Post Office.

Regarding recommendation 2, management contacted a local remediation company concerning the mold issue at the North Kenner Post Office and will remediate potential issues based on the contractor's findings and recommendations. The target implementation date is May 31, 2021.

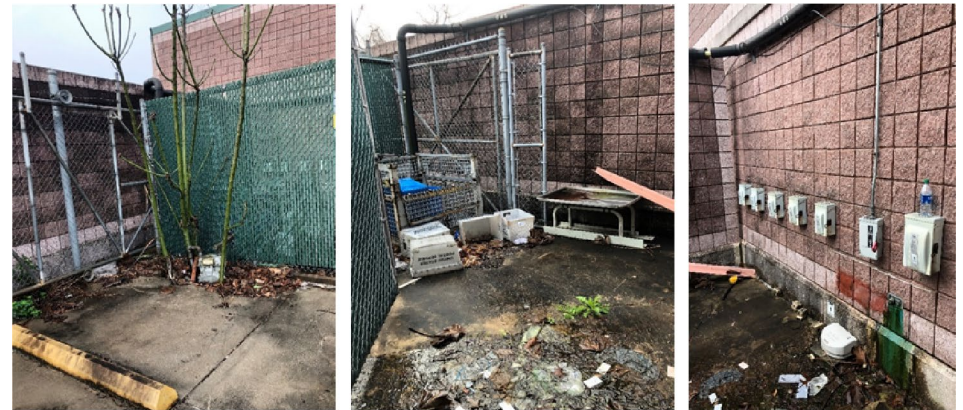
Figure 6. Tree Encroaching on Gas Meter and Excess Equipment and Trash in Fenced Area

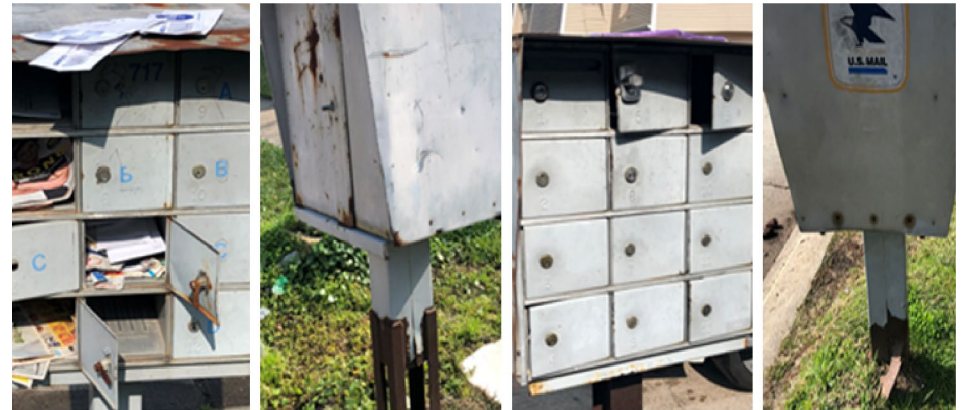
Figure 7. Damaged Cluster Box Units

Conditions related to building maintenance, safety, and security occurred due to lack of management oversight to address general maintenance and repair issues. Although management at all three facilities reported items in eFMS, they failed to consistently report and address maintenance and safety items such as damaged walls, cabinets and counters, exposed outlets, and exterior repairs. At the North Kenner Post Office, maintenance issues such as potential mold went undetected due to insufficient cleaning and lack of custodial staff. In addition, the cluster box units have not been replaced due to higher priority maintenance issues.

We recommend the **Manager, Louisiana District**, replace all damaged cluster box units reported in the electronic Facilities Management System and those assigned to the North Kenner Post Office.

Regarding recommendation 3, management ordered the cluster boxes to replace the damaged boxes assigned to the North Kenner Post Office and will schedule removal and installation upon receipt. The target implementation date is May 31, 2021.

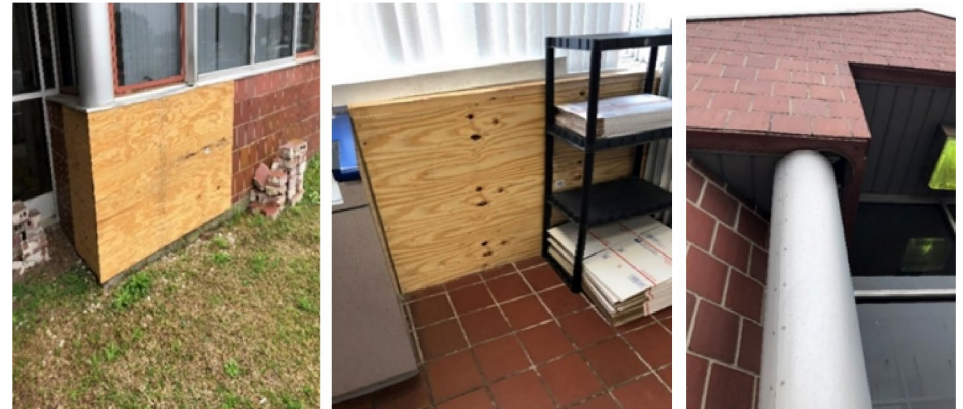
At the Lake Forest Post Office, we confirmed that the damage to the front of the building caused by a customer's vehicle in December 2020 — and previously reported in eFMS — had not been repaired (see Figure 8). We also identified scraped, chipped, and dirty floors (see Figure 9); a faded facility name on the front of the building (see Figure 10); stagnant water in the dock area due to an inoperable pump (see Figure 11); a dirty sink and fixtures in the lunchroom (see Figure 12); crud on the ice machine that appears to drain inside and potentially contaminate the ice (see Figure 13); and an uncovered hole in the storage room that leads to an unsecured box outside (see Figure 14).

Figure 8. Damage to Building Structure

Management at the Lake Forest Post Office reported the vehicle accident, which occurred in December 2020, in eFMS. Due to the nature of the call, the contractor immediately stabilized and secured the facility with plywood. The manager stated that she frequently calls the contractor to obtain a status update or estimated completion date but receives no response. The manager also called the contractor during our site visit, and again received no response. As of March 3, 2021, no further work has been performed.

We recommend the **Manager, Louisiana District**, repair building structure damage at the Lake Forest Post Office.

Regarding recommendation 4, management contacted Area Facilities concerning the building structure damage at the Lake Forest Post Office, and repairs are scheduled to begin in April 2021. The target implementation date is May 31, 2021.

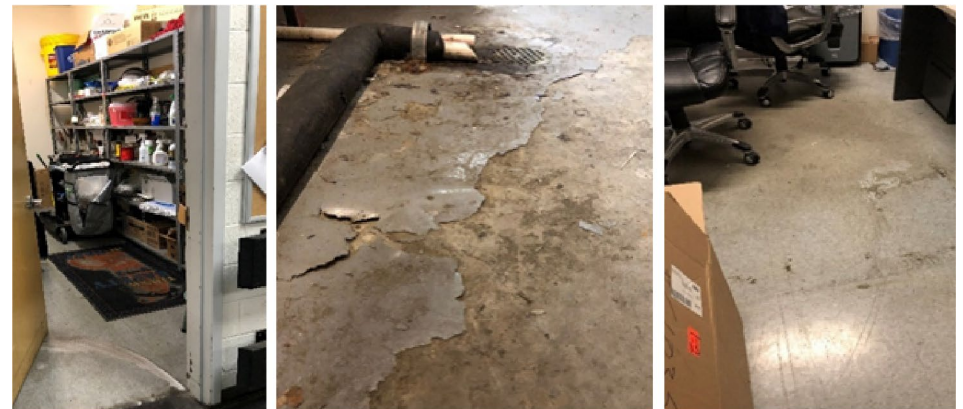
Figure 9. Scraped, Chipped, and Dirty Floors

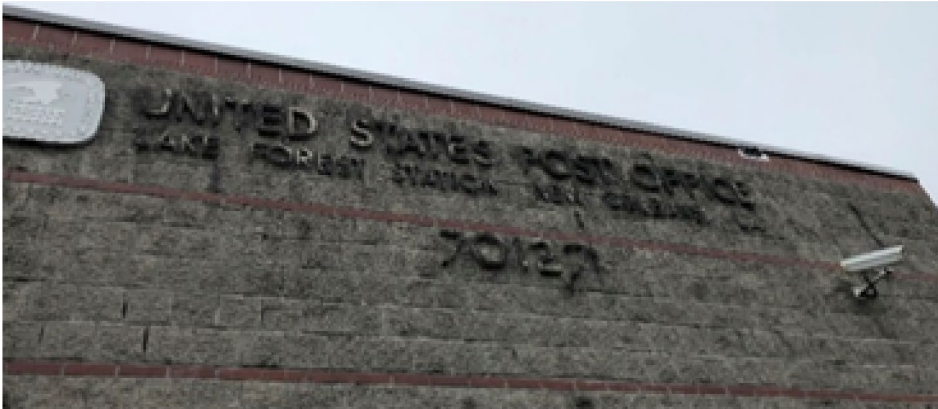
Figure 10. Faded Facility Name

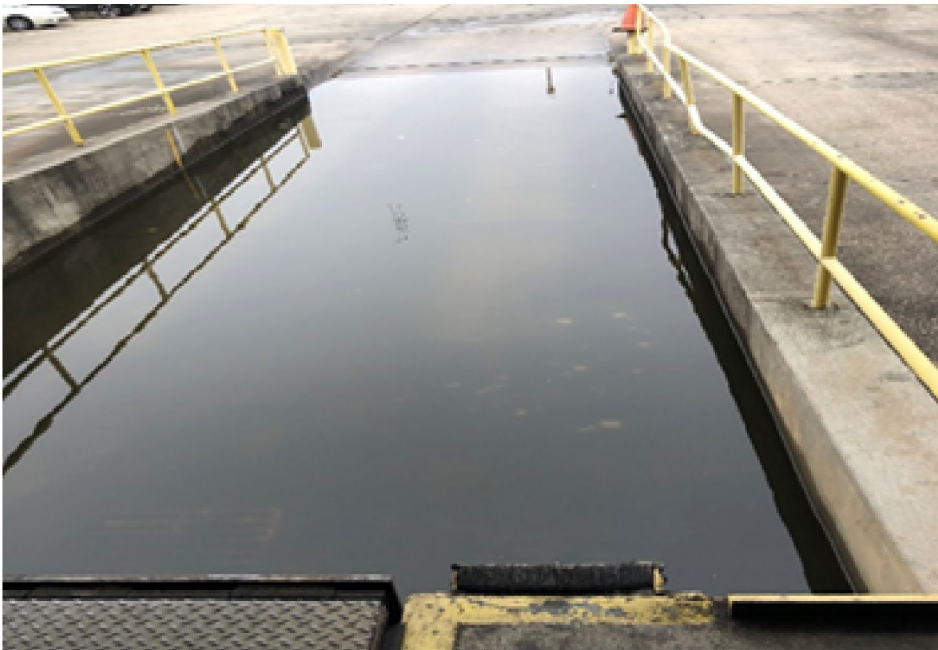
Figure 11. Stagnant Water

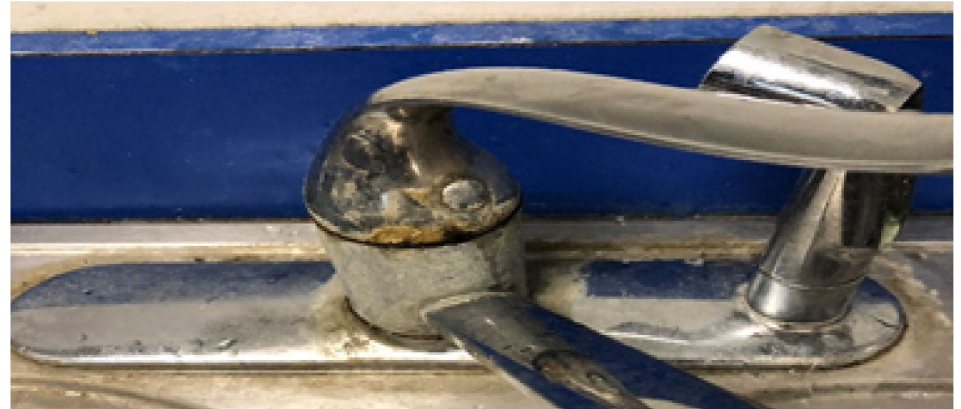
Figure 12. Dirty Sink and Fixture

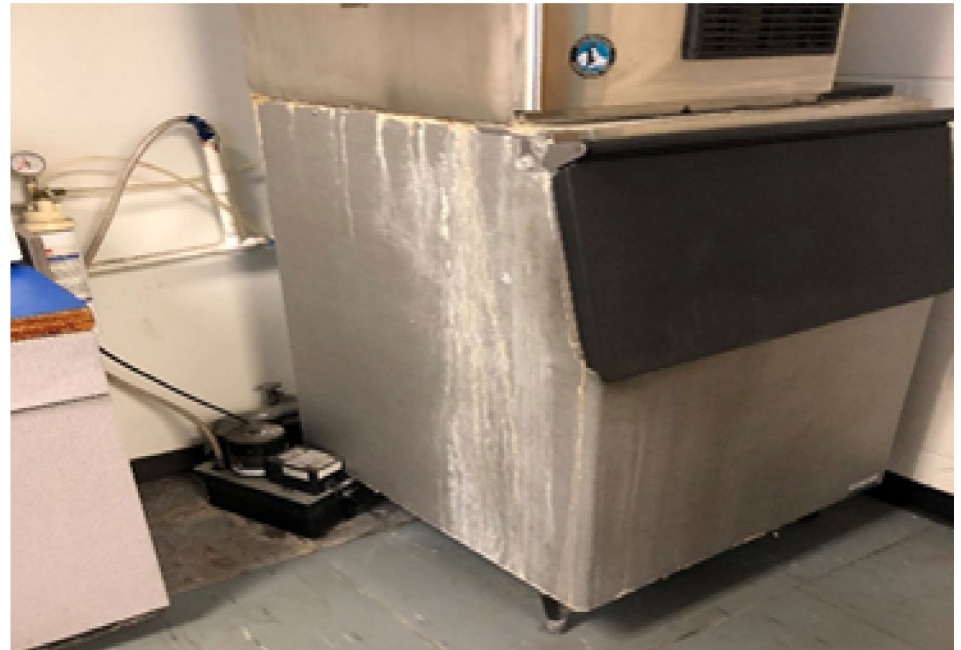
Figure 13. Crud on Ice Machine

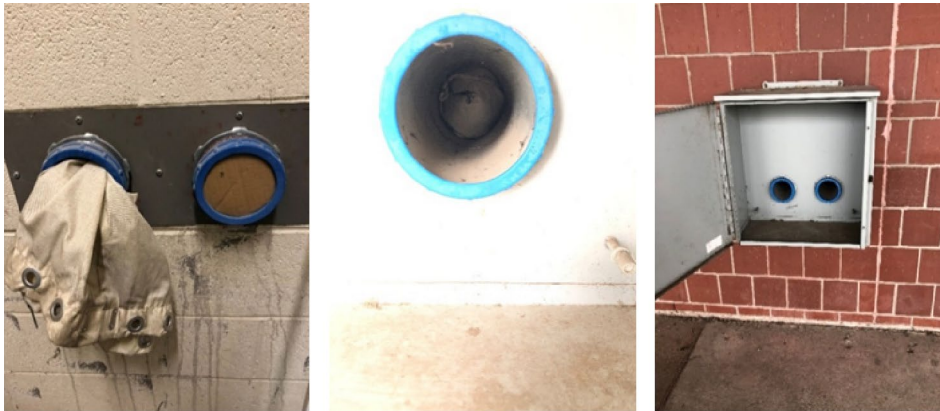
Figure 14. Uncovered Hole in Storage Room Leading to Unsecured Box Outside

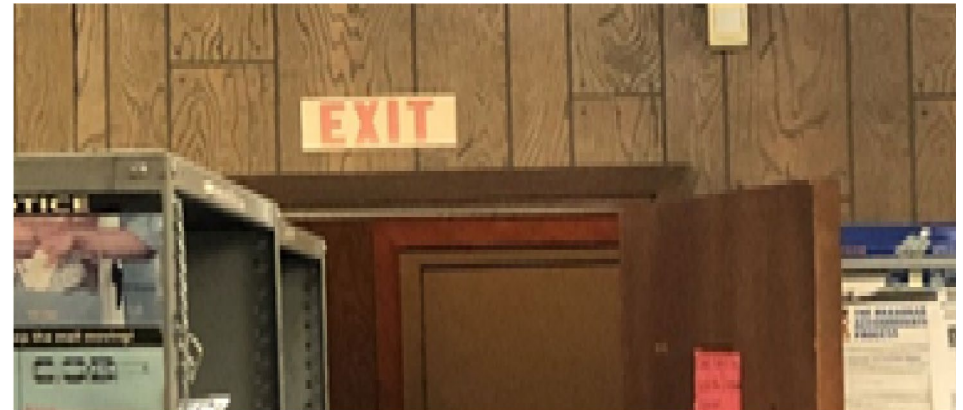
At the Garyville Post Office, we identified an emergency exit sign that was not illuminated (see Figure 15). In addition, none of the required posters, including Poster CA-10, *What a Federal Employee Should Do When Injured at Work*; OSHA posters 3165 and 3167, *Job Safety and Health* (English and Spanish versions); Zero Tolerance Policy and Reporting Procedures; and Poster 7, *Rules and Regulations Governing Conduct on Postal Property* were displayed. Management took corrective action and displayed all the required posters.

Figure 15. Exit Sign Not Illuminated

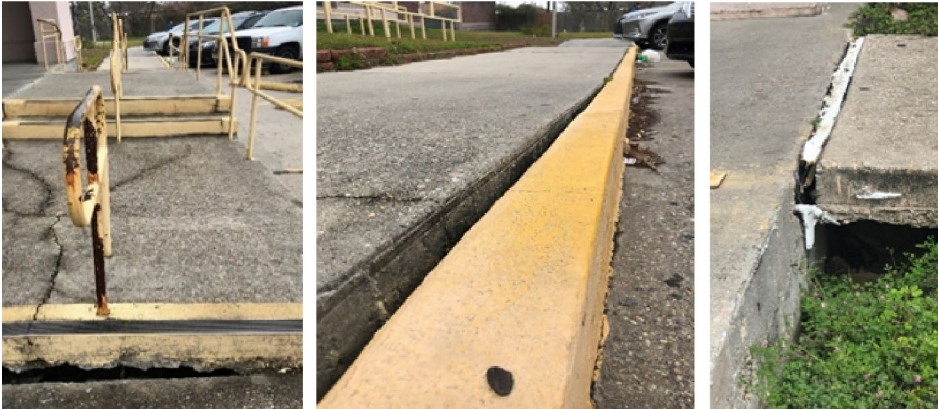
At the North Kenner Post Office, the entryway (stairs, curb, and walkway) was cracked and separated and had exposed rebar (see Figure 16). We also identified an uncovered fixture on the floor in the supply room, creating a potential trip hazard (see Figure 17). In addition, one fire extinguisher had no monthly tag and received the last annual inspection in June 2005. All the remaining fire extinguishers missed the January 2021 monthly inspection and had not been inspected annually since August 2019.

Figure 16. Cracked and Separated Entryway and Curb

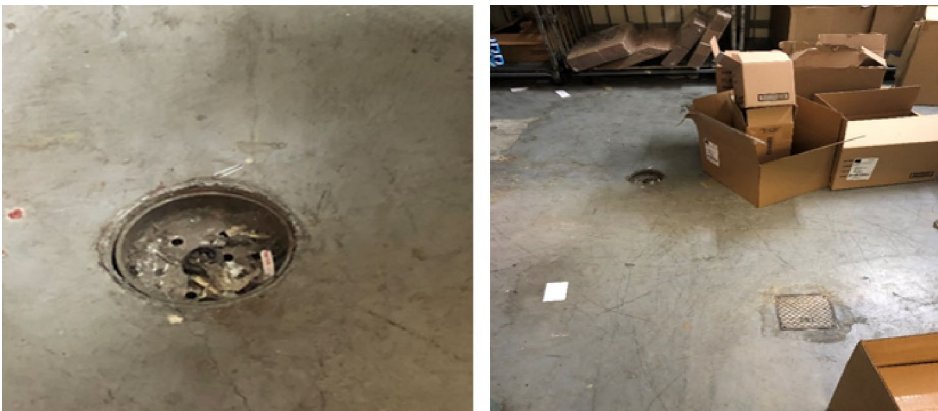
Figure 17. Uncovered Fixture on Floor

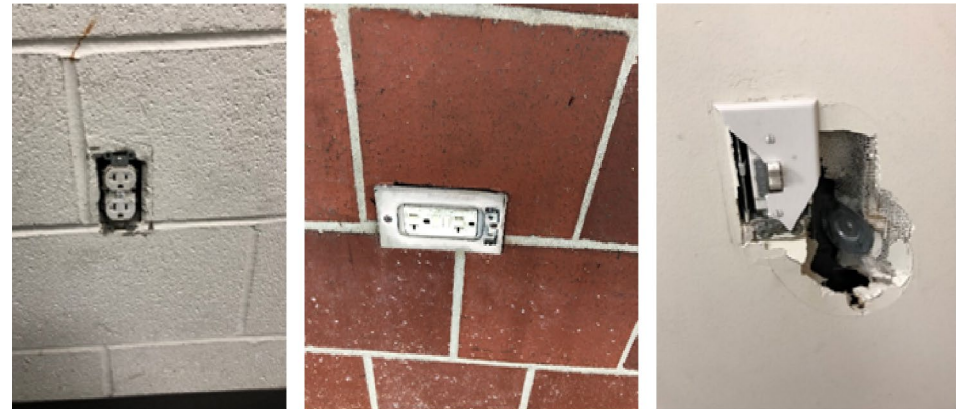
At the Lake Forest Post Office, we identified damaged and uncovered electrical outlets and switches (see Figure 18) and walkways and parking lots with cracks and uneven cement surfaces (see [Figure 19](#)). In addition, all fire extinguishers missed the January 2021 monthly inspection and had not been inspected annually since April 2018.

Figure 18. Damaged and Uncovered Electrical Outlets and Switch

Management took corrective action and displayed the required posters, unblocked the fire extinguisher and Inspection Service door, covered the electrical outlets, properly stored the flammable items, and had maintenance perform the monthly fire extinguisher inspections while the team was onsite. In addition, management scheduled the annual fire extinguisher inspections, which a contractor performed on February 18, 2021.

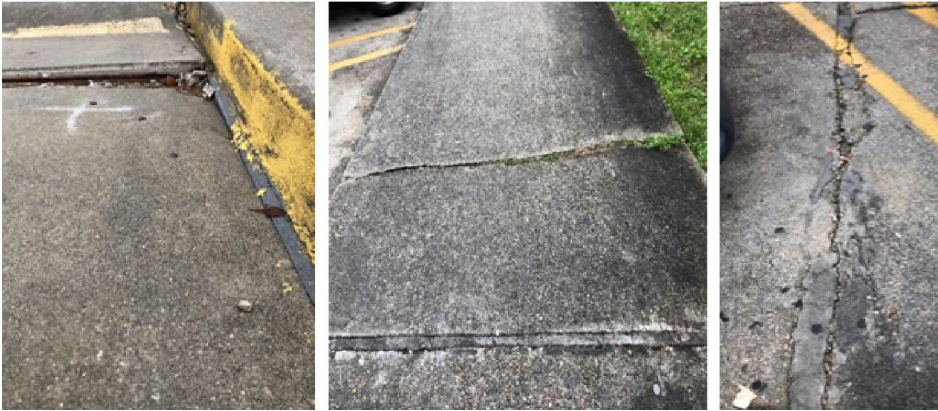
Figure 19. Walkway and Parking Lots with Cracks and Uneven Cement
