SUBJECT: Leased Trailer Deficiencies in the New York Metro Area (Report Number TR-MA-01-001)

## APPENDIX A. PHOTOS OF POSTAL SERVICE LEASED TRAILERS

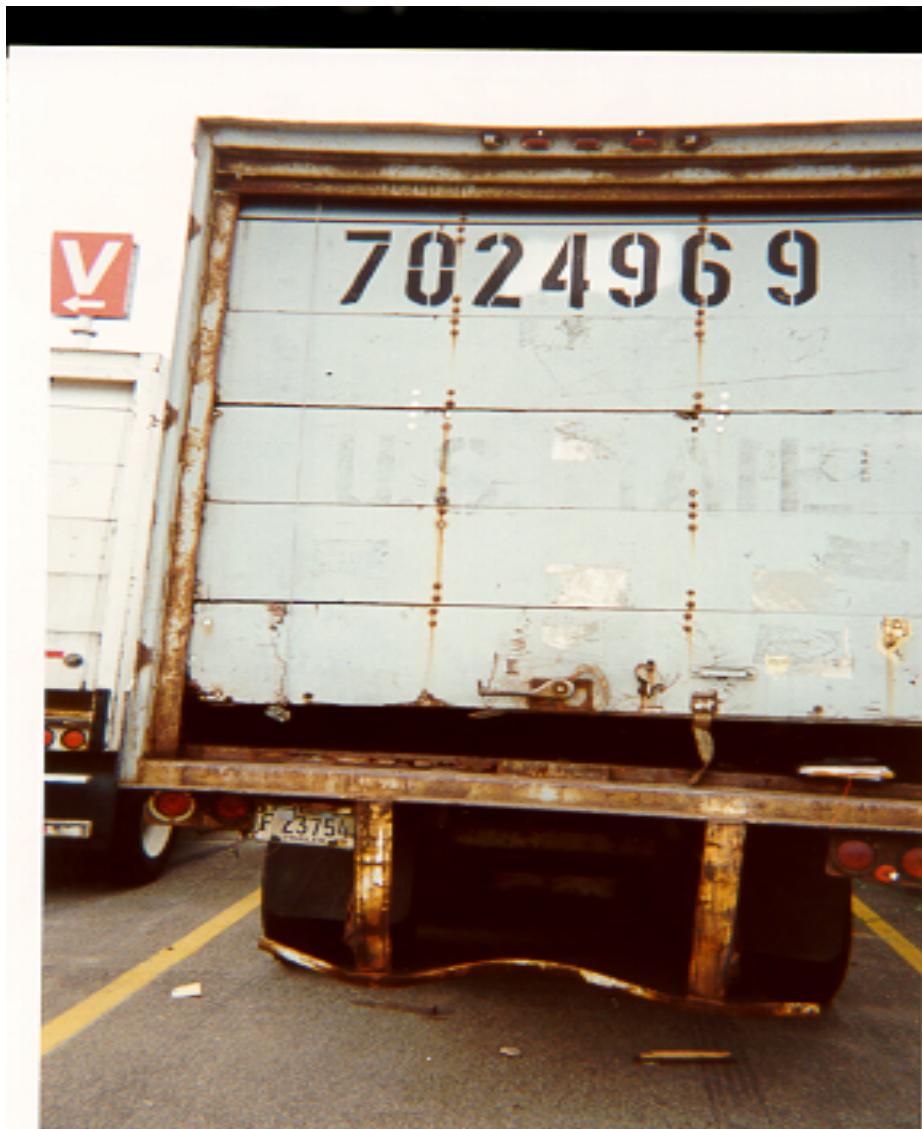
Picture 1: Trailer with excessive rust and damaged cross bar that protects vehicles from sliding under the trailer.

1. Require the contractor to meet contract provisions regarding trailer safety, maintenance, and appearance.

We agree with this suggestion, and we are coordinating with the vice president, New York Metro Area, to ensure that locally leased trailers meet federal and Postal Service safety requirements and are maintained in a manner that reflects favorably on the Postal Service.

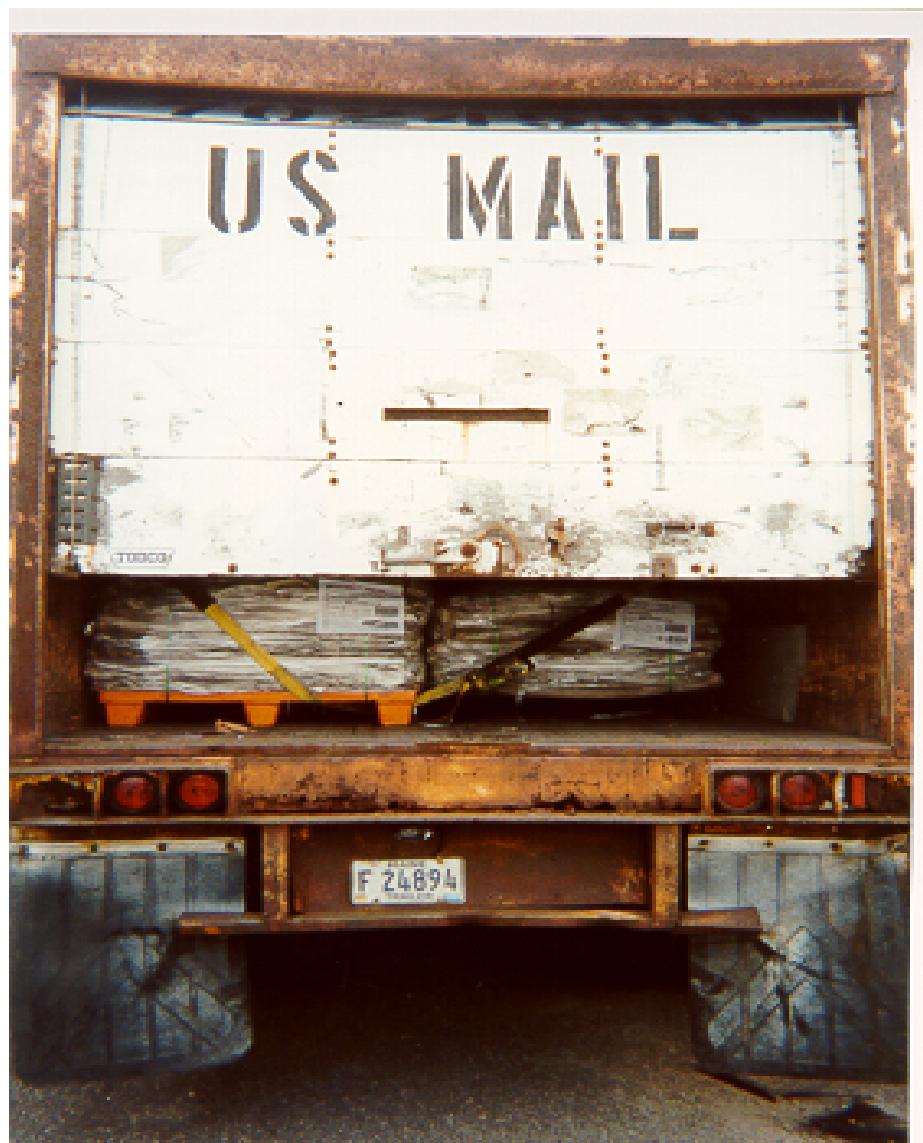
Picture 2: Trailer with excessive rust that reflects poorly on the  
Postal Service.

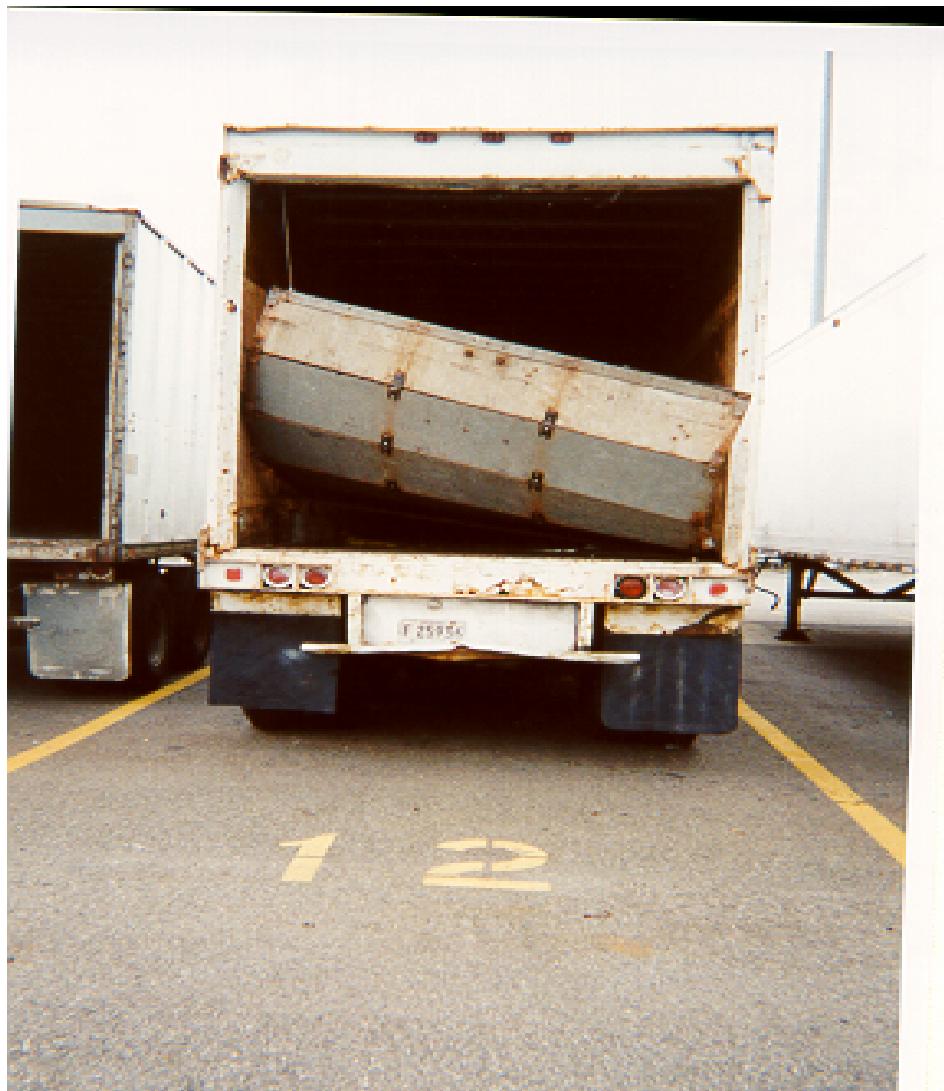
**Picture 3: Trailer with damaged door unfit for transportation.**

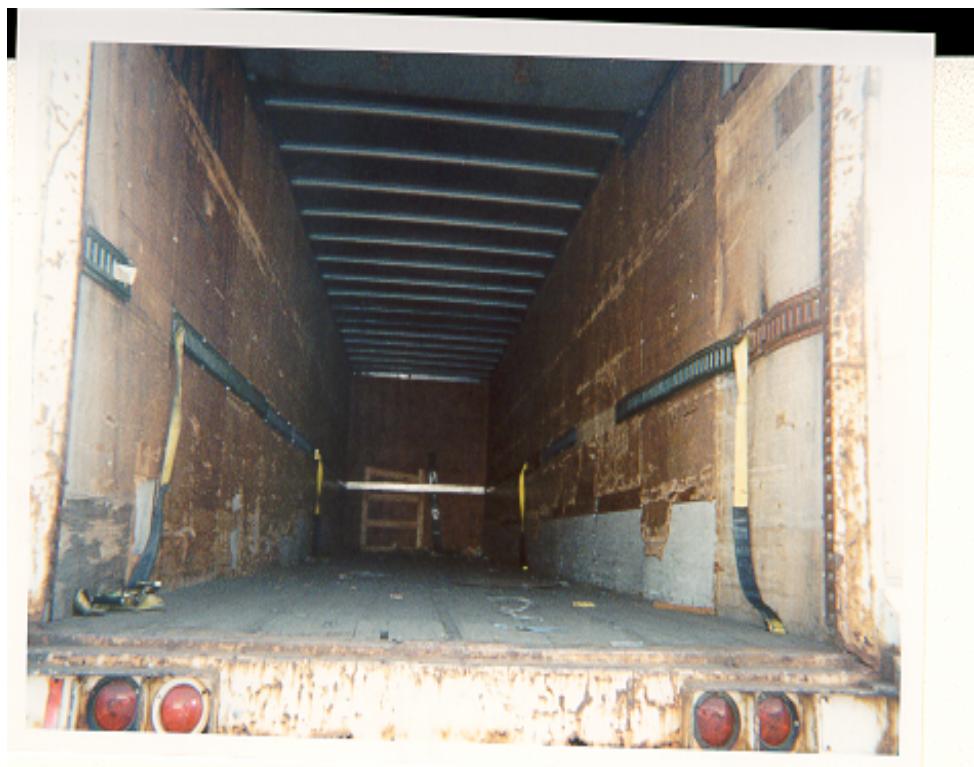
**Picture 4:** Trailer with damaged and missing load restraint system panels on the sides of trailer, which are used to secure mail or other cargo.

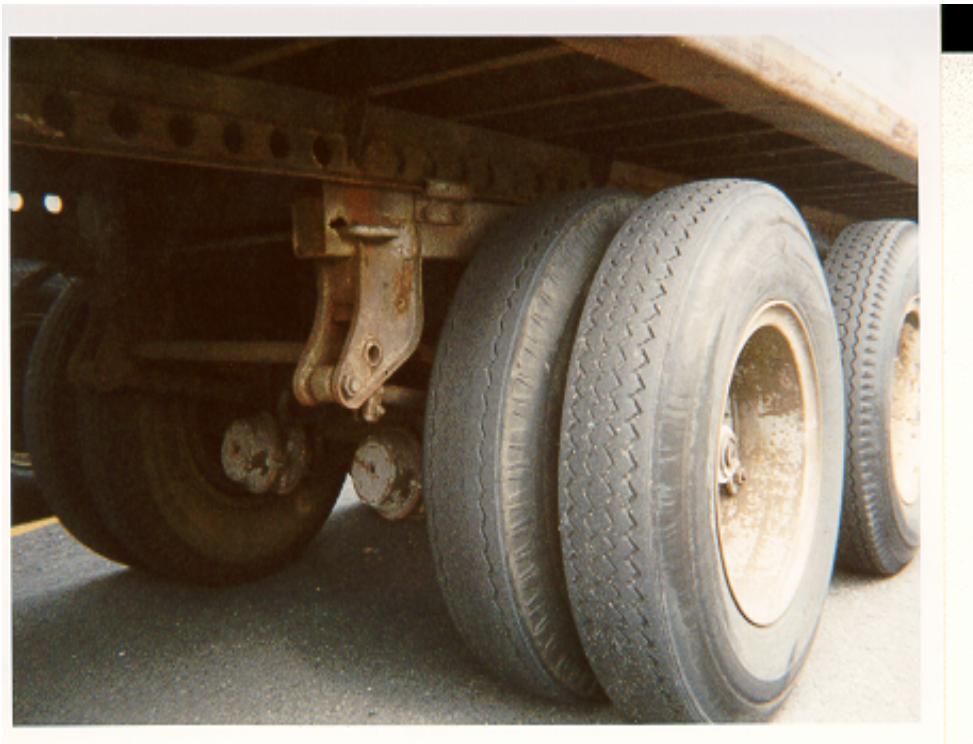
**Picture 5: Trailer with inside bald tire.**

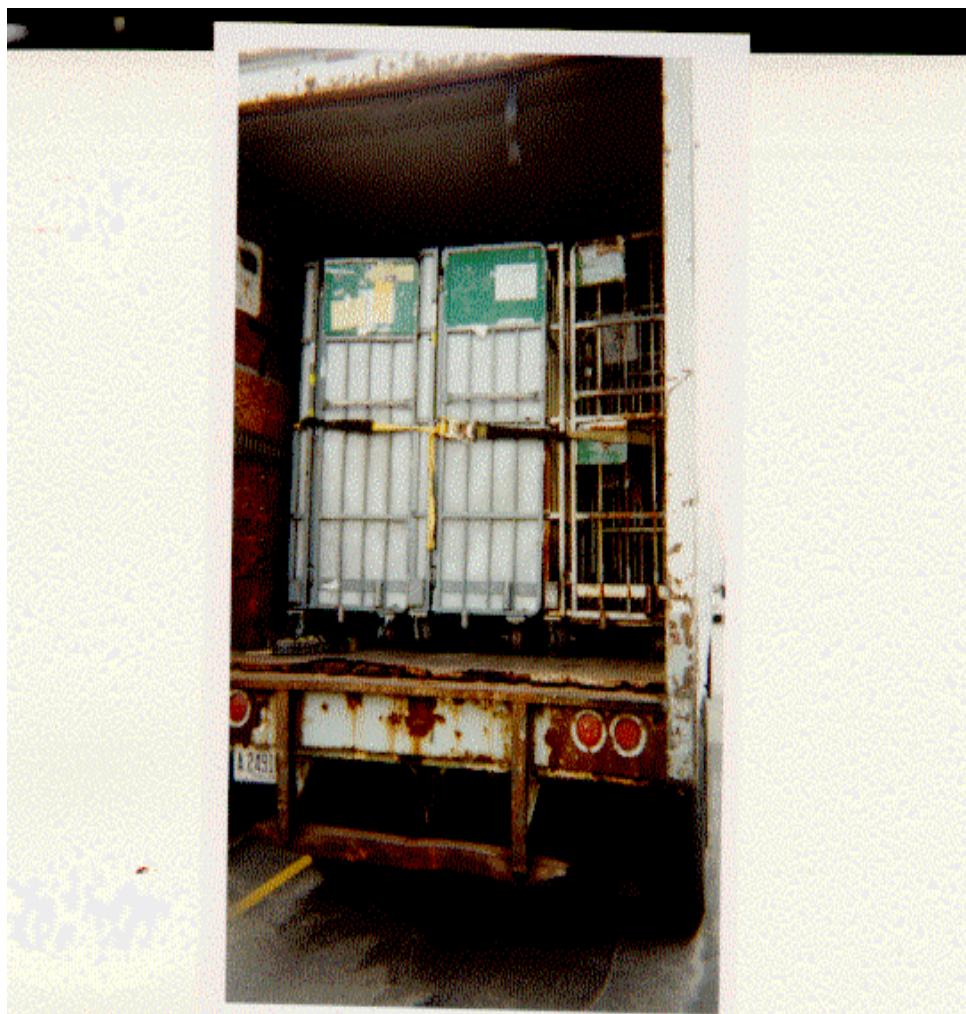
**Picture 6:** Trailer used to store empty mail transport equipment. Also note rotting floorboards and excessive rust.

**Suggestion #4:** Prohibit storing equipment in trailers leased for transportation.

We are in agreement with this suggestion. Further, we agree that local operating guidelines for using leased trailers for the storage of MTE must be more clearly defined. The DN Manager in New York will re-establish management guidelines to reduce the storage of MTE in trailers.
