Office of Inspector General | United States Postal Service

Audit Report

Facility Condition Reviews – Mail Processing Facilities

Report Number SM-AR-19-003 | May 6, 2019

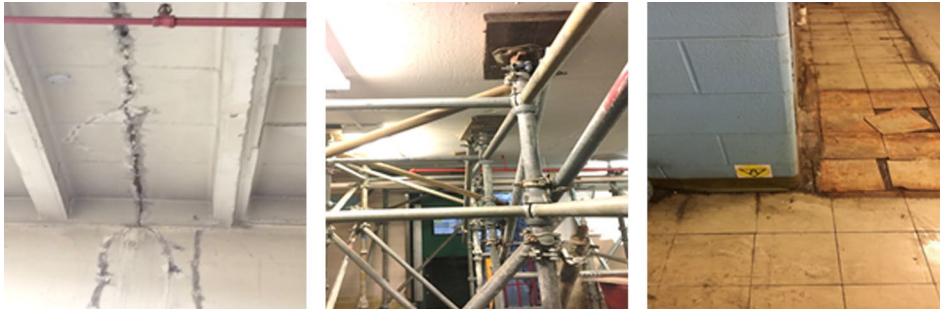
Figure 1. Indianapolis P&DC Issues

- Five facilities (16 percent) had cracked and/or broken tiles labeled as asbestos. At the Indianapolis, IN, P&DC, we observed severely damaged roofing, ceilings, and other infrastructure which had the potential risk for falling debris (see [Figure 1](#)).

Damaged Ceiling & Infrastructure

Damaged Floor Tiles

OIG photographs taken August 14, 2018.

These safety issues were escalated to the Postal Service's Chief Operating Officer on August 31, 2018.⁹ Subsequently, in October 2018, the Postal Service contracted with an engineering firm to complete a structural evaluation at the Indianapolis P&DC. In a February 2019 report, the engineering firm recommended that the Postal Service complete permanent repairs of the first-floor structural concrete slab as soon as practical. The consultant also recommended that management complete further site observations and a structural review of floor slab construction subjected to forklift traffic.

The **Vice President, Facilities**, develop and implement an action plan to address structural recommendations at the Indianapolis Processing and Distribution Center, including a timeline for completing items.

Regarding recommendation 2, management stated that Indianapolis P&DC structural issues have been temporarily and safely stabilized and are being monitored by an external engineering firm monthly to ensure the conditions remain safe for employees and operations. Management stated that permanent repairs are on hold because the Postal Service may dispose this building in the near future. Management stated the stabilization effort and monthly monitoring will continue until a final disposition date for the building is determined. Management requested that we close the recommendation with the issuance of this report.

Regarding recommendation 2, in subsequent discussions with management, we determined that all scaffolding and shoring to stabilize the Indianapolis P&DC's structural issues were completed on August 4, 2016, and the contract to provide monthly monitoring service was established on August 8, 2018. Based on these temporary remedies, management believes the recommendation should be closed with the issuance of this report. While corrective actions taken to date are going in the right direction, we believe permanent repairs are in the best interest of the Postal Service if it decides to keep the Indianapolis P&DC for operations. Therefore, we will keep this recommendation open until the final disposition date for the building is determined.

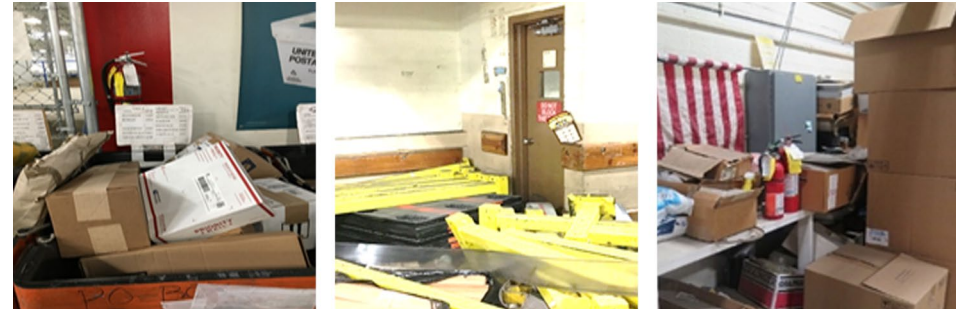
Figure 2. Safety Issues

- At eight facilities (25 percent), fire extinguishers were not serviced monthly, as required.¹⁰
- At 18 facilities (56 percent), we found blocked fire extinguishers and/or blocked fire alarm pull stations (see Figure 2).
- At ten facilities (31 percent), we found blocked exit doors (see Figure 2).
- At ten facilities (31 percent), we found blocked electrical panels (see Figure 2).

Blocked Fire Extinguisher

Blocked Exit Door

Blocked Electrical Panel

OIG photograph taken June 12, 2018, at the Richmond, VA P&DC.

OIG photograph taken June 13, 2018, at the Morgan P&DC

OIG photograph taken June 28, 2018, at the Corpus Christi P&DC.

Maintenance staff remedied certain deficiencies brought to their attention during our site visits - such as displaying missing posters, unblocking exits, unblocking and inspecting fire extinguishers, unblocking electrical panels, and securing unlocked doors, gates and vehicles. However, these were temporary remedies and not indicative of long-term solutions. When corrective actions are not implemented, or are implemented but inadequate, issues may continue to exist, increasing the Postal Service's exposure to Occupational Safety and Health Administration (OSHA) fines, and the risk of injury to employees and customers.

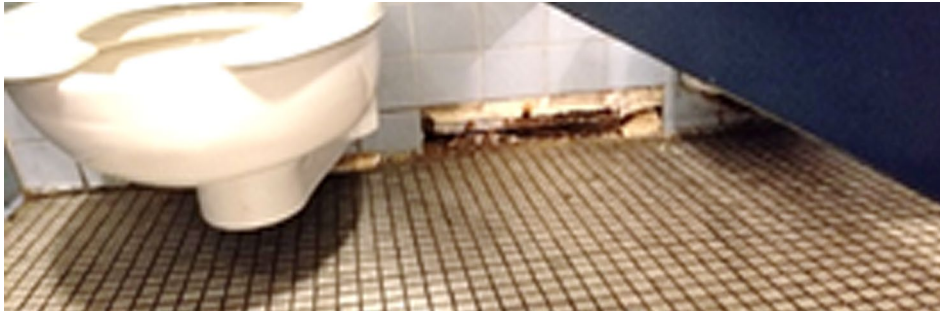
Figure 3. OIG photograph taken May 23, 2018, at the Northbay P&DC.

- At seven facilities (22 percent), we found deficiencies related to general cleanliness of restrooms, including unsanitary urinals/toilets, missing floor/wall tiles, and dirty sinks and floors. A more egregious example at one facility (Northbay P&DC in Petaluma, CA) had a restroom with a dirty floor, missing wall tiles, and a hole in the wall (see [Figure 3](#)).

Restroom cleanliness, holes in walls, and missing wall tiles.

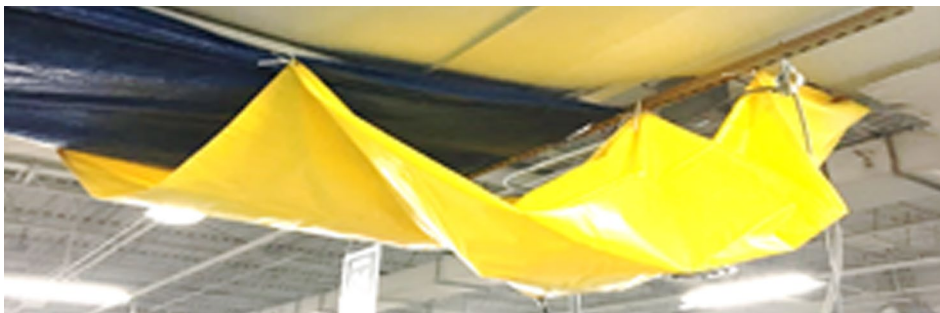
Figure 4. OIG photograph taken July 24, 2018, at the Brockton, MA, P&DC.

- At 16 facilities (50 percent), we found deficiencies related to stained or damaged ceiling tiles and/or leaking ceilings. To illustrate, Figure 4 shows a leaking ceiling at the Brockton, MA, P&DC. eFMS reports indicate the roof leaks as being reported; however, no actions have been taken to remedy the issue through the time of this reporting.

Ceiling leakage.

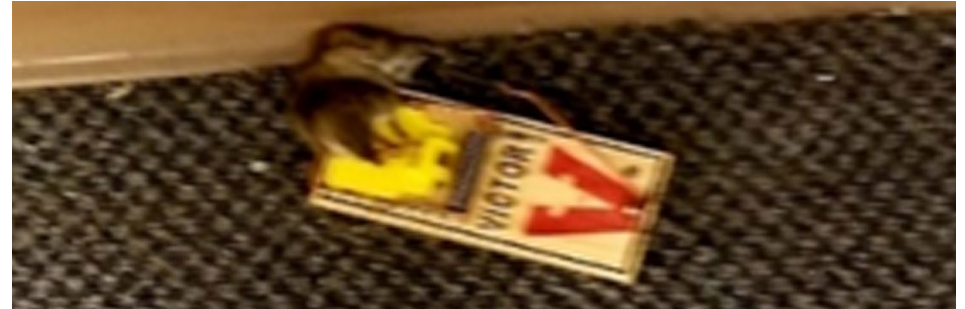
Figure 5. OIG photograph taken May 7, 2018, at the Southern Maryland P&DC

At three facilities (9 percent), we identified rodent issues, including a dead mouse that had not been removed from a trap in the administrative area for what appeared to be several days (see Figure 5). We also observed rodent droppings

Dead mouse left in a trap.

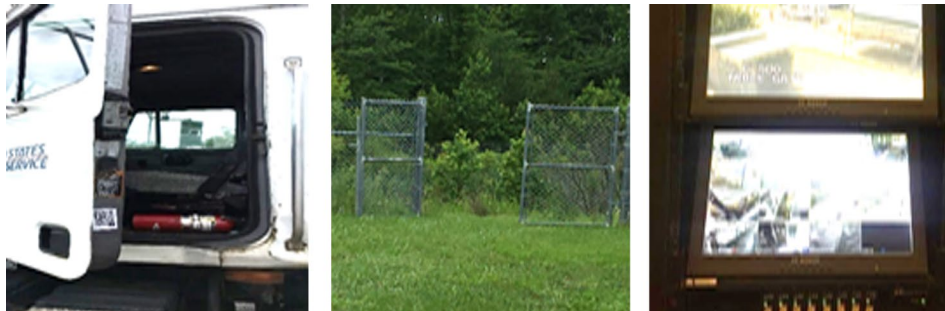
Figure 6. Building Security

- At ten facilities (31 percent), the “U.S. Property, No Trespassing” security signage was not posted every 100 feet, as required.
- At two facilities (6 percent), Postal Service delivery and maintenance vehicles were unlocked in unsecured areas (see Figure 6 for an example).
- At fifteen facilities (47 percent) perimeter fences were unlocked/unsecure (see Figure 6 for an example).
- At nine facilities (28 percent) security cameras for monitoring of the facility exterior that did not function properly (see Figure 6 for an example).

Unlocked vehicle

OIG photograph taken June 12, 2018, at the Richmond, VA P&DC.

Unlocked perimeter fence

Partially functional security camera/monitor

OIG photograph taken June 28, 2018, at the Green Bay, WI P&DC.
