## AUDIT REPORT

# Facility Condition Reviews – Miami Springs, Promenade, and Doral Post Offices

Report Number 20-212-R20

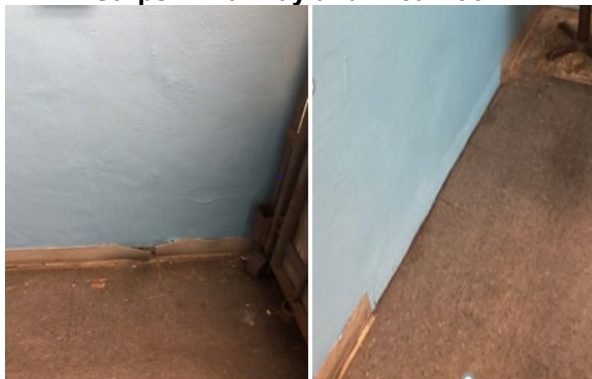
At the Miami Springs Post Office we identified stained and missing ceiling tiles in the workroom area, damaged and missing baseboard strips, and missing floor tiles in the hallway and breakroom areas (see Figures 1 and 2). We also identified other general maintenance issues such as an inoperable faucet handle for hot water and a hole in the wall under the sink in the men's restroom. In addition, there was a dirty air vent in the ladies' restroom (see Figure 3).

**Figure 1. Damaged and Missing Baseboard Strips in Hallway and Breakroom**

**Recommendation #1:** We recommend the **Manager, South Florida District**, address all building maintenance, safety, and security issues identified at the Miami Springs, Promenade, and Doral Post Offices.

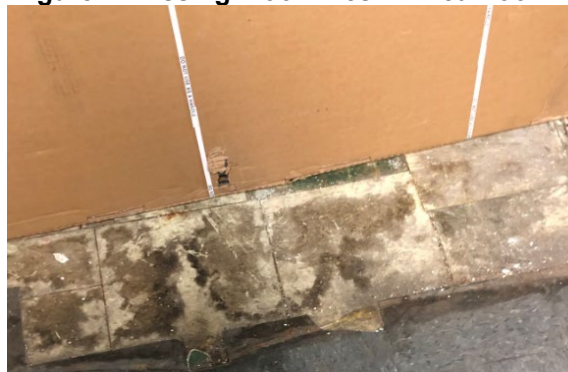
**Figure 2. Missing Floor Tiles in Breakroom**

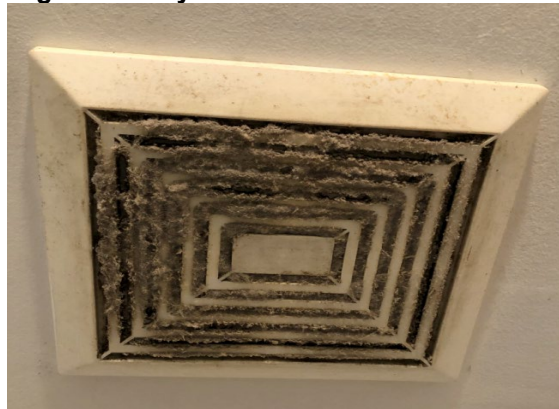
**Figure 3. Dirty Air Vent in Ladies' Restroom**

Management at the Miami Springs Post Office took corrective action while we were onsite by cleaning the dirty air vent in the ladies' restroom and downloading and displaying the CA-10, OSHA posters 3165 and 3167, and Poster 7. In addition, management at the Promenade and Doral Post Offices downloaded and displayed OSHA poster 3167, and at the Doral Post Office unblocked the exit door. We appreciate management's prompt attention to these matters.

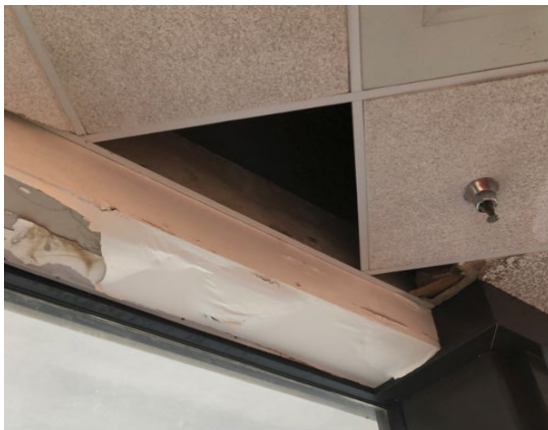
At the Promenade Post Office we identified one missing ceiling tile in the customer Post Office Box area (see Figure 4) and two missing ceiling tiles in the loading dock area

**Figure 4. Missing Ceiling Tile in Post Office Box Area**

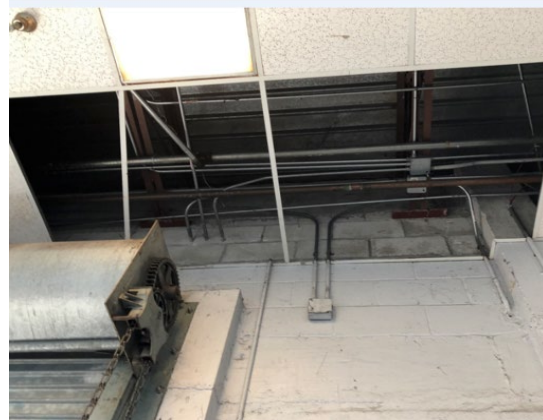
**Figure 5. Missing Ceiling Tiles in Loading Dock Area**

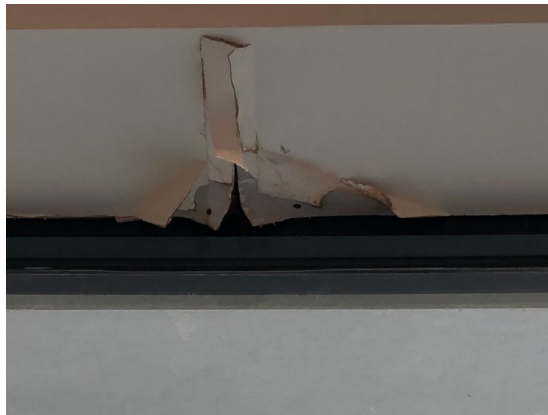
(see Figure 5), a damaged wall and dirty air vent in the customer service lobby (see Figures 6 and 7), damaged bumpers in the loading dock vestibule and exit doors, and a damaged door hinge in the loading dock area making the door difficult to close.

**Figure 6. Damaged Wall in Customer Lobby**

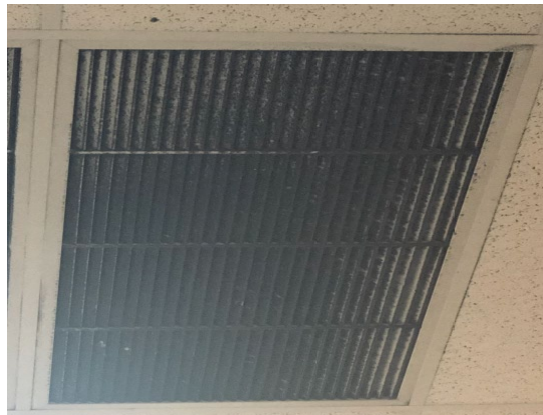
**Figure 7. Dirty Air Vent in Customer Lobby**

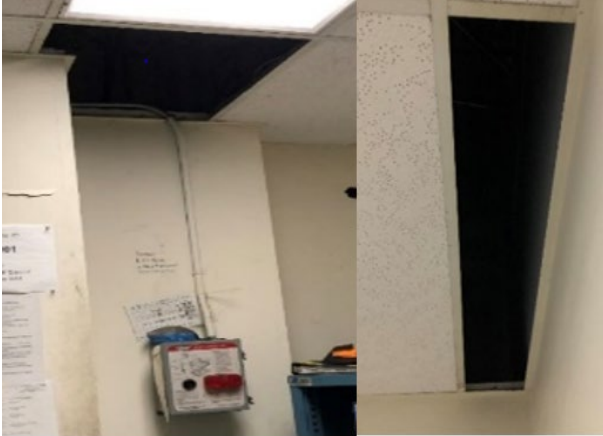
At the Doral Post Office we identified damaged and stained ceiling tiles in the workroom area and missing ceiling tiles in the vestibule and loading dock areas (see Figure 8). In addition, we found damaged walls near the vault (see Figure 9), a dirty and rusted paper towel holder in the ladies' restroom, and no hot water in the restroom near the manager's office.

**Figure 8. Missing Ceiling Tiles**

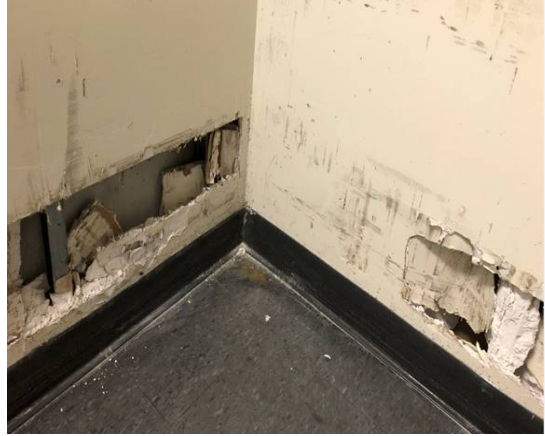
**Figure 9. Damaged Walls Near Vault**

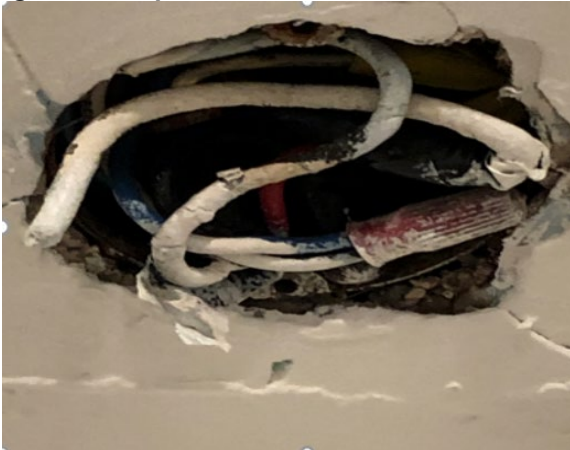
At the Miami Springs Post Office there were missing electrical outlet plate covers in the breakroom and ladies' restroom and exposed wires on the ceiling in the ladies' restroom and workroom areas (see Figure 10). We also identified blocked electrical panels and an unsecured ladder leaning against the wall in the workroom area (see Figures 11 and 12). In addition, two fire extinguishers had not been inspected monthly since March 2017 (see Figure 13).

**Figure 10. Exposed Wires in Ladies' Restroom**

Regarding recommendation 1, management needs to address the remaining deficiencies such as damaged and missing ceiling tiles, damaged walls, and exposed electrical wires and provide confirmation that the work has been completed.

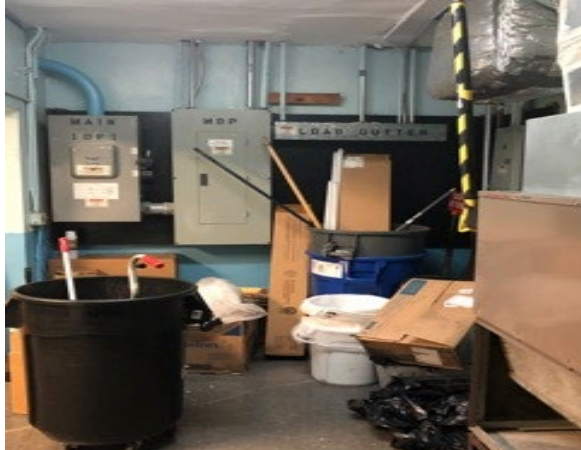
**Figure 11. Blocked Electrical Panels**

OSHA requires the inspection, maintenance, and testing of all portable fire extinguishers, including monthly and annual inspections.<sup>3</sup> Management is also required to ensure electrical panels are unblocked,<sup>4</sup> a requirement that local management was unaware of. In addition, Postal Service policy requires vehicle doors to be locked, except when loading or unloading the vehicle.<sup>5</sup>

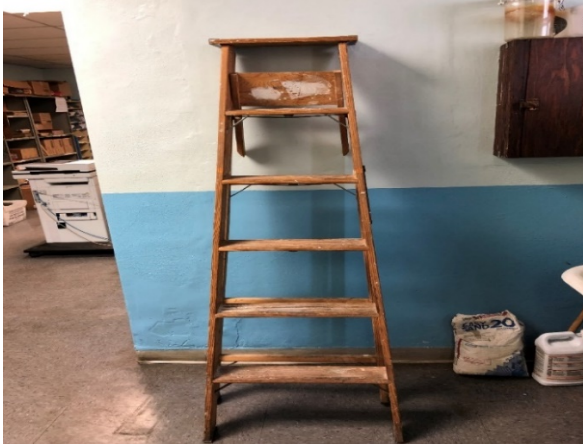
Figure 12. Unsecured Ladder

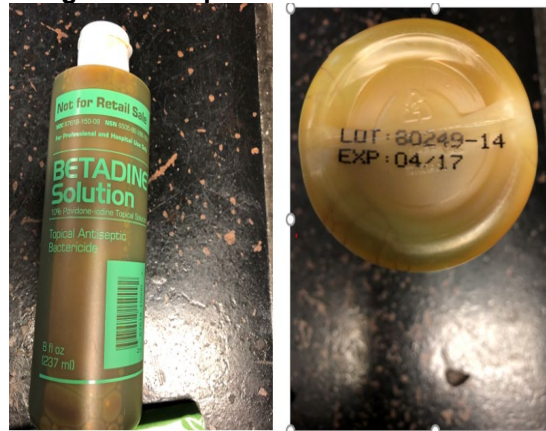
At the Promenade Post Office there were [REDACTED] in the loading dock area that dangled and posed a safety risk (see Figure 14). This issue was reported in the eFMS on February 18, 2020 and was still unresolved at the time of our visit on March 10, 2020. In addition, we identified expired items in the first-aid kit, including one Tussin expectorate that expired in January 2015, one betadine solution that expired in April 2017, and two ammonia inhalants that expired in July 2017 (see Figure 15).

Figure 15. Expired Item in First-Aid Kit

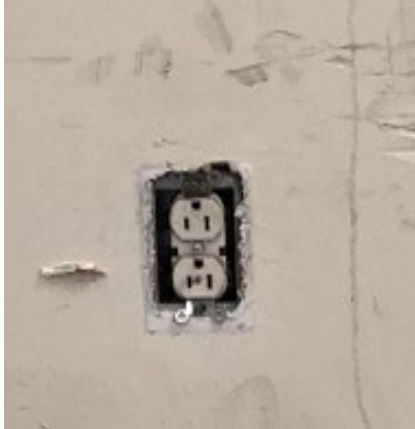
At the Doral Post Office we found one missing electrical outlet cover in the vestibule leading to the loading dock area and a blocked exit door (see Figures 16 and 17). In addition, there were expired items in the first-aid kit, including burn relief spray (expired April 2014) and hydrocortisone cream (expired February 2016).

**Figure 16. Missing Electrical Outlet Cover**

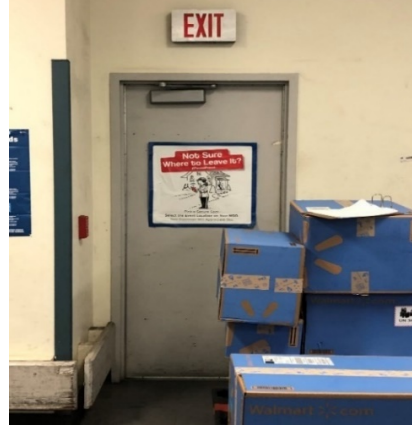
**Figure 17. Blocked Exit Door**

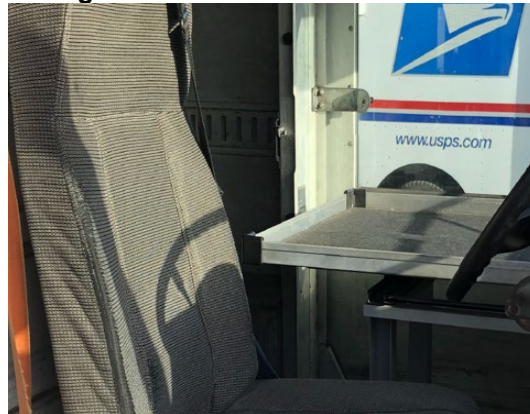
At the Promenade Post Office, we found 12 of 38 carrier trucks unlocked in the secured Postal Service parking lot (see Figure 18). In addition, the [REDACTED] cited above as a safety risk, could also pose a security risk since there were no [REDACTED]

**Figure 18. Unlocked Carrier Truck**

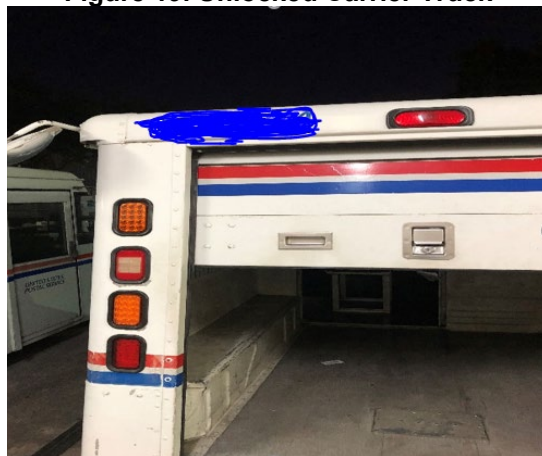
At the Doral Post Office, five of 22 carrier trucks were unlocked in the unsecured parking lot, leaving the vehicles susceptible to possible theft and vandalism (see Figure 19).

**Figure 19. Unlocked Carrier Truck**
