AUDIT REPORT

Property Condition Reviews – Smithville, Leander, and Kyle Post Offices

January 11, 2021

Report Number 20-321-R21

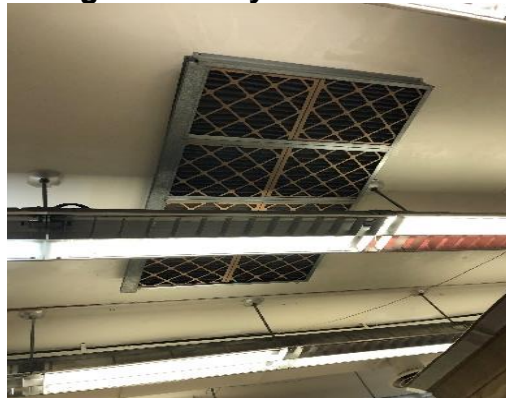
Figure 1. Dirty HVAC Filters

At the Smithville Post Office, we identified cobwebs and chipped paint throughout the facility, and dirty HVAC filters (see Figure 1). In addition, the postmaster's restroom was inoperable (see Figure 2). These issues were not previously reported in eFMS or on Postal Service (PS) Form 4805, *Maintenance Work Order Request*.

Recommendation #1: We recommend the **Manager, Rio Grande District**, address all building maintenance, safety, and security issues identified at the Smithville, Leander, and Kyle post offices.

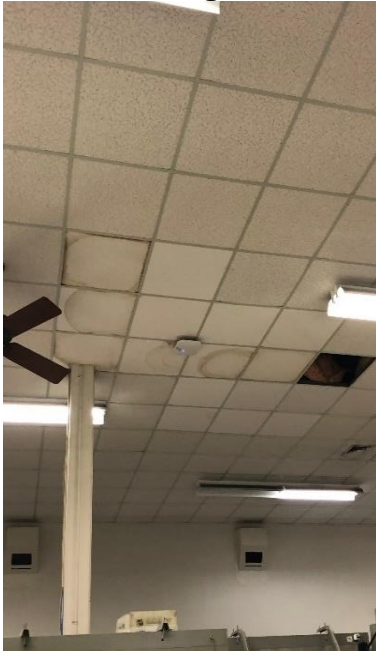
Figure 3. Stained/Missing Ceiling Tile

At the Leander Post Office, we identified stained and missing ceiling tiles (see Figure 3); stained walls (see Figure 4); burnt out light bulbs; dirty floors; and a ceiling leak caused by HVAC issues. In addition, the gutter near the employee entrance was damaged (see Figure 5), the toilets in the women’s restroom leaked, and the urinal in the men’s restroom was slow to drain.

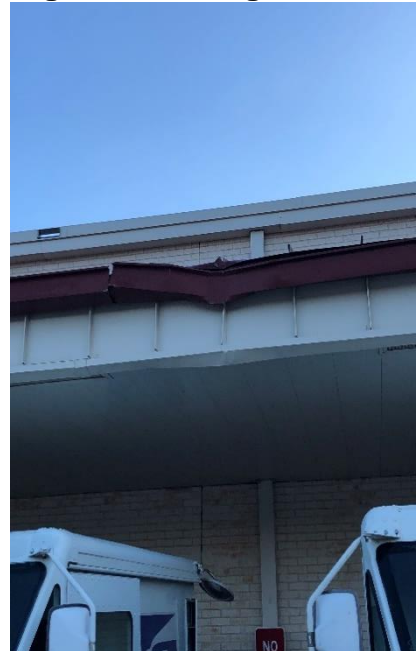
Figure 5. Damaged Gutter

The gutter and toilet issues at the Leander Post Office were reported in eFMS on April 17 and 26, 2019; however, these issues were not corrected during our visit. Management reported the urinal issue on a PS Form 4805, before our visit on October 19, 2020.

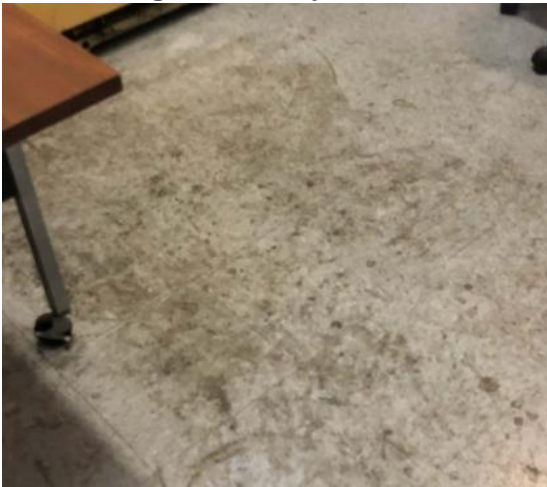
Figure 6. Dirty Floors

At the Kyle Post Office, we identified cobwebs in the lobby; dirty floors throughout the facility (see [Figure 6](#)), a dirty and severely stained water fountain (see [Figure 7](#)), missing bumper replaced by a traffic drum used to prevent vehicles from backing into the platform (see [Figure 8](#)), and missing concrete near a walkway, causing the railing to be unstable (see [Figure 9](#)).

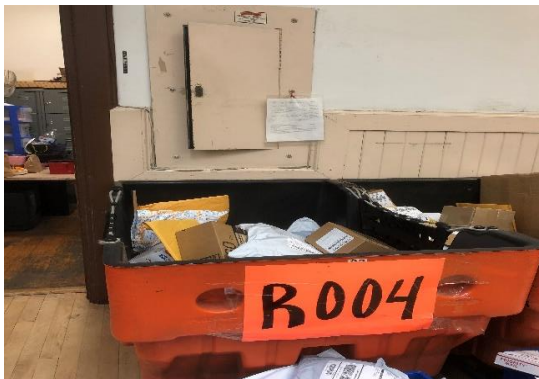
Figure 10. Open and Blocked Electrical Panel

At the Smithville Post Office we identified open and blocked electrical panels (see Figure 10); an emergency exit sign not illuminated (see Figure 11); a faded stop sign facing the wrong direction (see Figure 12); and a drainage hole that created a potential trip hazard (see Figure 13).

OSHA requires the inspection, maintenance, and testing of all portable fire extinguishers, including monthly and annual inspections.⁶ Management is also required to ensure electrical panels are unblocked,⁷ a requirement that management at the Smithville Post Office overlooked due to space constraints.

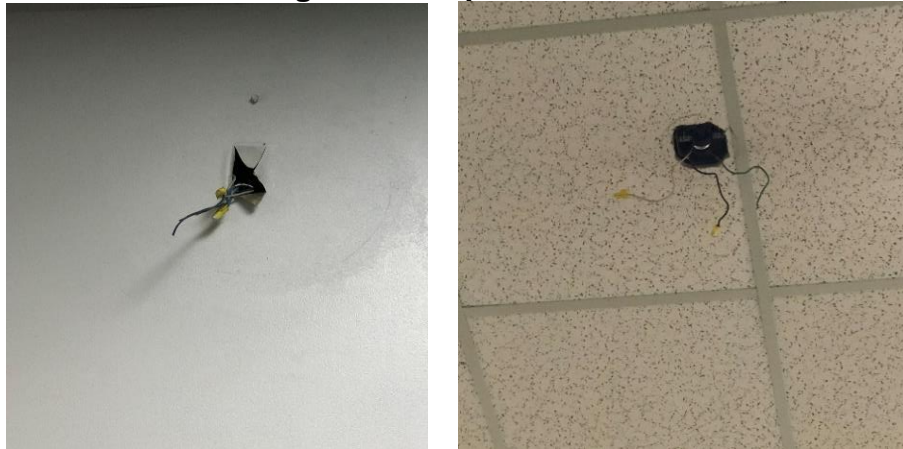
Figure 14. Exposed Wires

At the Leander Post Office, we identified multiple areas with exposed wires (see Figure 14); exposed pipes; a blocked Inspection Service door; and fire extinguishers not inspected annually or monthly since 2005 and 2012, respectively.

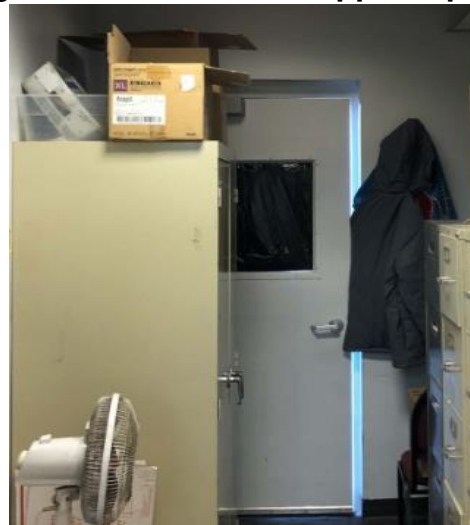
Figure 16. Side Door Propped Open

At the Kyle Post Office, we found two of 11 postal carrier trucks unlocked in an unsecured parking lot. In addition, we observed a side door propped open (see Figure 16).
