Office of Inspector General | United States Postal Service

# Property Condition Reviews – Center Ossipee, East Wakefield, and Conway Post Offices in New Hampshire

Report Number 21-187-R21 | August 12, 2021

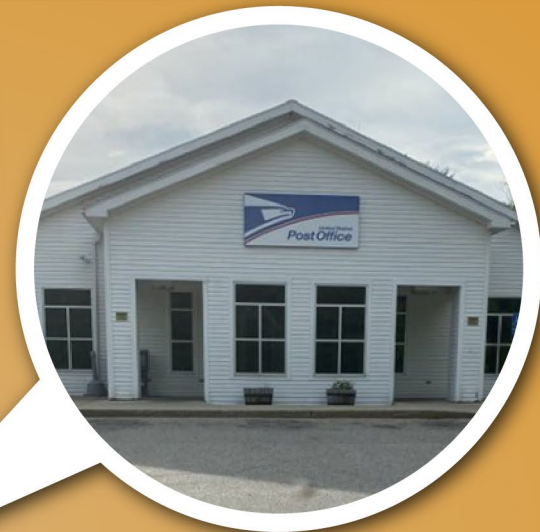
**Figure 1. Damaged Ramp**

At the Center Ossipee Post Office, we found stained ceiling tiles and unpainted walls in the workroom area, a damaged and uneven ramp posing a potential trip hazard and a rusted handrail near the main entrance (see Figures 1 and 2), and exterior trim on the front and side of the building that needed repairs and paint.

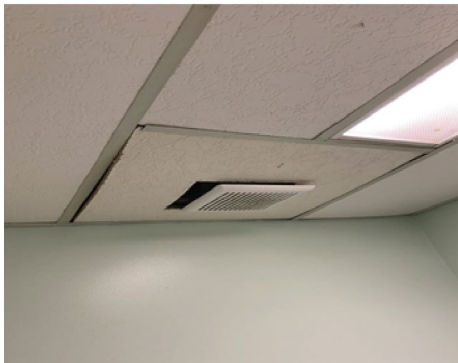
**Figure 3. Misaligned Ceiling Vent in Restroom**

At the East Wakefield Post Office, we found bulging ceiling tiles in the lobby and workroom areas, a misaligned ceiling vent in the restroom (see Figure 3), and a missing baseboard strip near the lobby entrance. We also identified:

We recommend the **Manager, Maine-New Hampshire-Vermont District**, address all building maintenance and safety issues identified at the Center Ossipee, East Wakefield, and Conway post offices.

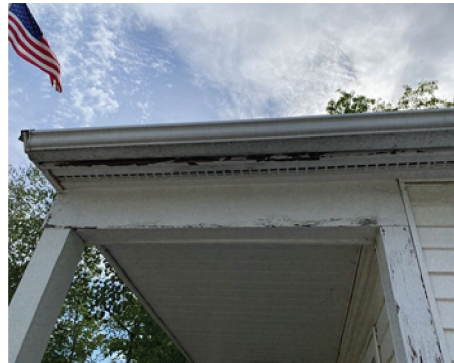
**Figure 4. Exterior Walls Needing Repairs and Paint**

- Exterior walls near the lobby entrance and rear of building needed repairs and paint (see Figure 4).
- Faded stripes in the customer parking lot.
- Shingles on the roof that appeared to be loose or damaged (see Figure 5).
- A damaged chimney wall (see Figure 6).
- Cobwebs around both building entrances.
- Grounds in need of landscaping (no grass).

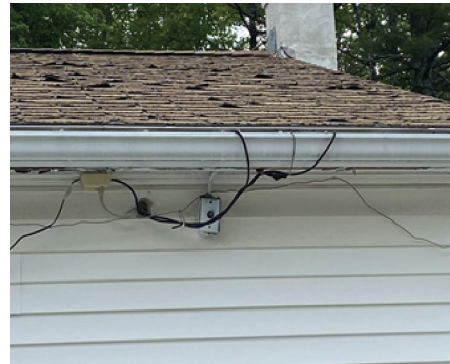
**Figure 5. Loose or Damaged Shingles**

Conditions related to building maintenance and safety occurred due to management not prioritizing some issues, a lack of oversight or awareness of the issues, or lack of knowledge of OSHA requirements. For example, some maintenance issues such as the damaged chimney, loose and damaged shingles on the roof, and the damaged exterior trim were not considered a priority. Safety issues such as blocked electrical panels and fire extinguishers that missed required inspections were not addressed due to lack of management oversight. The non-illuminated exit signs were not addressed due to management not being aware of the OSHA requirement.

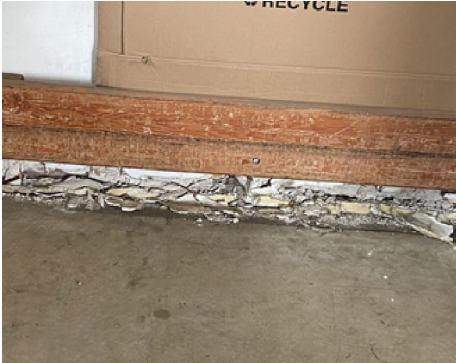
**Figure 7. Damaged Wall in Loading Dock Area**

At the Conway Post Office, we identified a damaged wall in the loading dock area (see Figure 7), misaligned and stained ceiling tiles in the workroom area, and a damaged ceiling in the loading dock area (see Figure 8). In addition, we identified dirty lightbulbs in both lobby entrances and cobwebs around the main entrance and in the loading dock areas (see Figures 9 and 10). Further, we identified a damaged wall in the P.O. Box area (see Figure 11), faded parking stripes and a damaged handrail in the customer parking lot (see Figure 12), and a cracked window in the electrical panel room.

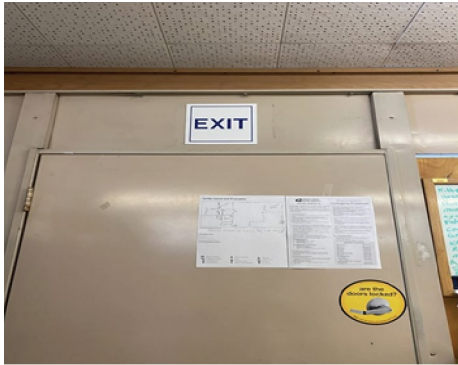
**Figure 13. Non-Illuminated Exit Sign**

At the Center Ossipee Post Office, we identified two exit signs not illuminated (see [Figure 13](#)), two expired items in the first-aid kit, and a blocked fire extinguisher (see [Figure 14](#)). In addition, we found the following posters were not displayed as required:

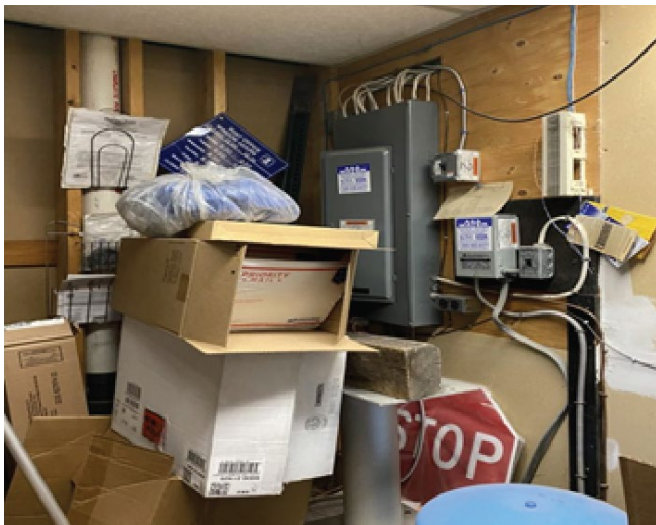
**Figure 15. Blocked Electrical Panels**

At the East Wakefield Post Office, we found blocked electrical panels in the storage room (see Figure 15), and the only fire extinguisher in the facility did not have an annual inspection performed. In addition, posters CA-10 and OSHA 3167 were not displayed as required.

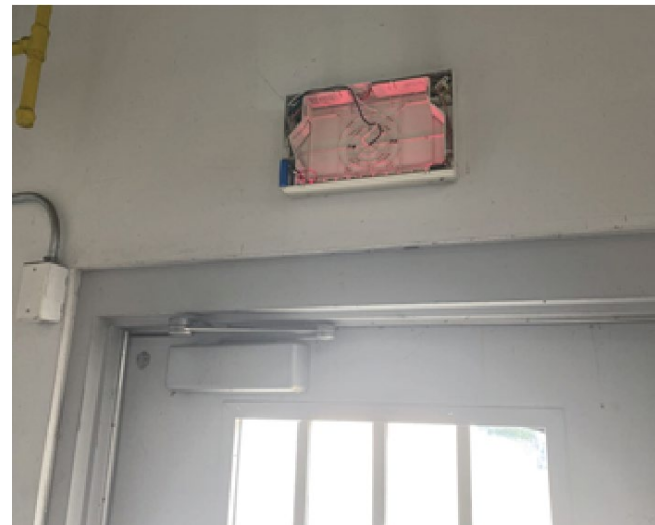
**Figure 16. Missing Exit Sign Cover**

At the Conway Post Office, we identified a missing exit sign cover in the loading dock area (see Figure 16). In addition, all three fire extinguishers missed their monthly inspections. The fire extinguishers did not have the monthly tags and management stated that the last monthly inspection was performed about two years ago. We also found that posters CA-10, OSHA 3165 *Job Safety and Health*, (English version), OSHA 3167, and Poster 7 were not displayed as required.
