Office of Inspector General | United States Postal Service

# Property Condition Review - Menlo Park, Excelsior, and Sutter Street Post Offices in California

Report Number 21-200-R21 | September 15, 2021

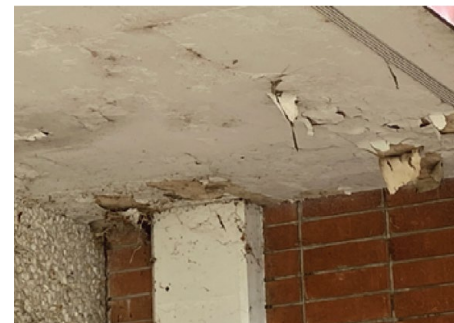
**Figure 1. Peeling Paint and Holes**

At the Menlo Park Post Office, we identified peeling paint and holes in the front awning near the customer entrance (see [Figure 1](#)), excess equipment inside and outside the facility (see [Figure 2](#)), and dirty floors throughout the facility. In addition, there was excessive vegetation growth on various areas of the building's exterior, cracked and broken windowpanes in the lobby and rear of the facility (see [Figure 3](#)), and trash and debris scattered outside the facility (see [Figure 4](#)).

We recommend the **Manager, California 1 District**, address all building maintenance, safety, and security issues identified at the Menlo Park, Excelsior, and Sutter Street post offices.

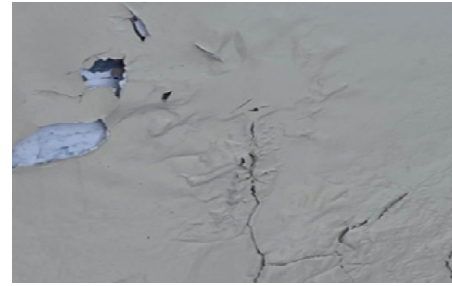
**Figure 5. Peeling Paint and Holes in Walls**

At the Excelsior Post Office, we identified walls with peeling paint and holes (see Figure 5), dirty air vents throughout the facility (see Figure 6), and ceilings with stains from water leaks and peeling paint (see Figure 7). The staff informed us that they place buckets to catch the water when it rains. We also identified damaged and dirty floors throughout the facility, excess equipment inside and outside the facility, and housekeeping inspections were not performed.

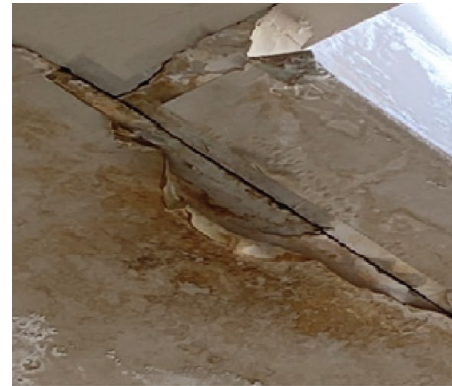
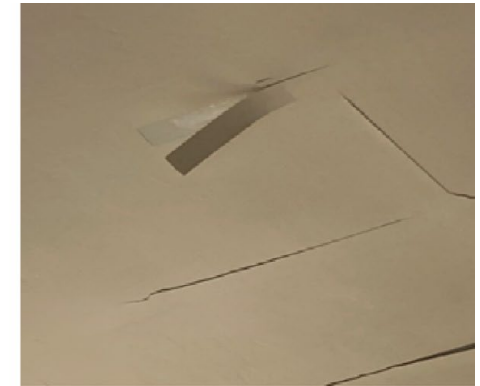
**Figure 7. Stained and Peeling Ceilings**

The supervisor at the Excelsior Post Office did not report the ongoing ceiling leak. Excelsior and Sutter Street post offices are leased facilities and must adhere to guidance outlined in Postal Service's policy.<sup>7</sup> Postal Service leases have provisions making the lessor responsible for maintaining the premises in good repair and tenantable condition (except for repair of damage caused by Postal Service agents or employees). Failure to report maintenance and safety issues into eFMS prevents proper reporting to the National Facilities Response Line, which can lead to additional problems.

We recommend the **Manager, California 1 District**, report the ceiling leak at the Excelsior Post Office in the electronic Facilities Management System and follow-up to ensure the leak is repaired.

Regarding recommendation 5, management stated that maintenance inspected and abated the ceiling leak and replaced all damaged ceiling panels. Management also stated that a national contractor will conduct periodic roof inspections. Management stated that they abated this issue on July 29, 2021.

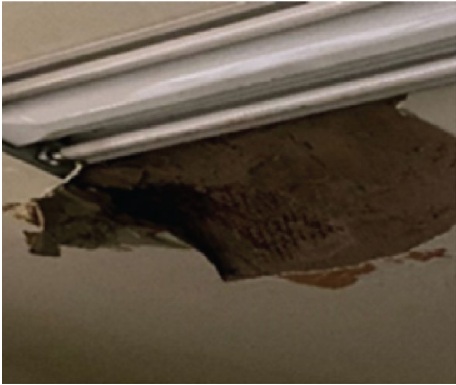
**Figure 8. Damaged Ceiling**

At the Sutter Street Post Office, we identified stained and damaged ceilings (see Figure 8) and damaged and dirty floors throughout the facility (see Figure 9). We also observed dirty and damaged walls on the upper level with potential mold (see Figure 10).

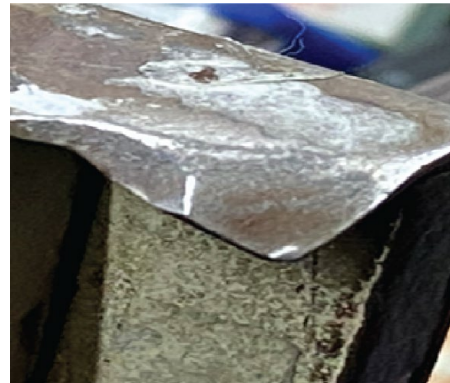
**Figure 11. Sharp Edges at Retail Counter**

At the Menlo Park Post Office, we identified retail window counters with sharp metal edges posing a risk to employees (see Figure 11), an improperly stored canister of gasoline near the shed (see Figure 12), an unsecured ladder, and a microwave plugged into an extension cord. None of the facility's 10 fire extinguishers had been inspected monthly since April 2021 and seven annual tags were incorrectly punched for May 2023. We also identified broken concrete pavement at the front entrance of the facility, creating a potential trip hazard for customers.

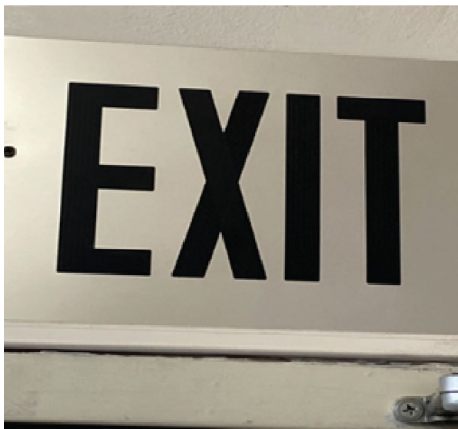
**Figure 13. Exit Sign Not Illuminated**

At the Excelsior Post Office we identified retail window counters with sharp metal edges posing a risk to employees, an emergency exit sign not illuminated (see Figure 13), a broken electrical panel door (see Figure 14), non-exit doors that were not clearly marked, and neither of the facility's two fire extinguishers had been inspected monthly since January 2021.

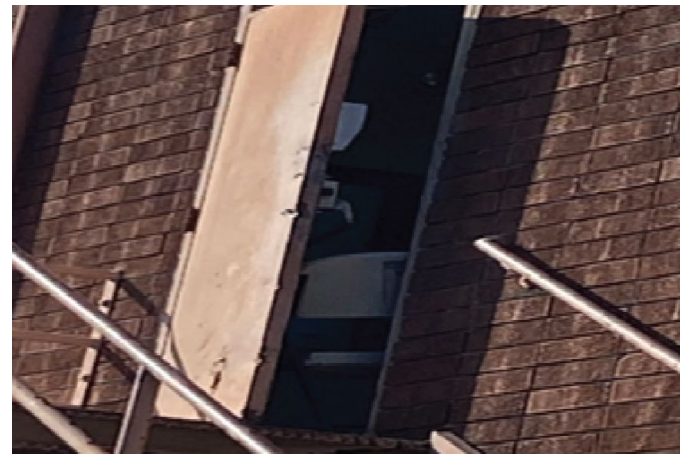
**Figure 15. Breakroom Door Propped Open with Chair**

At the Menlo Park Post Office we found an unsecured door leading from the employee breakroom to the exterior of the building (see Figure 15). At the Sutter Street Post Office we found a door with an inoperable locking mechanism in the retail lobby leading to the workroom floor. We did not identify any security issues at the Excelsior Post Office.

The unsecured door at Menlo Park occurred because carriers propped the breakroom door open with a chair as a shortcut for re-entry from the vehicle parking lot. The door was intended for exit only and not re-entry or unauthorized

entry into the facility as a safety precaution. The postmaster was not aware that employees were propping the door open until we brought it to his attention.

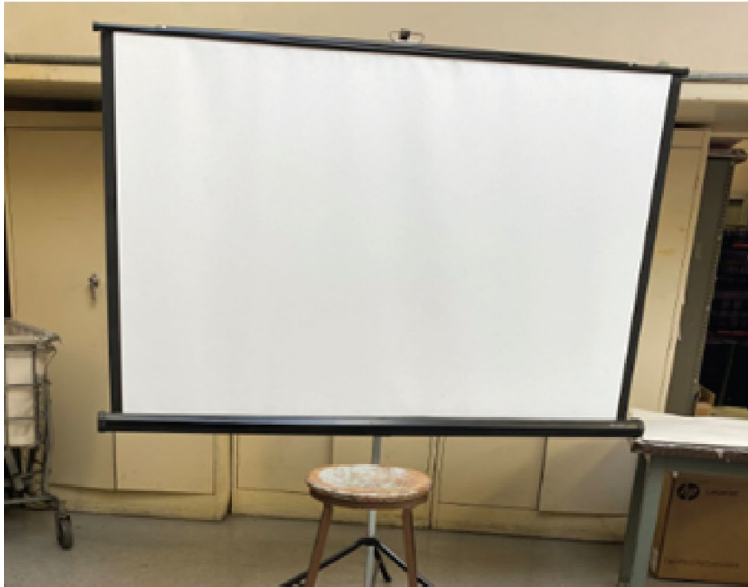
**Figure 16. Passport Photos taken on Workroom Floor**

During our review at the Excelsior Post Office we observed an employee taking passport photos on the workroom floor (see Figure 16). The facility offers passport services Monday through Saturday. This current setup which allows customers onto the workroom floor is not an ideal situation, as it potentially creates challenges to the safety and security of Postal Service assets and employees. Management should consider an alternative space for taking passport photos.
