Office of Inspector General | United States Postal Service

## Audit Report

# Mail Delivery, Customer Service, and Property Condition Reviews – Select Units, Portland, OR Region

Report Number 22-001-R22 | March 22, 2022

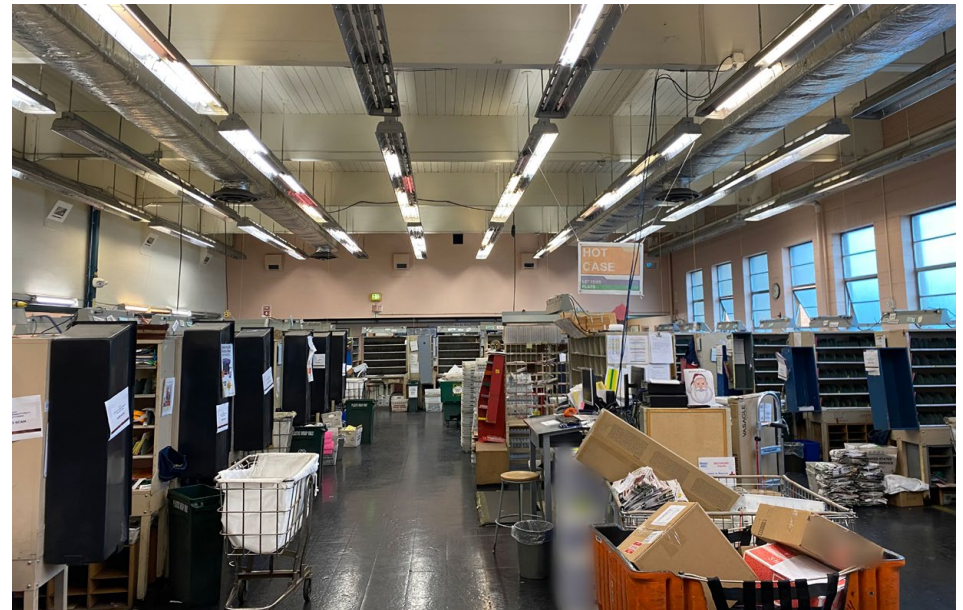
Figure 1. Beaverton MPO

- At the Beaverton MPO, we identified uneven floors at the customer front entrance, a loose handrail on the dock caused by crumbling concrete, lobby doors that did not work properly, and over 60 percent of lightbulbs in the workroom area were burned out (see Figure 1).
- At the Parkrose Station, we identified fire extinguishers that were missing monthly and annual inspections, blocked exit route doors, and a metal object protruding from cement (see Figure 2).

Inoperable Workroom Floor Lights

We recommend the **District Manager, Idaho-Montana-Oregon**, address all remaining building maintenance and safety issues identified at the Beaverton Main Post Office and the Parkrose and Piedmont Stations.

Regarding recommendation 5, management stated that they have had the fire extinguishers professionally serviced and have begun monthly inspections for Piedmont Station. All items blocking access have been removed and they have scheduled the repair of the missing ceiling with the landlord. Regarding Parkrose Station, management stated that they will monitor doorways and exits for access, recognize and report hazards on the day they are identified, and complete

monthly inspections of fire extinguishers. The target implementation date for the Piedmont and Parkrose Stations is 3/30/22. Concerning the Beaverton MPO, management stated that the pothole in the parking lot and both lobby doors have been repaired, the interior lighting will be updated to LED style fluorescent lighting, and that the concrete work has been scheduled for repair with a contractor. The target implementation date for Beaverton MPO is 6/30/22.

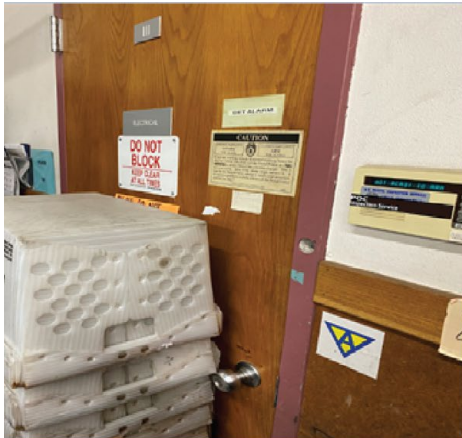
**Figure 2. Parkrose Station**

Blocked Exit Route

- Management at the Parkrose Station provided documentation that blocked exit routes were cleared and the metal object protruding from the cement was removed.
- Management at the Piedmont Station provided documentation that fire extinguishers were current on inspections and the blocked exit routes were cleared.
- Management at the Vancouver MPO provided documentation that fire extinguisher inspections were current, ceiling tiles were replaced, and a work order was submitted to replace the inoperable urinal.

Parkrose – Management will do a walkthrough of the building daily and weekly to maintain the safety and security of the building. Management at Parkrose will continue to monitor exits, doorways, and maintain signs in good conditions where "Do Not Block" is noted. Management will recognize hazards and address them on that day to include any workorders to be submitted for repairs; workorders will be documented and filed for future inspections and OSHA regulations. We have identified the issues and current management has corrected them at this time. Unblocked doors and removed metal plate attached to wall that was a safety issue for anyone passing by. Monthly fire extinguisher inspection is now current.

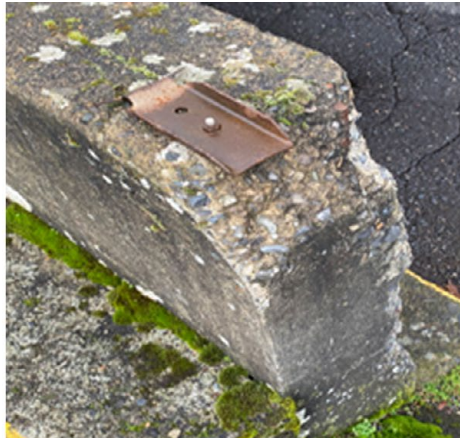
Cement With Protruding Metal Object

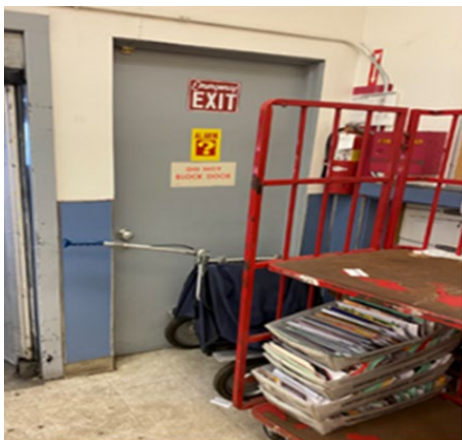
**Figure 3. Piedmont Station**

- At the Piedmont Station, we identified fire extinguishers that were missing monthly and annual inspections, blocked exit route doors, and pieces of ceiling missing in the loading dock area (see Figure 3).
- At the Vancouver MPO, we identified fire extinguishers that were missing monthly inspections, water-stained ceiling tiles, an inoperable urinal and toilet in the men's room, and damaged asphalt in the customer and employee parking lots (see Figure 4).

Blocked Emergency Exit and Extinguisher

Piedmont – Management has had all 6 fire extinguishers professionally serviced at a cost of \$146 and has begun monthly inspections. All items blocking the locations have also been removed. The piece of the missing ceiling is scheduled to be covered as one of the next projects by the owner as his next is repairing the entrance gate.

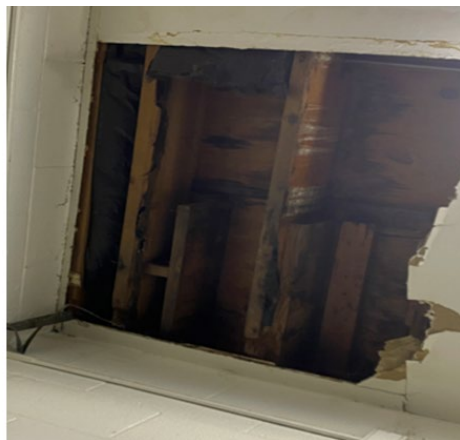
Missing Ceiling on Loading Dock

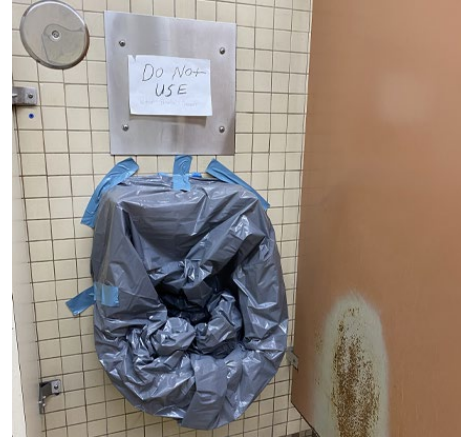
**Figure 4. Vancouver Main Post Office**

Broken Urinal

Regarding recommendation 6, management stated they have requested a new urinal and received a quote from a contractor. The target implementation date is 3/31/22.

Management stated that they have requested a new urinal, instead of fixing the current one. They had a contractor come out to give them a quote, which is being handled by the field manager for IMO. Management stated they will send all supporting documents and or a date for repair completion with the management response. As indicated in OIG's report immediate action was taken during the visit: "During our audit, management took corrective action for the fire extinguishers as they attached monthly inspection tags to all 15 extinguishers and assigned one of the custodians to perform monthly inspections."

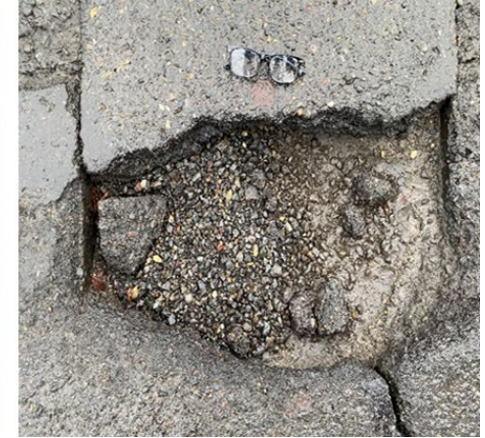
Damaged Asphalt

We recommend the **District Manager, Washington**, address all remaining building maintenance and safety issues identified at the Vancouver Main Post Office.
