Audit Report

Mail Delivery, Customer Service, and Property Conditions Review – Vancouver Main Post Office, Vancouver, WA

Report Number 22-032-R22 | February 3, 2022

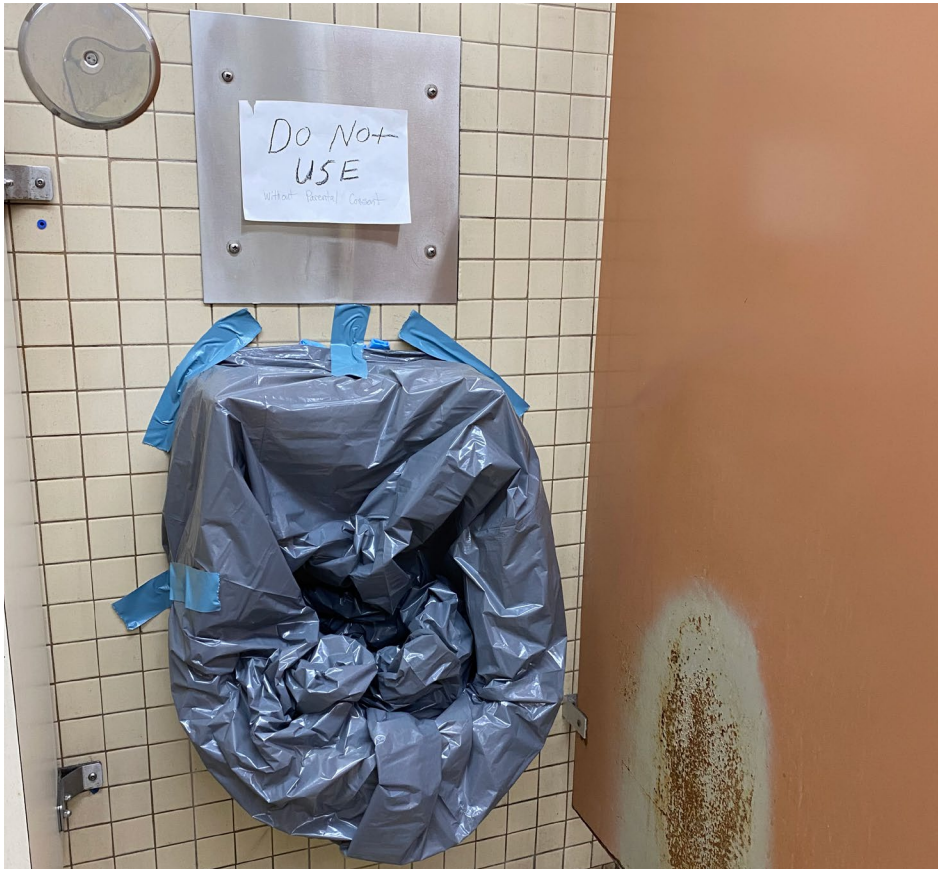
Figure 1. Broken Urinal

We found safety and maintenance issues at the Vancouver MPO, including fire extinguishers that had not been inspected as required,¹⁵ water-stained ceiling tiles above computer equipment, and an inoperable urinal (see [Figure 1](#)) and toilet in the men's restroom that were not reported in the electronic Facilities Management System (eFMS).¹⁶ We also identified damaged asphalt in the customer and employee parking lots (see [Figure 2](#)) that was reported in eFMS in June 2019, but the repairs were still pending. During our audit, management took corrective action for the fire extinguishers as they attached monthly inspection tags to all 15 extinguishers and assigned one of the custodians to perform monthly inspections.

Unit management did not take the necessary actions to ensure that property condition issues were corrected because other duties took priority such as addressing customer inquiries and ensuring carriers returned on time. Unit management stated they were unaware of the monthly inspection requirement for fire extinguishers and that they relied on district maintenance management to input the broken urinal and toilet maintenance requests in eFMS.

Management stated that they have requested a new urinal, instead of fixing the current one. They had a contractor come out to give them a quote, which is being handled by the field manager for INO. Management stated they will send all supporting documents and or a date for repair completion with the management response. As indicated in OIG's report immediate action was taken during the visit: "During our audit, management took corrective action for the fire extinguishers as they attached monthly inspection tags to all 15 extinguishers and assigned one of the custodians to perform monthly inspections."

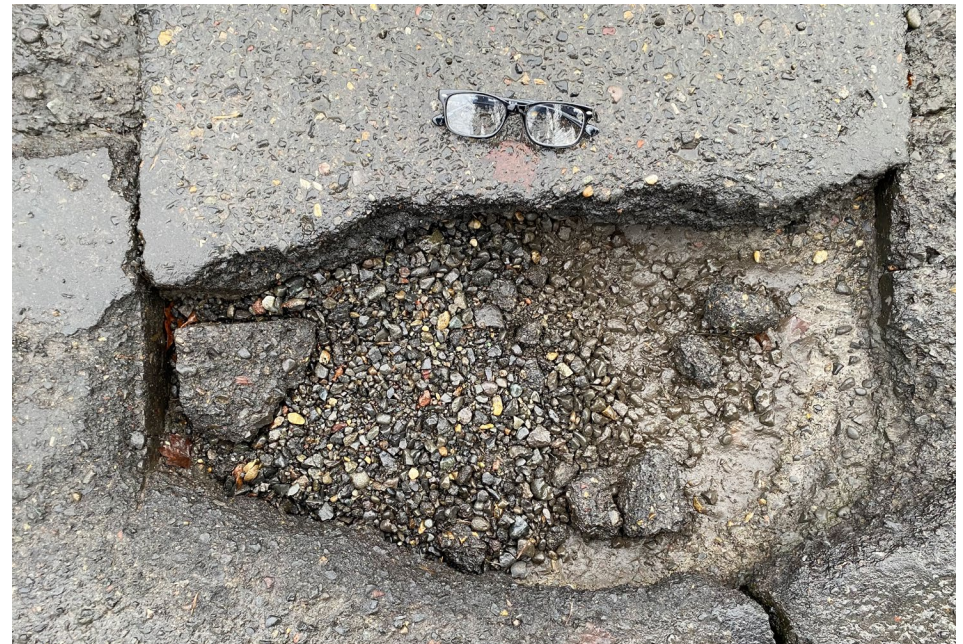
Figure 2. Damaged Asphalt

We found safety and maintenance issues at the Vancouver MPO, including fire extinguishers that had not been inspected as required. One area in the building has water-stained ceiling tiles above computer equipment, and an inoperable urinal and toilet in the men's restroom that were not reported in the electronic Facilities Management System (eFMS). There is damaged asphalt in the customer and employee parking lots, that was reported in eFMS in June 2019, but the repairs were still pending.

- Fire extinguishers with required inspections.
- Water stained tiles were replaced on 1/18/2022.
- Parking lot repairs to begin 01/28/2022, as indicated in the email confirmation.
