Audit Report

Mail Delivery, Customer Service, and Property Conditions Review – Plainfield Main Post Office, Plainfield, IN

Report Number 22-085-R22 | May 26, 2022

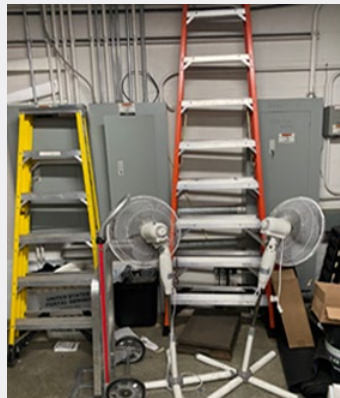
Blocked Electrical Panels

We found safety, security, and maintenance issues at the Plainfield MPO, including fire extinguishers that had not been inspected,¹⁷ blocked electrical panels in the boiler room, and a toilet in the men's restroom that did not flush properly (see Figure 1).

Figure 1. Examples of Safety and Maintenance Issues

Management should have provided sufficient oversight of facility maintenance, reported safety, security, and maintenance issues as they arose, and followed up to ensure resolution. The Postal Service is required to maintain a safe environment for employees and customers. In addition, Occupational Safety and Health Administration (OSHA) requires employers to provide a safe and healthy workplace free of recognized hazards.¹⁹

Manager, Greater Indiana District agrees with the finding. The Carmel Post Office has been instructed to perform regular housekeeping inspections and provide copies to their MPOO. The Postmaster has been instructed on the proper procedures and schedule for fire extinguisher inspections.

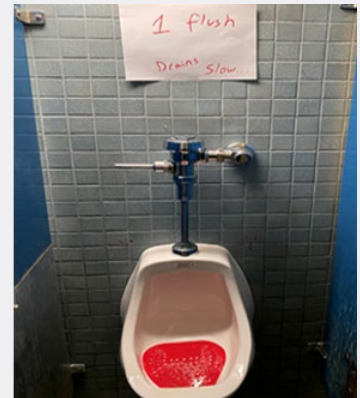
Toilet Issues

Management did not provide adequate oversight to ensure that property condition issues were corrected. Management stated it thought the ceiling tiles and the hole above the window would be fixed by maintenance once the roof leaks were fixed. Therefore, a follow-up request was never submitted to get the items fixed. Management also stated the urinal was flushing slowly due to a bad pipe.

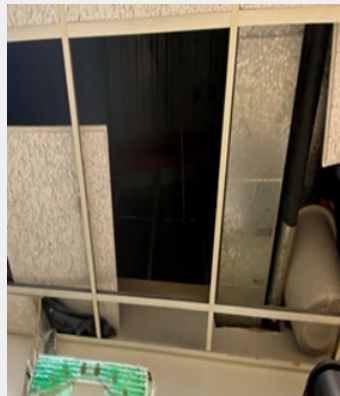
Missing Ceiling Tiles

We also identified missing ceiling tiles in the locker room area and a hole above the window in the Business Mail Entry Unit office (see Figure 2). In addition, we identified there was no signage posted in the employee parking lots stating that "vehicles may be subject to search".¹⁸ During our audit, management took corrective action and fixed a pothole.

Figure 2. Examples of Maintenance Issues
