## Audit Report

# Mail Delivery, Customer Service, and Property Conditions Review – Carmel Main Post Office, Carmel, IN

Report Number 22-086-R22 | May 26, 2022

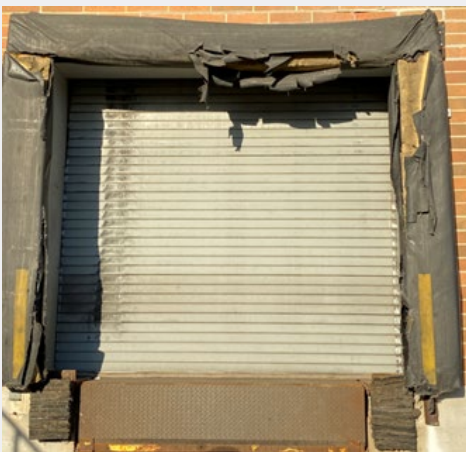
**Figure 1. Padding Around Dock Door**

We found maintenance, security, and safety issues at the Carmel Main Post Office, including blocked fire extinguishers<sup>19</sup> on the workroom floor, missing fire extinguisher inspections, worn padding around the dock door (see Figure 1), damaged bricks on the indoor dock wall (see Figure 2), and a hole in the ceiling partially concealed with ceiling tiles near the women's restroom (see Figure 3). We also observed crumbling concrete and a rusted railing outside the dock and business caller services entrance (see Figure 4 and Figure 5). Further, there was no signage posted in the employee parking lots stating that "vehicles may be subject to search".<sup>20</sup> During our audit, the custodian took corrective action and unblocked the fire extinguishers on the workroom floor and performed the monthly inspections.

The manager at the Carmel Post Office has been instructed to perform regular housekeeping inspections and provide copies to their MPOO. The Postmaster has been instructed on the proper procedures and schedules for the fire extinguisher inspections. Please see attached the completed Facility Maintenance issues (FSSP) (Item 2), additional missing sign (Item 3).

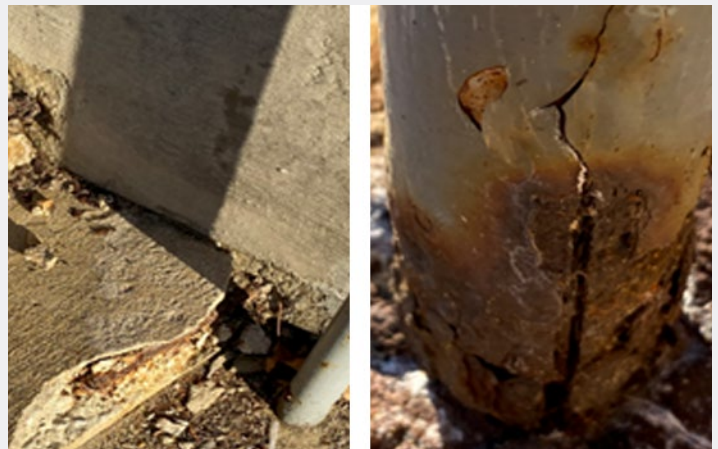
**Figure 4. Crumbling Concrete and Rusted Railing**

We found maintenance, security, and safety issues at the Carmel Main Post Office, including blocked fire extinguishers. We also observed crumbling concrete and a rusted railing outside the dock and business caller services entrance. Further, there was no signage posted in the employee parking lots stating that "vehicles may be subject to search" on the workroom floor, missing fire extinguisher inspections, worn padding around the dock door, damaged bricks on the indoor dock wall, and a hole in the ceiling partially concealed with ceiling tiles near the women's restroom. During our audit, the custodian took corrective action and unblocked the fire extinguishers on the workroom floor and performed the monthly inspections.
