Office of Inspector General | United States Postal Service

Interim Audit Report

Mail Delivery, Customer Service, and Property Conditions Review – Linwood Station, Indianapolis, IN

Report Number 22-087-R22 | May 26, 2022

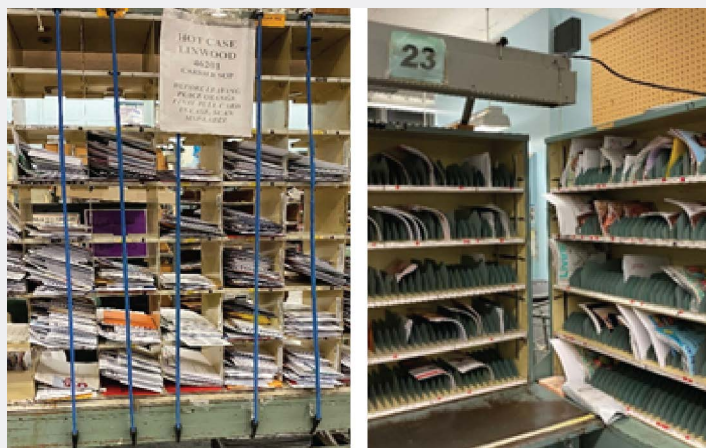
Figure 1. Examples of Delayed Mail

We identified about 2,023 pieces of delayed mail, which included about 1,269 letters and 754 flats in the hot case⁶ and carrier cases on the morning of March 15, 2022. In addition, management did not accurately report delayed mail in the Customer Service Daily Reporting System (CSDRS).⁷ While they reported 1,148 delayed letters and flats, this represented only about 57 percent of the delayed mailpieces we identified at the unit. See Figure 1 for examples of delayed mail found at the hot case and carrier cases.

The Postmaster of Indianapolis has made it a priority to improve staffing at Linwood Station, the unit currently has 0 CCA's on the roles which has eliminated failed deliveries and delayed in mail in the unit most every day. A CRDO level 2 team was assigned to Linwood and they conducted targeted training with the EAS staff regarding proper volume recording in CSDRS and DCV now that CSDRS has been retired. See attached documentation from CRDO level 2 support team.

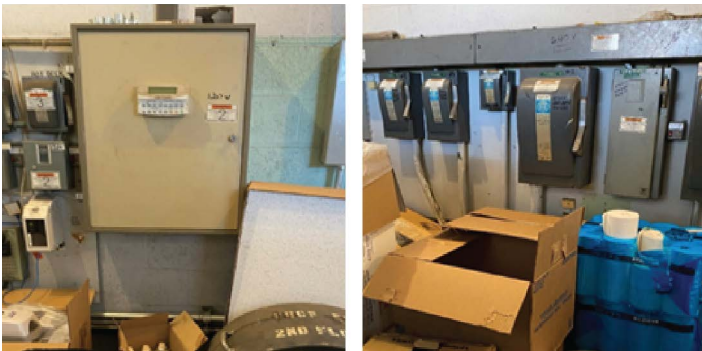
Figure 2. Blocked Electrical Panels

We found safety and maintenance issues at the Linwood Station, including fire extinguishers that had not been inspected, blocked electrical panels in a boiler room (see Figure 2), and broken windows outside the customer entrance (see Figure 3).

Unit management did not provide adequate oversight to ensure that facility condition issues were corrected. Management stated that other duties, such as dealing with staffing shortages and delivering mail, took priority. The station manager stated she was aware of the issues

Fire extinguishers have been inspected- see attached photos
Area around electrical panels have been cleared- see attached photos
Broken windows have not been repaired- FFSP request 3320944
Ceiling tile/ boiler room ceiling repairs have not been completed- FSSP request 3305466
Vent area has been cleaned- see attached photos

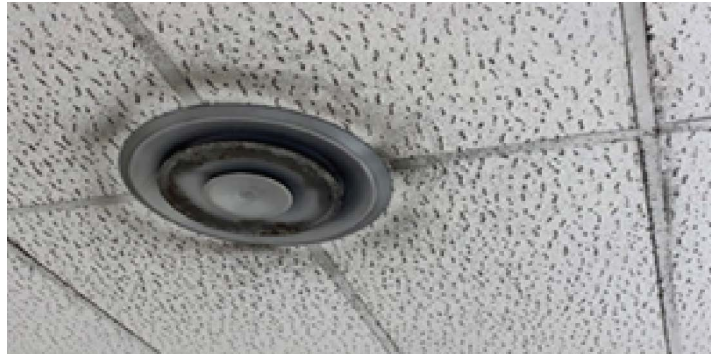
Figure 4. Dust Around Air Vent

- Dust build-up around air vents in the customer lobby (see Figure 4).
- Damaged and missing ceiling tiles in the workroom area (see Figure 5).
- Holes in the boiler room ceiling (see Figure 6).

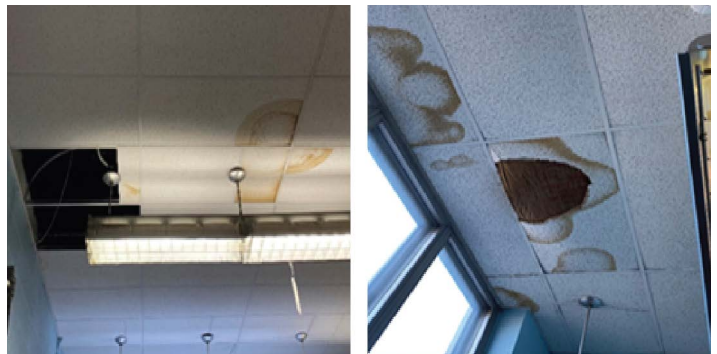
Figure 5. Issues with Ceiling Tiles in Workroom Area

related to the damaged and missing ceiling tiles and tried to resolve them by contacting Facilities Single Source Provider (FSSP)²⁴ and filing a request in the electronic Facilities Management System (eFMS)²⁵. During our site observations, local maintenance personnel came on-site to begin addressing these issues.
