Audit Report

Mail Delivery, Customer Service, and Property Conditions Review – Select Units, Indianapolis, IN Region

Report Number 22-091-R22 | June 22, 2022

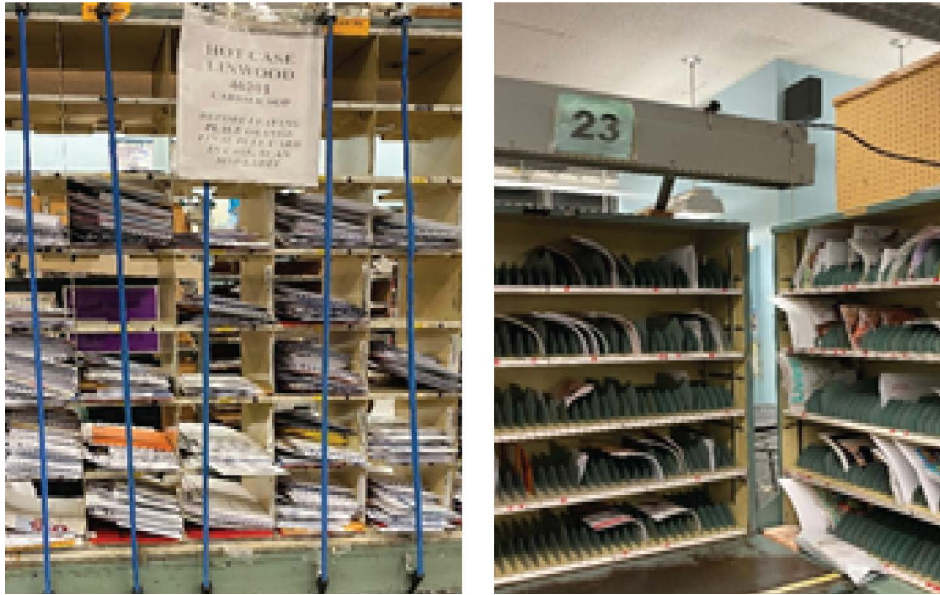
Figure 1. Examples of Delayed Mail

At the Linwood Station, we identified about 2,023 pieces of delayed mail, which included 1,269 letters and 754 flats in the hot case¹⁰ and carrier cases on the morning of March 15, 2022. In addition, management did not accurately report delayed mail in the CSDRS. While they reported 1,148 delayed letters and flats, this represents only about 57 percent of the delayed mailpieces we identified at the unit. We did not find any delayed mail issues at the Plainfield and Carmel MPOs. See [Figure 1](#) for examples of delayed mail found in the hot case and carrier cases.

Management did not ensure the station had enough resources to deliver all committed mail each day. Specifically, the station has five limited light-duty carriers and several new city carrier assistants who are training in order to carry longer routes. In addition, carriers often transferred out of the unit to other offices and were not immediately replaced. However, it is still the responsibility of management to ensure that the unit has adequate coverage for each route.

We recommend the **District Manager, Indiana District**, develop a plan to ensure that all committed mail at the Linwood Station is delivered daily, all delayed mail volume is entered into the proper system, and management systematically reviews data and enforces reporting compliance at the Linwood Station.

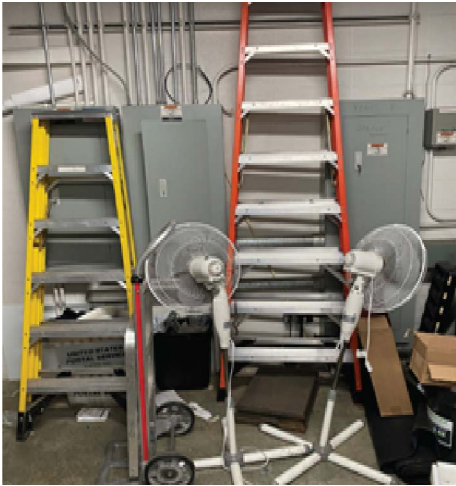
Figure 2. Blocked Electrical Panels

We found safety, security, and maintenance issues at all three delivery units. At the Plainfield MPO, we identified fire extinguishers that had not been inspected,²⁸ blocked electrical panels in the boiler room (see Figure 2), and a toilet in the men's restroom that did not flush properly (see Figure 3). We also identified missing ceiling tiles in the locker room area (see Figure 4) and a hole above the window in the Business Entry Unit (see Figure 5). In addition, there was no signage posted in the employee parking lot stating that "vehicles may be subject to search."²⁹ During our audit, management took corrective action and fixed a pothole we identified in the parking lot.

Management did not provide adequate oversight to ensure that property condition issues were corrected. Specifically, at the Plainfield MPO, management stated that they thought the ceiling tiles and the hole above the window would be fixed by maintenance once the roof leaks were fixed. Therefore, a follow-up request was never submitted to get the items fixed. At the Carmel MPO, management was more focused on mail delivery. Additionally, at the Linwood Station, management stated that other duties, such as dealing with staffing shortages and delivering mail, took priority.

Plainfield Post Office management provided documentation showing that they updated inspections for the fire extinguishers we identified during the site visit, replaced missing ceiling tiles, repaired the damaged hole above a window, removed all items blocking the electrical panels, and repaired the toilet in the men's restroom.

We recommend the **District Manager, Indiana District**, address all building safety, security, and maintenance issues identified at the Plainfield Main Post Office, the Carmel Main Post Office, and Linwood Station.

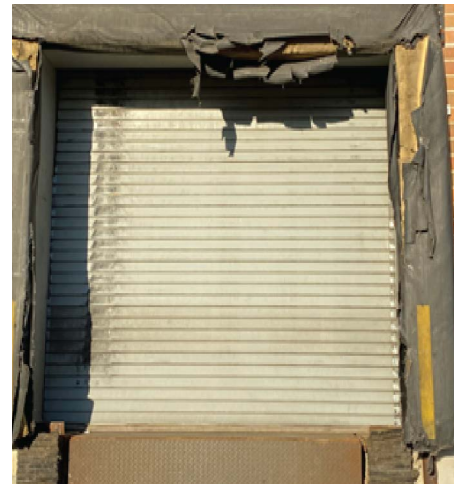
Figure 6. Padding Around Dock Door

At the Carmel MPO, we identified issues including blocked fire extinguishers on the workroom floor, missing fire extinguisher inspections, worn padding around the dock door (see Figure 6), damaged bricks on the indoor dock wall (Figure 7), and a hole in the ceiling partially concealed with ceiling tiles near the women's restroom (see Figure 8). We also observed crumbling concrete and a rusted railing outside the dock and business caller services entrance (see Figure 9 and Figure 10). Further, there was no signage posted in the employee parking lot stating that "vehicles may be subject to search." During our audit, the custodian took corrective action and unblocked the fire extinguishers on the workroom floor and performed the monthly inspections.

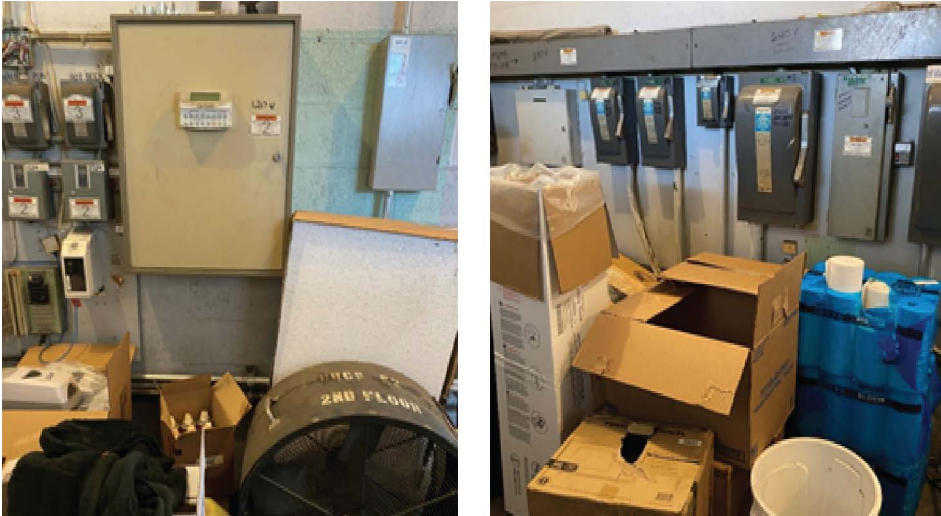
Figure 11. Blocked Electrical Panels

At the Linwood Station, we identified fire extinguishers that had not been inspected, blocked electrical panels in a boiler room (see [Figure 11](#)), and broken windows outside the customer entrance (see [Figure 12](#)). There were other issues related to the ceiling throughout the facility including dust build-up around air vents in the customer lobby (see [Figure 13](#)), damaged and missing ceiling tiles in the workroom area (see [Figure 14](#)), and holes in the boiler room ceiling (see [Figure 15](#)). During our site observations, local maintenance personnel came on-site to begin addressing these issues.

Linwood Station management provided documentation showing that they removed items blocking the electrical panels, cleaned the dirty air vent, and repaired ceiling tiles in the workroom area.
