Audit Report

Mail Delivery, Customer Service, and Property Conditions Review – Kent Main Post Office, Kent, WA

Report Number 22-096-R22 | June 7, 2022

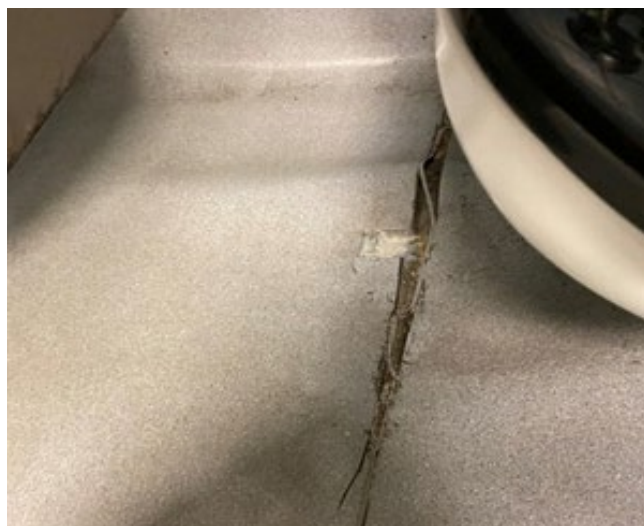
Figure 2. Cracked Flooring in Men's Restroom

- Cracked flooring alongside the toilet in the men's restroom (see Figure 2).
- Holes in walls in various locations (see Figure 3).
- Dirty air vents in the retail post office box area and workroom floor (see Figure 4).

- Management states the fire extinguisher inspections have been updated.
- Crack in the floor and holes in the wall will be completed by Friday June 3, 2022.
- On June 2, 2022, contractor from Capital Duct will be at the Kent Main Post Office to provide an estimate and schedule work.

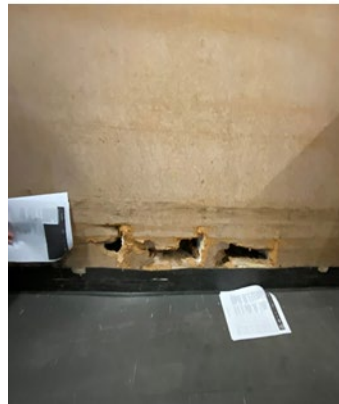
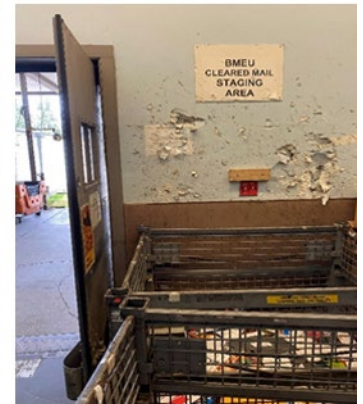
Figure 3. Holes in Walls

Location: Workroom Floor

Location: Inside Dock Area

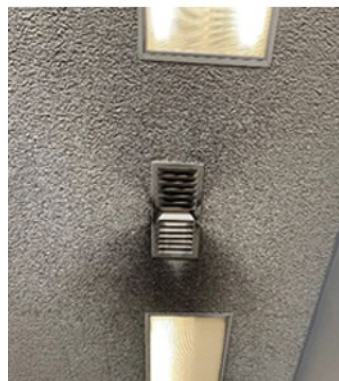
Figure 4. Dirty Air Vents

Location: Post Office Box Retail Area

Location: Workroom Floor
