Audit Report

Mail Delivery, Customer Service, and Property Condition Reviews – Select Units, Seattle, WA Region

Report Number 22-101-R22 | July 28, 2022

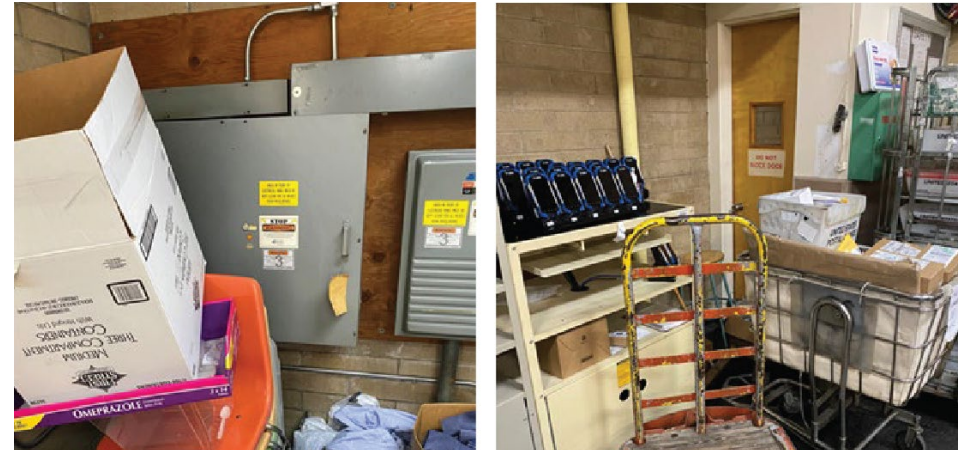
Figure 1. Blocked Electrical Panel and Inspection Service Door

We found safety and maintenance issues at all four delivery units. At the Parkland Branch, we identified issues including a blocked electrical panel, a blocked Inspection Service door (see Figure 1), fire extinguishers not being consistently inspected¹⁸ (see Figure 2 and Figure 3), and an exit door without an illuminated exit sign (see Figure 4).

- Management at the Parkland Branch provided documentation showing the blocked electrical panel and Inspection Service door were cleared, and the fire extinguisher inspections were current.
- Management at the Renton MPO provided documentation showing the blocked door and fire extinguisher were cleared, the fire extinguisher inspections were current, the damaged lights in the parking lot, and the damaged ceiling tiles in the lobby and manager's office were repaired.
- Management at the Lacey Branch provided documentation showing the exterior PO Box area door and the lobby door in the PO Box area were repaired.

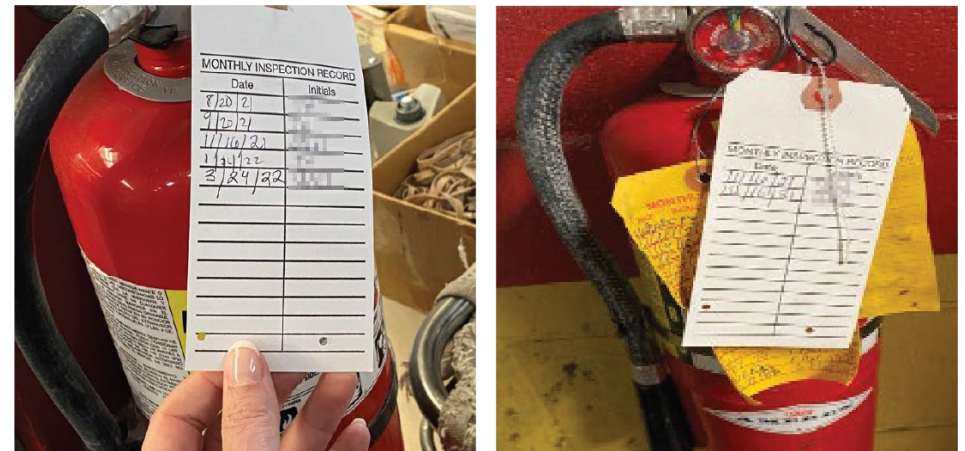
Figure 2. Portable Fire Extinguishers Missing Monthly Inspections

¹⁸ Occupational Safety and Health Administration (OSHA) 29 CFR 1910.157(e)(2) and 29 CFR 1910.157(e)(3) requires that fire extinguishers be inspected monthly and annually.

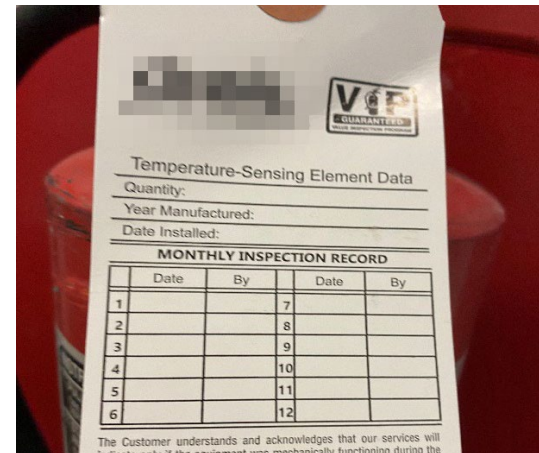
Figure 5. Fire Extinguishers Missing Monthly Inspections

At the Kent MPO, we identified issues including fire extinguishers not being consistently inspected (see Figure 5), cracked flooring in men’s restroom (see Figure 6), holes in the walls (see Figure 7), and dirty air vents in the retail PO Box area and on the workroom floor area (see Figure 8).

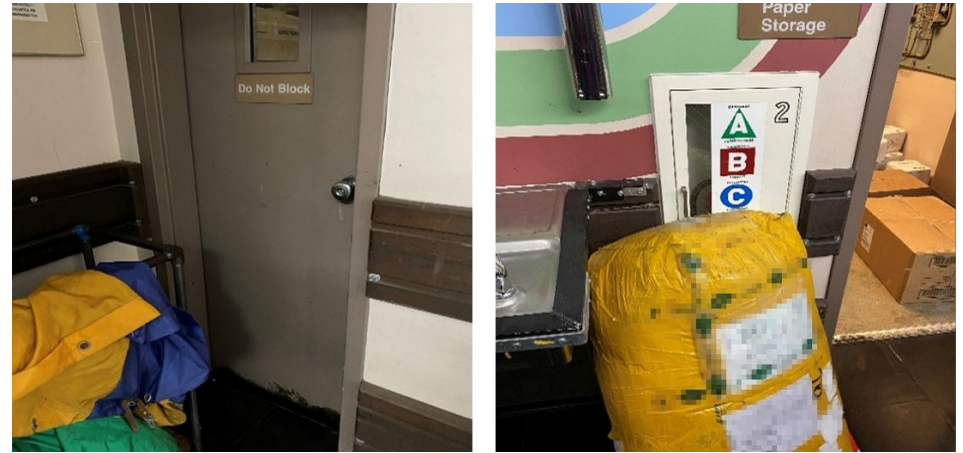
Figure 9. Blocked Inspection Service Door and Fire Extinguisher

At the Renton MPO, we identified issues including a blocked door and fire extinguisher (see Figure 9), five fire extinguishers had not been inspected (see Figure 10), two damaged lights in the parking lot, and stained and damaged ceiling tiles in the lobby and manager's office (see Figure 11).

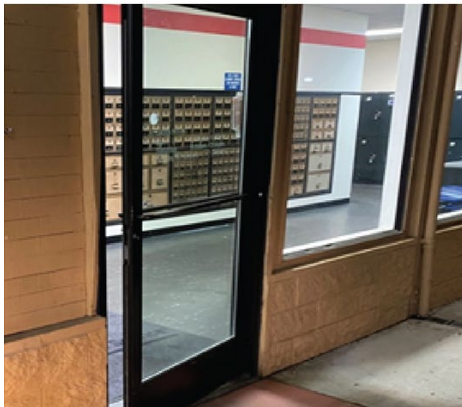
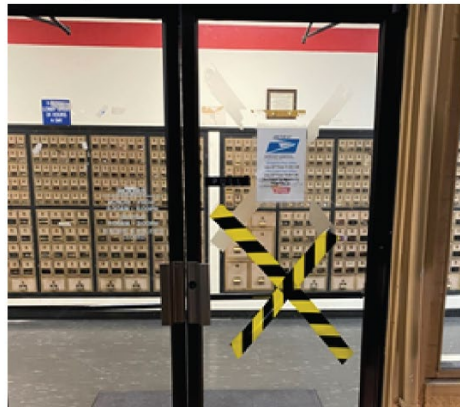
Figure 12. PO Box Area Doors

At the Lacey Branch, we identified issues including an exterior PO Box area door that does not close completely, and a lobby door in the PO Box area that is broken (taped up - see Figure 12).
