Audit Report

Mail Delivery, Customer Service, and Property Conditions Review – Marian Oldham Station, St. Louis, MO

Report Number 22-115-4-R22 | July 13, 2022

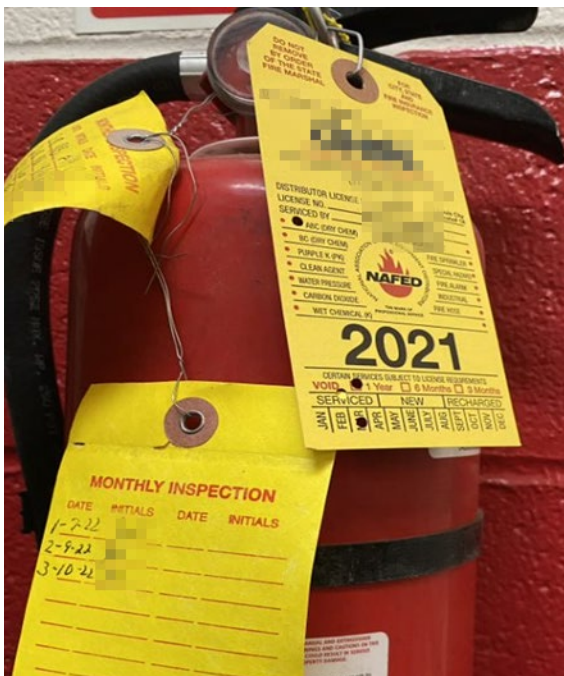
Figure 1. Example of Fire Extinguisher Missing Inspections

We found building safety and maintenance issues at the Marian Oldham Station, including all seven fire extinguishers missing both monthly and annual inspections. Monthly inspections were last completed on March 10, 2022, and annual inspections were last completed in March 2021 (see Figure 1).¹³ We also found a space heater plugged into a surge protector rather than directly into the wall outlet in the sales associate's area (see Figure 2), five dirty vents in the customer lobby (see Figure 3), and one large pothole (approximately two inches deep) in the employee parking lot (see Figure 4).

¹³ Occupational Safety and Health Administration (OSHA), 29 CFR 1910.157(e)(2) and 29 CFR 1910.157(e)(3) requires that fire extinguishers be inspected monthly and annually.

Management did not provide adequate oversight to ensure all property condition issues were identified timely. Specifically, the station manager was not aware of any of the issues we identified. For the annual fire extinguisher inspections, the station manager stated that he usually receives an alert from the company that does the inspections when they are due, but he had not received one this year.

Management should have provided sufficient oversight of facility maintenance, reported safety and maintenance issues as they arose, and followed up to ensure the issues were addressed. The Postal Service is required to maintain a safe environment for employees and customers. In addition, OSHA requires employers to provide a safe and healthy workplace free of recognized hazards.¹⁴
