Mail Delivery, Customer Service, and Property Conditions Review – Logan Station, Philadelphia, PA

AUDIT REPORT

Report Number 22-208-2-R23 | January 10, 2023

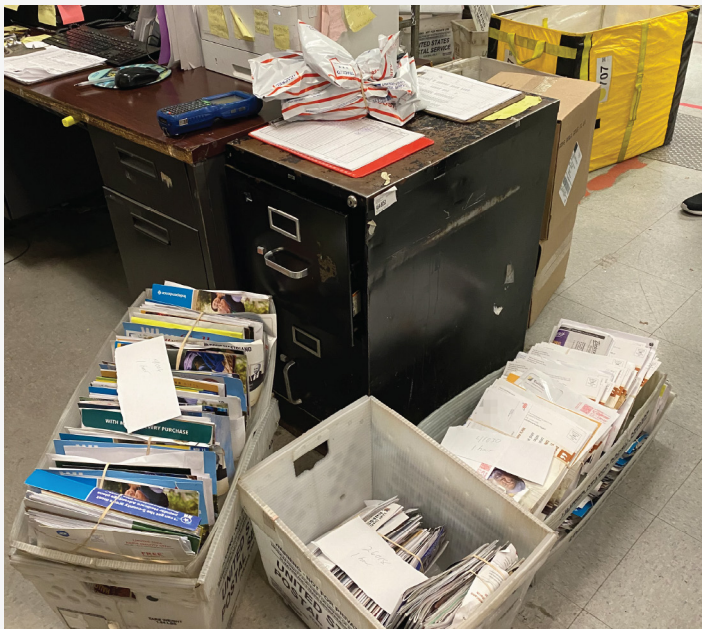
Figure 1. Delayed Mail in Supervisor’s Desk Area

On the morning of October 25, 2022, we identified 2,477 delayed mailpieces at the unit. Specifically, we identified approximately 1,595 pieces in 23 carrier cases and 882 pieces, including one piece of Election Mail, in the supervisor’s desk area.⁹ In addition, this mail was not reported as undelivered in the Delivery Condition Visualization (DCV)¹⁰ system. See Table 2 for the number of pieces of each mail type and Figures 1 and 2 for examples of delayed mail.

The unit had delayed mail due to increased mail volume related to the election and lack of staff hours. Management stated that delayed mail was due to political mail volume and the district’s desire to limit hours that city carrier assistants are allowed to work. In addition, the day prior to our visit, a carrier had unexpectedly returned to the station early with a truck full of undelivered packages and mail. The PM supervisor stated that competing responsibilities,

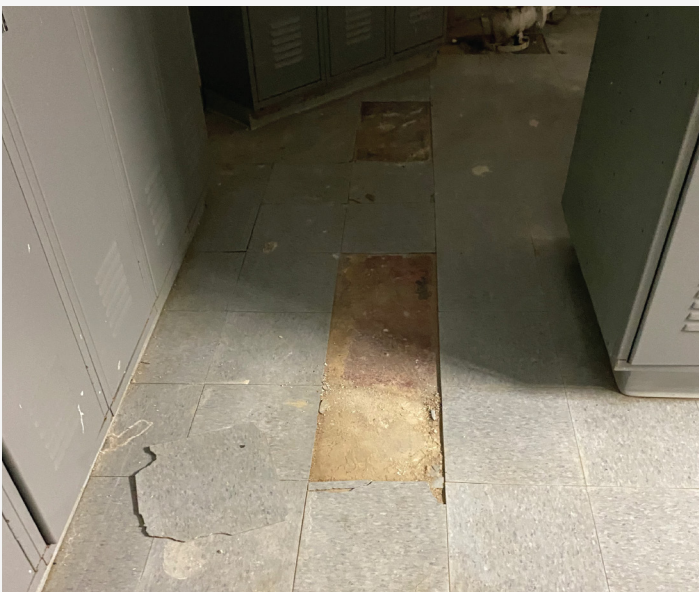
Figure 3. Missing Floor Tiles in Men's Locker Room

- Missing floor tiles in the men's locker room (see Figure 3).
- A damaged dock staircase with multiple tripping hazards (see Figure 4).
- A large opening in the roof above the dock (see Figure 5).
- Missing monthly fire extinguisher inspections.
- A blocked internal Postal Inspection Service door.
- No signage posted around the facility stating that employee vehicles may be subject to search.
- Evidence of potential mold on the men's locker room floor (see Figure 6).
- Non-operational light fixtures inside the men's locker room floor.
- Dirty air vents in customer lobby.
- Damaged wall near workroom exit.
- Missing ceiling tiles in basement.

Management did not take the necessary actions to ensure that facility condition issues were corrected because they were unaware of some issues, such as missing floor tiles in the men's locker room and potential mold, and unaware of some requirements, such as employee parking lot signage. In addition, management overlooked reassigning the responsibility when the unit custodian responsible for overseeing facility safety and maintenance issues was on medical leave.

Management should have provided sufficient oversight of personnel responsible for maintaining facilities, reported safety and maintenance issues as they arose, and followed up to ensure these issues were addressed. The Postal Service is required to maintain a safe environment for employees and customers. In addition, the Occupational Safety and Health Administration (OSHA) requires employers to provide a safe and healthy workplace free of recognized hazards.²³
