# Mail Delivery, Customer Service, and Property Conditions Review – Edgemoor Branch, Wilmington, DE

## AUDIT REPORT

Report Number 22-208-5-R23 | January 10, 2023

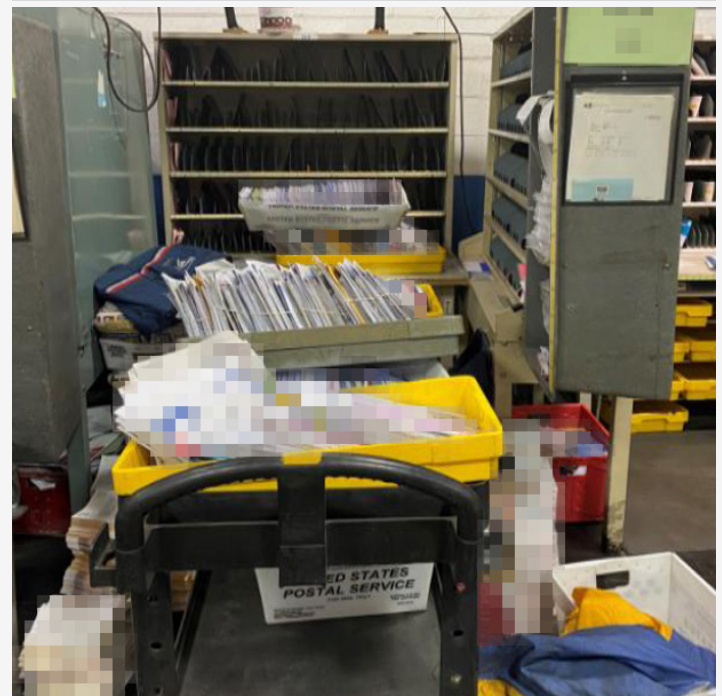
Figure 1. Example of Delayed Mail at a Carrier Case

On the morning of October 25, 2022, we identified about 39,547 delayed mailpieces at 57 carrier cases and on the workroom floor.<sup>10</sup> Specifically, we identified 30,873 pieces at the carrier cases and 8,674 pieces on the workroom floor. Unit management did not report this mail as delayed in the Delivery Condition Visualization (DCV)<sup>11</sup> system. See Table 2 for the number of pieces of each mail type and Figure 1 for an example of delayed mail found at carrier case.

Management should have ensured that all mail was processed and delivered daily and that the station had enough resources to deliver all the mail each day. Postal Service policy<sup>12</sup> states that all types of First-Class Mail, Priority Mail, and Priority Express Mail are always committed for delivery on the day of receipt. In addition, management is required<sup>13</sup> to report all mail at the delivery unit after the carriers

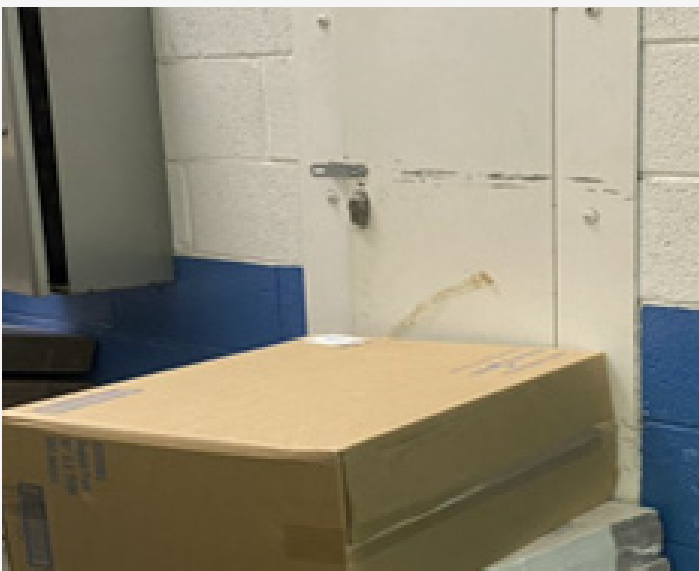
**Figure 3. Blocked Electrical Panel**

- A blocked electrical panel in the workroom (see Figure 3).
- A blocked Postal Inspection Service door in the workroom area (see Figure 4).
- All 12 fire extinguishers were missing the annual inspection. The last annual inspection was done in March 2021. In addition, 11 fire extinguishers were missing monthly inspections and one did not have a tag, so the inspection date could not be determined. Further, two fire extinguishers were blocked and not easily accessible – one in the storage room and one in the workroom.
- An uneven surface at the dock door entrance causing a potential trip hazard (see Figure 5).
- Stained ceiling tiles and a dirty wall in the lobby (see Figure 6) and workroom area.
- Cracked concrete around the railing outside the dock entrance (see Figure 7).
- No signage posted in the employee parking lot stating that vehicles may be subject to search.<sup>25</sup>

Management should have provided sufficient oversight of personnel responsible for maintaining facilities, reported safety and maintenance issues as they arose, and followed up for completion. The Postal Service is required to maintain a safe environment for employees and customers. In addition, the Occupational Safety and Health Administration (OSHA) requires employers to provide a safe and healthy workplace free of recognized hazards.<sup>26</sup>

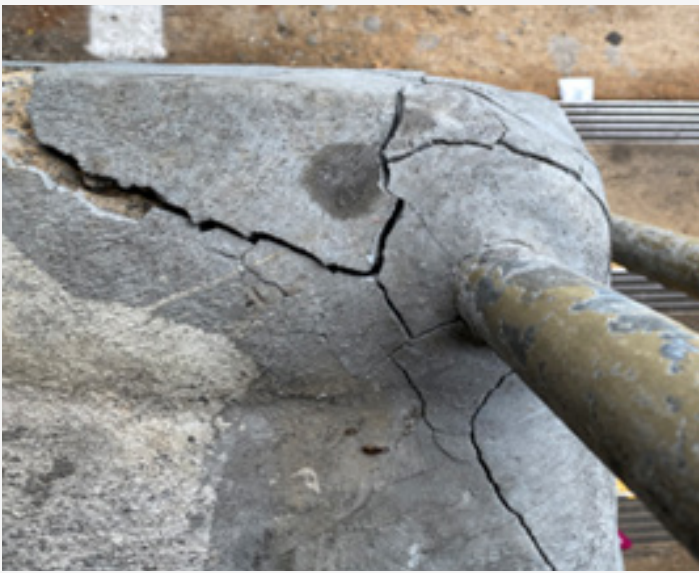
**Figure 7. Cracked Concrete**

Management did not take the necessary actions to ensure that facility condition issues were corrected because other duties, such as addressing customer inquiries and getting the mail out for delivery each day took priority. In addition, the station manager stated that he was not aware of the uninspected fire extinguishers, blocked electrical panel, blocked inspection service doors, and cracked concrete.
