SUBJECT: Audit Report – Facility Optimization: Capital Metro Area (Report Number DA-AR-11-004)

This report presents the results of our audit of facility optimization in the Capital Metro Area (Project Number 10YG029DA000). The U.S. Postal Service Office of Inspector General (OIG) initiated this audit from a random sample of districts nationwide. For the Capital Metro Area, our objective was to identify opportunities to optimize existing real estate in the Greensboro District. See Appendix A for additional information about this audit.

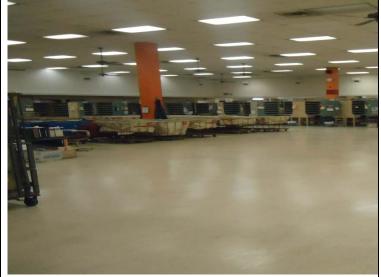
To highlight excess space in the Greensboro District, Illustration 1 depicts two facilities with excess interior space. The Lenior Main Post Office is Postal Service-owned and has delivery and retail operations along with vacant space in the facility. The Greenville Main Post Office is leased facility with delivery operations and significant vacant space on the workroom floor. According to our calculations, 77 percent of the sites visited contained excess space, ranging from 1,800 to 49,235 SF.

114 Ridge St. NW, Lenior, NC Interior Square Footage: 31,851 OIG-Calculated Excess SF: 20,351

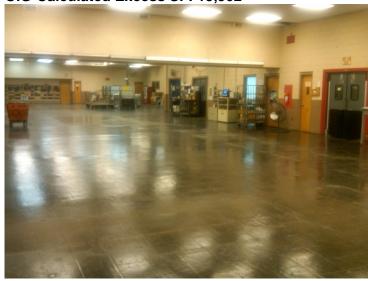
Greenville Main Post Office

300 W 2nd St.Greenville, NC Interior Square Footage: 20,902 **OIG-Calculated Excess SF: 15,902**

The Greenville, NC MPO is a USPS owned facility first occupied in 1969. Management agrees there is excess space in this facility. There is a planned study to relocate the carriers from the leased Greenville carrier annex and then terminating that lease. If instituted, there would be minimal excess workroom space in this building. It should be noted, relocation of the carriers back to the MPO is only now possible that the CSBCS machines at the annex are no longer being utilized.
