Mail Delivery, Customer Service, and Property Conditions Review - Industrial Park Annex, Saco, ME

AUDIT REPORT

Report Number 23-076-1-R23 | May 10, 2023

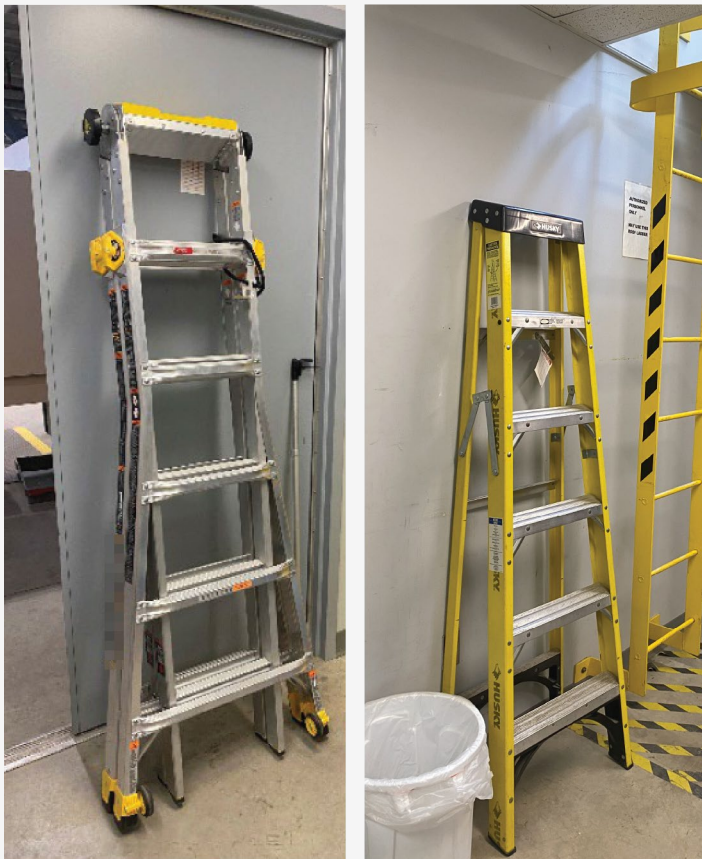
Figure 4. Unsecured Ladders

- One fire extinguisher that was not mounted or clearly marked on the wall.
- Two unsecured ladders (Figure 4).
- One electrical outlet in the carrier loading area that was broken and unsecured against a post (Figure 5).
- Five areas with missing, damaged, and stained ceiling tiles (Figure 6).
- A hole in the wall in the custodian's closet (Figure 7).
- No signage posted in the employee parking lot stating that vehicles may be subject to search.

Property Conditions: Five of the six property conditions sited during the visit have been abated and pictures provided as verification as well as onsite review. A requisition is pending for the sign "Vehicles Subject to Search" and will be posted upon arrival.

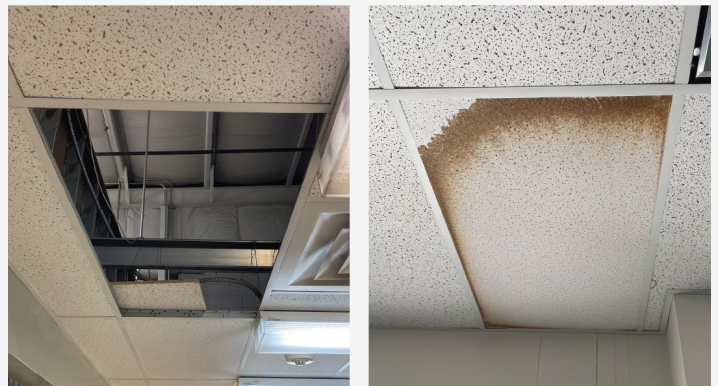
Figure 6. Examples of Missing and Stained Ceiling Tiles

Unit management did not take the necessary actions to verify that property condition issues were corrected because they were unaware of the issues we identified, except for the ceiling tiles. Management stated that they do not routinely walk around the facility to check for issues. Management also stated that they had fixed the roof leak which caused the stained ceiling tiles but had not made replacing the tiles a priority.
