Postal Service's Use of Automated Guided Vehicles

AUDIT REPORT

Report Number 23-057-R23 | August 17, 2023

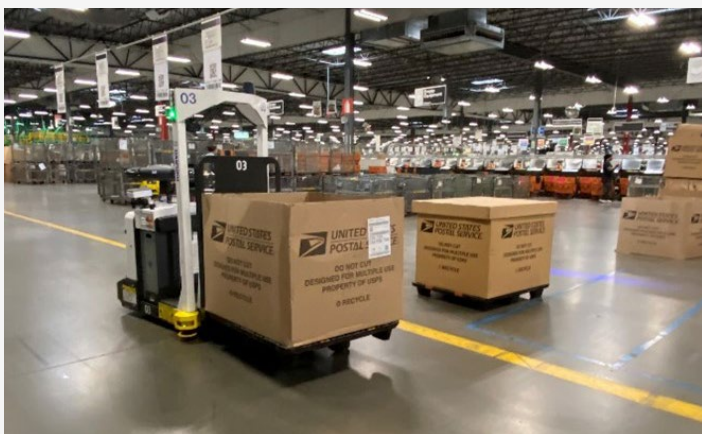
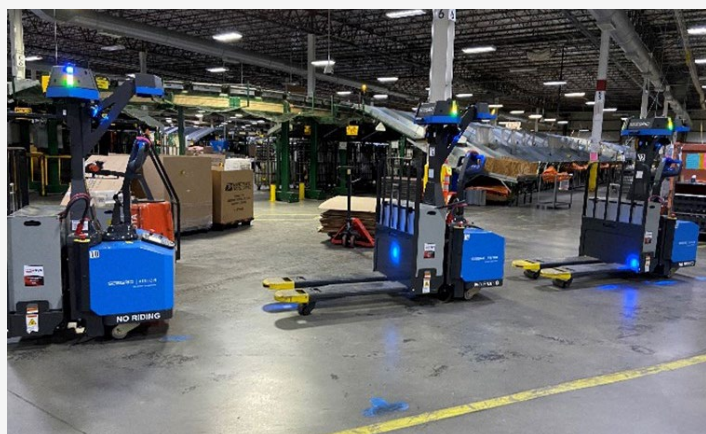
Pallet Jacks

the Postal Service spent [REDACTED] to purchase and deploy 350 AGVs between October 2019 and April 2022. The two types of Postal Service AGVs are pallet jacks, which move palletized mail, and tuggers, which pull wheeled mail transport equipment (MTE)¹ within a processing facility. The Postal Service expected AGVs would reduce mail handling hours, generate labor savings, and introduce automation to mail handling operations. See Figure 1 for the types of Postal Service AGVs.

Figure 1. Automated Guided Vehicles

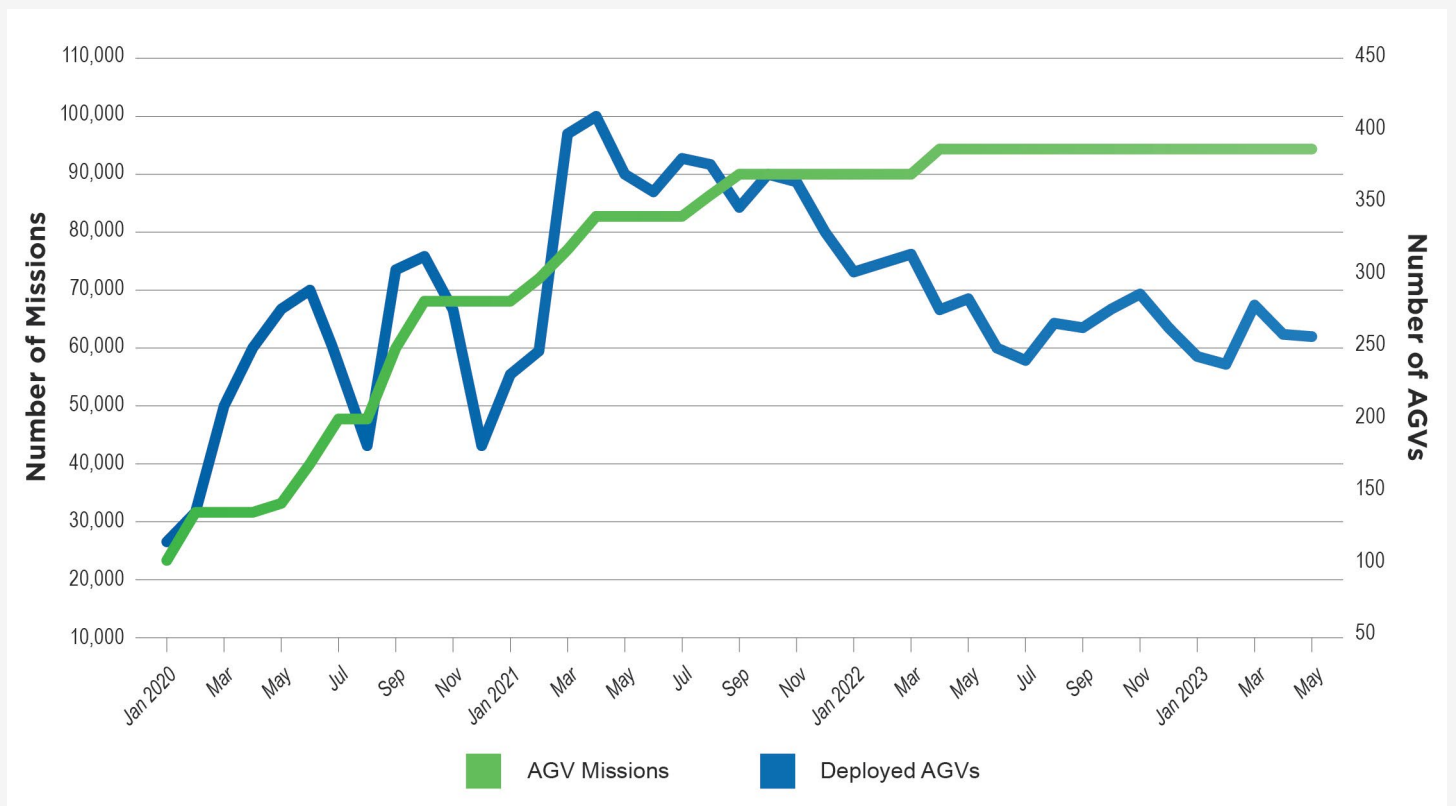
Figure 3. Deployed AGVs Compared to Completed Missions From January 2020 Through May 2023

The Postal Service did not use all AGVs as intended and did not meet performance goals for AGV use. Specifically, none of the AGVs or facilities consistently met either the hourly or mission performance goals. Further, we found the number of completed missions did not increase despite the Postal Service deploying more AGVs. See [Figure 3](#) for monthly completed missions.

We recommend that the **Vice President, Processing and Maintenance Operations** and the **Vice President, Engineering Systems**, develop and execute a plan to evaluate Automated Guided Vehicle locations, and require and monitor usage to improve performance.

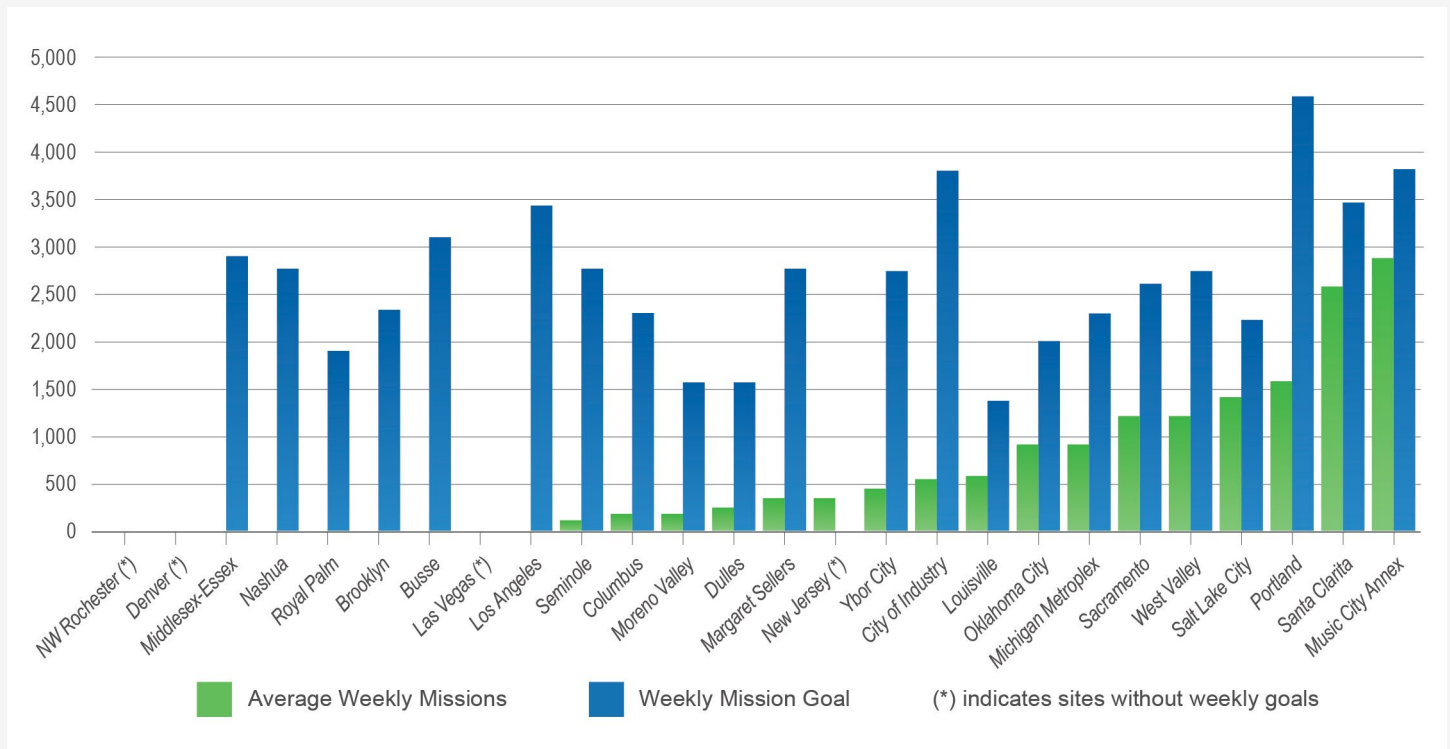
Figure 4. CY 2022 Average Weekly Missions

consistently met its performance goal.⁶ In CY 2022, only two processing facilities ever met their weekly goal: one for a total of three weeks and the other for nine weeks. In CY 2023, only one facility (Louisville) met average weekly performance goals. See Figure 4 and Figure 5 for a comparison of average weekly missions in CYs 2022 and 2023 to performance goals by processing facility.

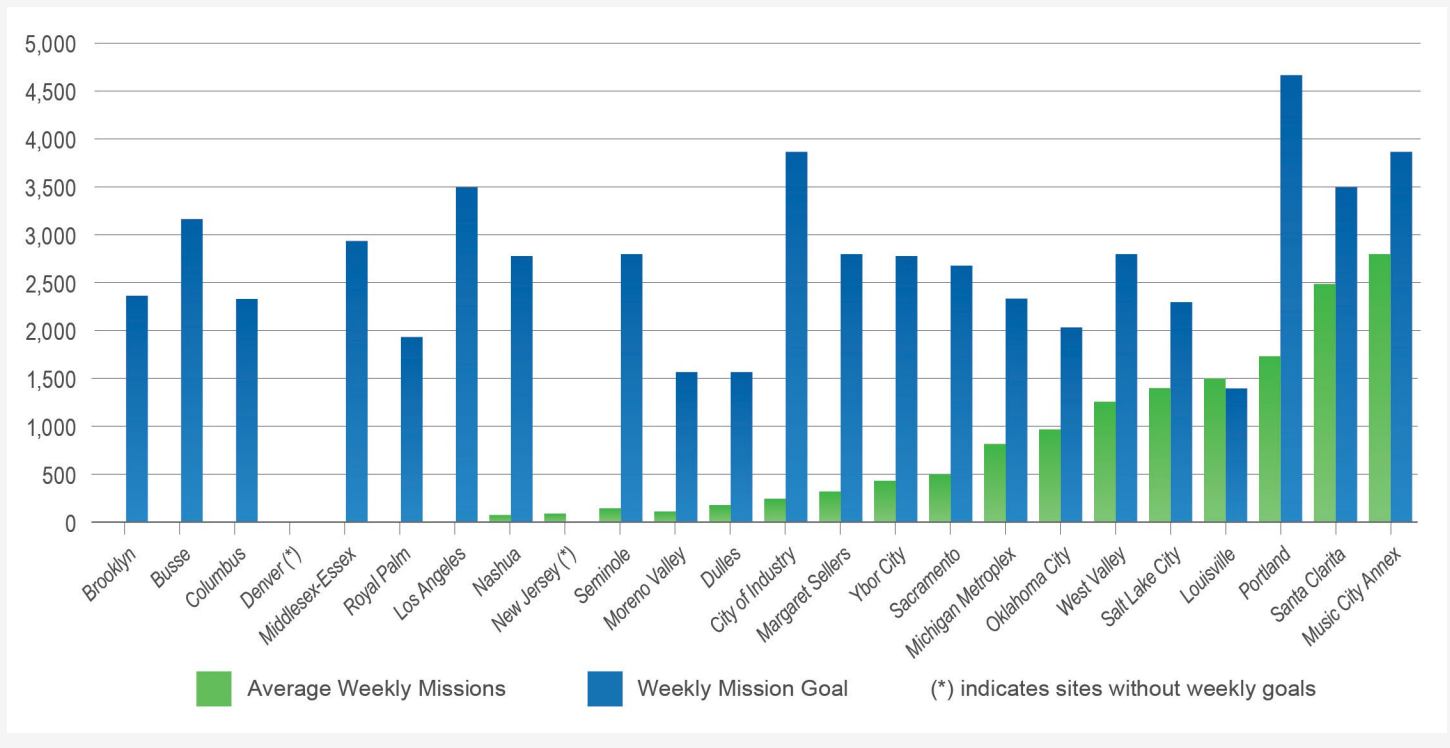
Figure 5. CY 2023 Average Weekly Missions Through June 11, 2023⁷

⁷ This figure displays mission data covering January 1, 2023, to June 11, 2023. Postal Service removed all AGVs in FY 2022 from Northwest Rochester and Las Vegas P&DCs.

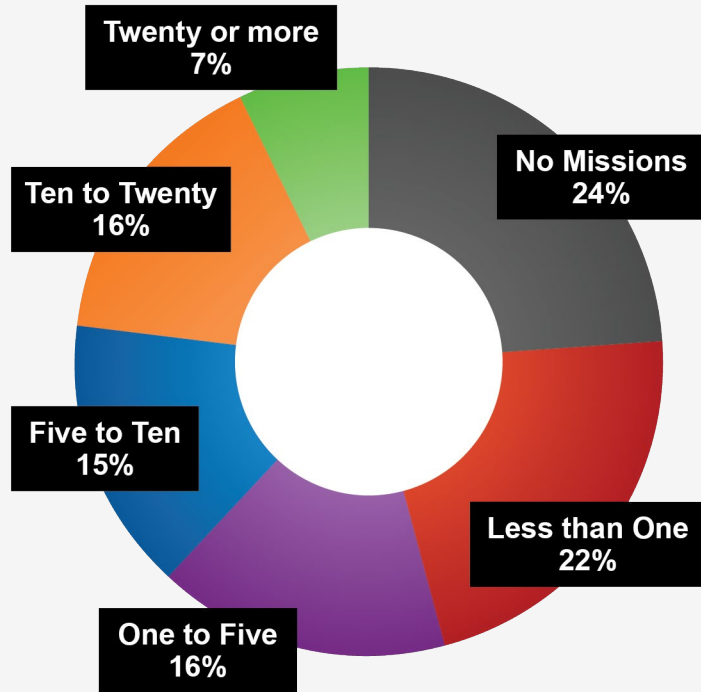
Figure 6. Average Daily Missions per AGV - CY 2022

We found 93 of 389 AGVs (24 percent) at processing facilities did not complete a single mission in CY 2022. In addition, 84 AGVs (22 percent) only completed, on average, less than one mission per day. See Figure 6 for unused and underused AGVs during CY 2022.

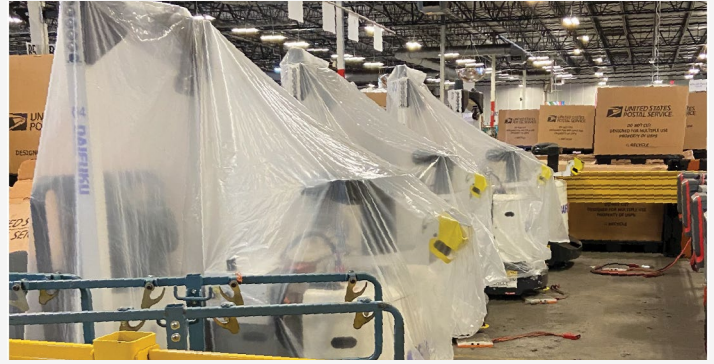
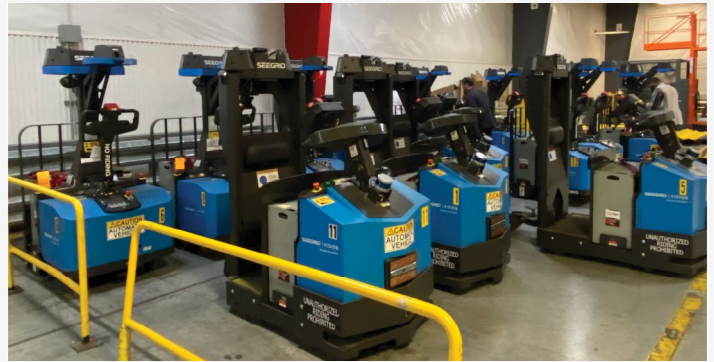
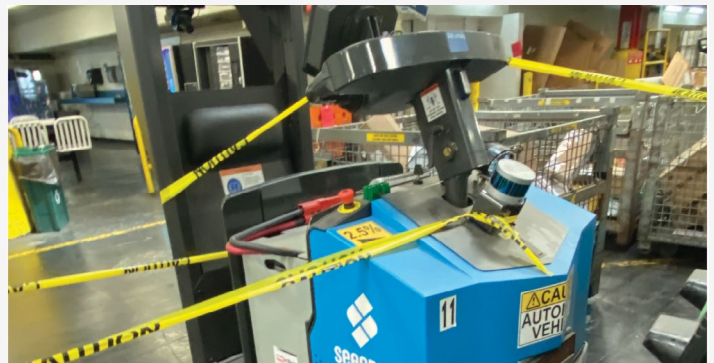
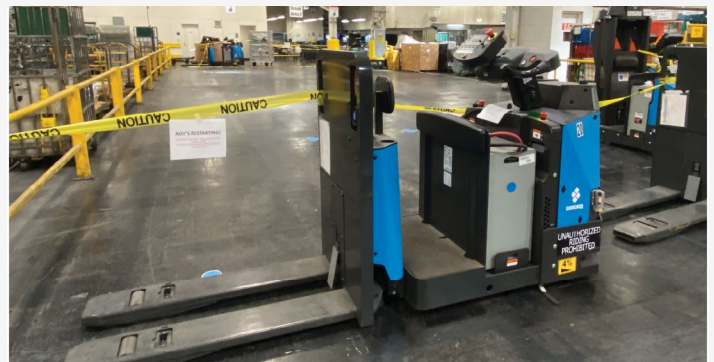
Figure 7. Unused Automated Guided Vehicles

We found unused or underused AGVs at all nine processing facilities visited. At the Royal Palm P&DC, we found AGVs covered in plastic wrap. At the Middlesex-Essex P&DC, we found all fifteen AGVs sitting uncharged in a closed wing of the processing facility. At the Los Angeles P&DC, we found AGVs used to block off floor space instead of moving mail. See Figure 7 for examples of unused AGVs.

We also found unused equipment at the two processing facilities with higher AGV use. Specifically, the Music City Annex completed the most AGV missions in CY 2022 but did not use two of its 18 AGVs. At the Oklahoma City P&DC, personnel did not use seven of its 20 AGVs. Management at both locations informed the OIG they planned to add AGV routes and increase future use.

Underuse of AGVs occurred because the Postal Service did not require or monitor the usage of AGVs. Postal Service Headquarters management stated changes to processing equipment and facility layout limited the usefulness of AGVs and drove down usage. Additionally, the Postal Service experienced high mail and package volumes due to the COVID-19 pandemic, which caused congestion at facilities and made AGV use difficult. In previous audits, we discussed the negative impact to operations due to the increased parcel volume during the FY 2021 peak mailing season.⁹

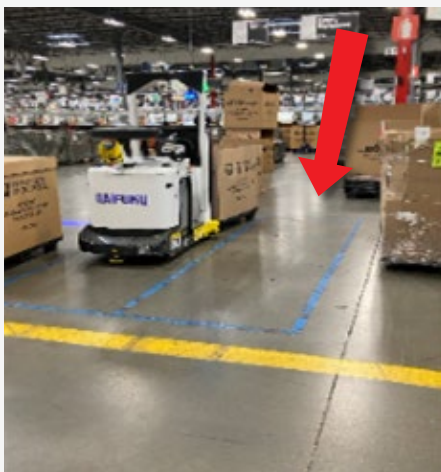
Clear Staging Area

Management at these facilities stated that they could not use AGVs on all tours. They stated congestion, using less wheeled MTE, and the removal of mail processing equipment as reasons why AGVs were impractical and not used. See Figure 8 for examples of clear and obstructed AGV areas.

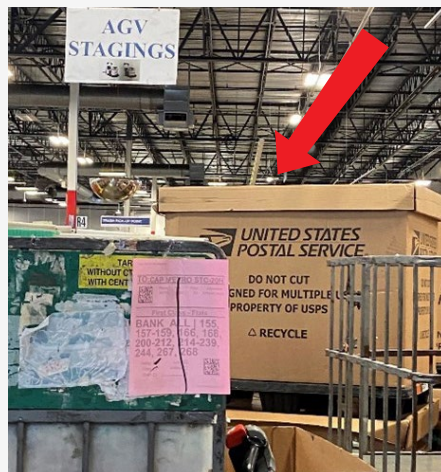
Blocked Staging Area

- Narrow or cluttered aisles.
- Lack of trained or knowledgeable personnel.
- Inability to change routes and pickup and drop off points in response to changing conditions.
- Unclear understanding of how to optimize AGV use.
- Lack of management support.
- Low support from craft personnel.

We recommend the **Vice President, Processing and Maintenance Operations**, in coordination with the **Vice President, Engineering Systems**, train and share best practices and usage goals with personnel at processing facilities that will have Automated Guided Vehicles to improve performance.
