Fleet Modernization – Facility Preparedness for Electric Vehicles at the Topeka Sorting and Delivery Center

AUDIT REPORT

Report Number 24-056-R25 | January 8, 2025

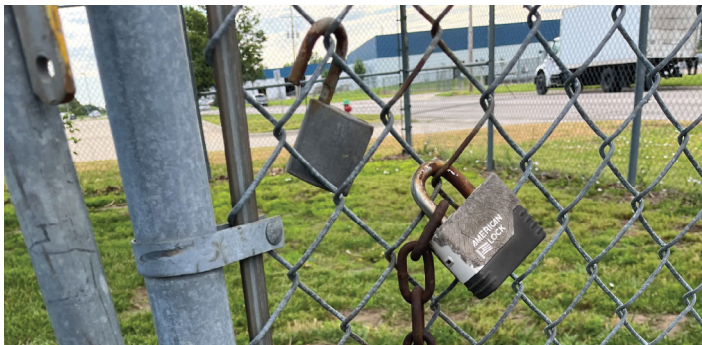
Figure 1. Unlocked Delivery Parking Lot Gate

Local management at the Topeka S&DC failed to secure EV infrastructure. Specifically, management did not secure the delivery vehicle parking lot at the end of the day (see Figure 1) and left all the electrical panels unlocked with the keys inside their box (see Figure 2). In addition to being unlocked, one panel had several taped drill marks within the enclosure (see Figure 3), which if not properly sealed could possibly compromise the National Electrical Manufacturer Association¹³ 3R¹⁴ rating, potentially allowing water into the enclosure. Additionally, the facility lacked readable signage to restrict public access to the delivery vehicle parking lot, chargers, transformers, or electrical panels as required (see Figure 4).

Postal Service policy¹⁵ states gates must have a hardened steel chain secured with a padlock to prevent the opportunity for burglary or vandalism. It is the responsibility of all Postal Service employees to practice good security habits to prevent such crimes from taking place. Additionally, policy¹⁶ indicates security signage must be provided at 100-foot intervals using standard signage, which specifies parking regulations, towing enforcement, and restricted Postal Service property areas, and it

Topeka S&DC previously operated as a 24-hour facility, local management did not need to lock the delivery operation gates. Since its transition to an S&DC on June 3, 2023, and the cessation of round-the-clock operations, it is now necessary to secure the delivery gates daily. However, local management stated they never got into the habit of locking the gates once the facility stopped operating as a 24-hour facility. The facility's deteriorated signage, indicating vehicles are subject to search in the employee parking areas, resulted from prolonged exposure to sunlight and was not monitored or reported by local management as required. During the commissioning process, the drill holes in the panels were identified; however, the Postal Service contractor determined that the National Electrical Manufacturer Association 3R rating was intact.

Recommendation #1

Regarding recommendation 1, management stated it will reinforce the existing policy with the local management team. The target implementation date is February 28, 2025.

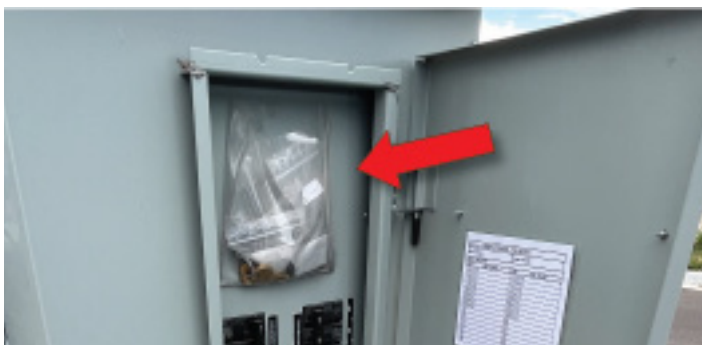
Figure 2. Electrical Panels Were Unlocked with Keys Inside

Further, local management stated they were aware of the unlocked electrical panels; however, they were too busy to lock them and would be locking them in the future. The Postal Service took corrective action and reiterated guidelines for managing locks and keys.¹⁹ Therefore, we are not making any recommendations pertaining to the unlocked electrical panels.

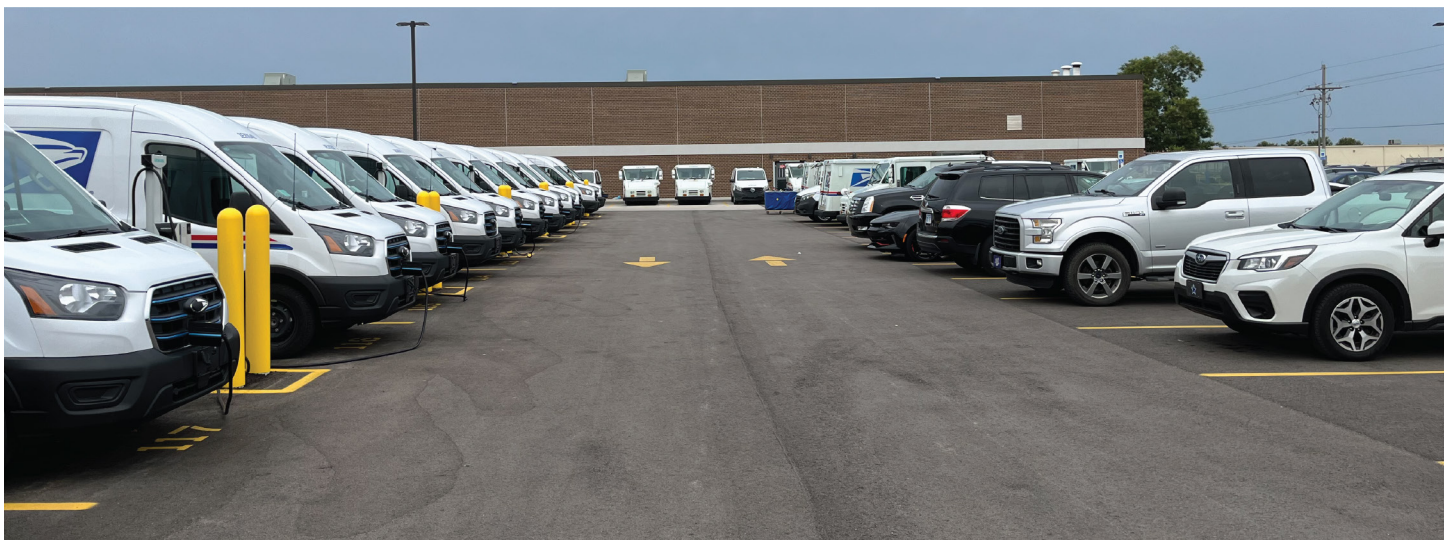
Figure 5. Insufficient Space for Maneuvering of COTS EVs

The Postal Service did not confirm the parking lot construction met the design criteria blueprints.²⁰ During a site visit on June 5, 2024, we statistically selected 35 of the 95 EV parking spaces and found 12 of the 35 (34 percent) spaces were less than the 20 feet in length as outlined in the design specifications. This — along with the size of the COTS EVs and the width of a parking lot drive aisle being shorter than the specified 24 feet (see Figure 5) — did

not provide sufficient space for maneuvering. The OIG witnessed and multiple Postal Service delivery carriers stated it takes six-to-eight attempts to safely maneuver the vehicles in and out of the parking spaces. Additionally, bollard spacing at one electrical panel frame did not meet design criteria blueprints for protecting critical electrical equipment from vehicular traffic (see Figure 6).

The drive aisle spacing constraints create a risk of damage to charging station infrastructure and the newly acquired EVs and could result in

accidents or delivery service impacts. Additionally, not ensuring that work performed by the contractor is in accordance with the required specifications before a site commissioning is completed can create an unsafe work environment for Postal Service personnel.

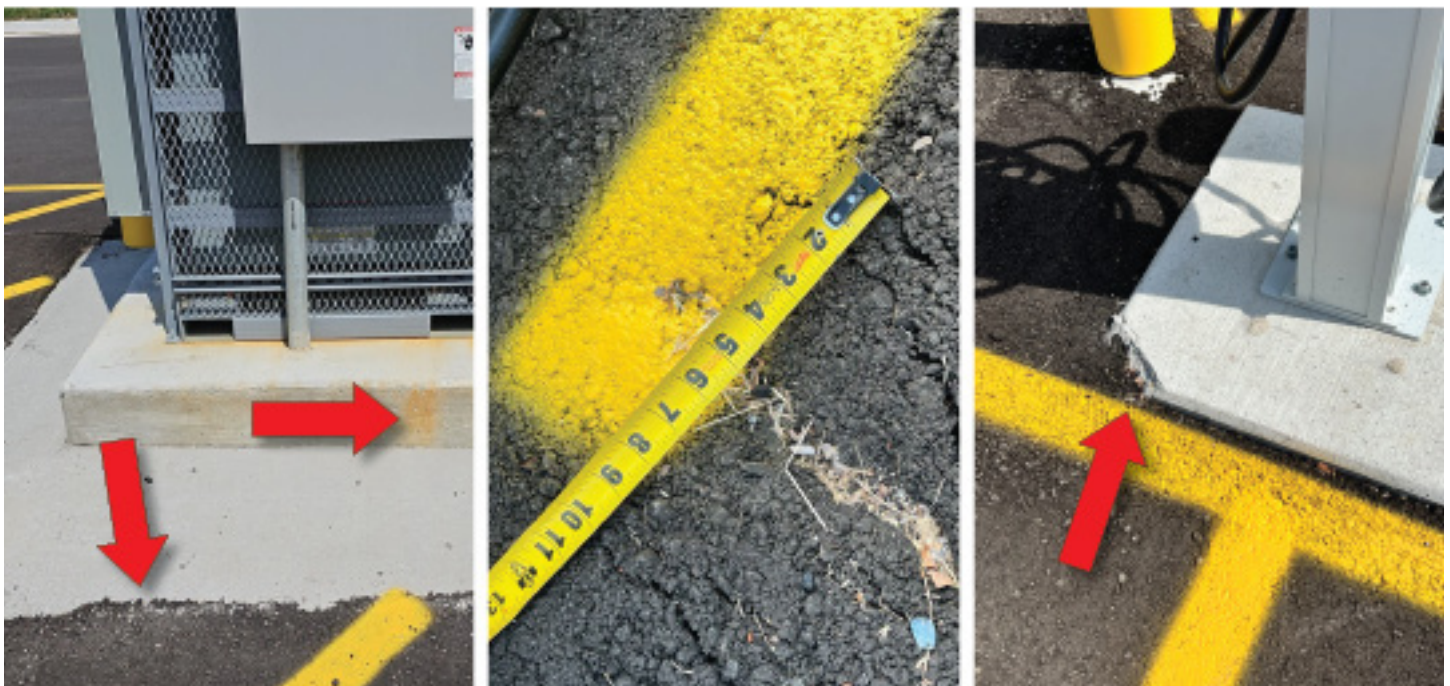
Figure 7. Rust, Chipped Concrete, and Sinking Asphalt in Parking Lot.

We also identified three additional potential safety issues in the parking lot such as visible rust, chipped concrete slabs, and the deterioration of pavement (see Figure 7). These issues were discussed with management during our audit and not previously reported to the NFRL or locally on a Postal Service

Form 1767 – *Record of Hazard, Unsafe Working Condition or Practice*. Local management was not aware they had to report EV Infrastructure issues as they were not involved in the installation process.

Management acknowledged that the items flagged in Figure 7 may represent minor quality or workmanship issues, so it was not concerned about failing to meet construction standards or design requirements. Management stated notable issues should be captured in either the construction punch list or in the commissioning process (which the field personnel participate in) for remediation by the installation supplier.

The **Chief Logistics and Infrastructure Officer and Executive Vice President**, in coordination with **Retail and Post Office Operations Vice President**, communicate to locations with electric vehicle infrastructure that policy regarding reporting safety hazards also includes electric vehicle infrastructure.

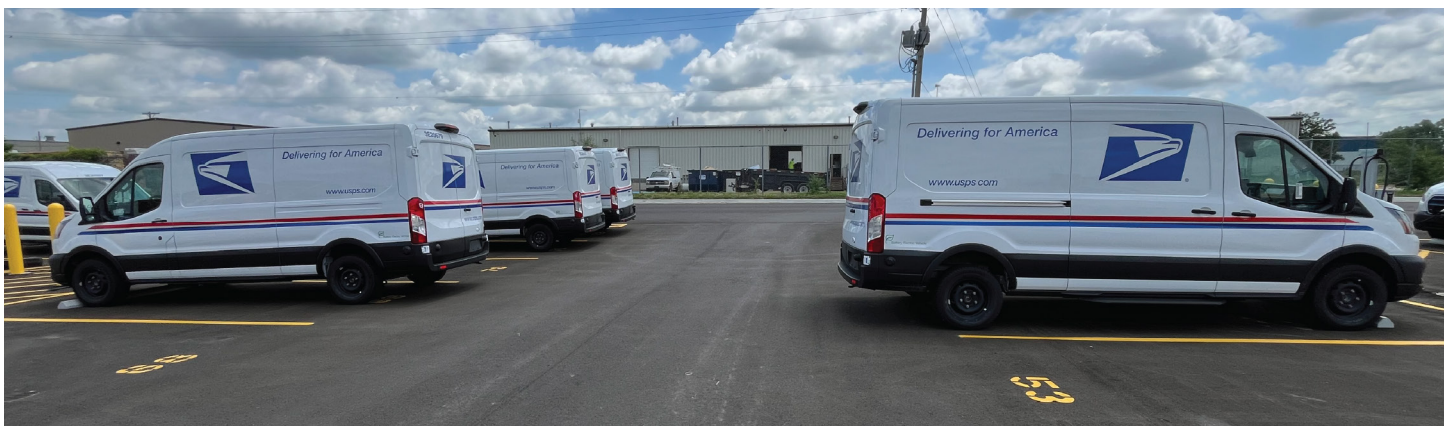
Figure 8. Incorrectly Parked COTS EVs

We also observed the COTS EVs incorrectly parked headfirst into stalls designed for NGDV EVs, which would require carriers to load vehicles in traffic (see Figure 8). We informed local management that the vehicles should be backed into the space
